Stonybrook Creek Watershed

A Strategic Plan for Eliminating Barriers to Steelhead Migration

June 4, 2010

Michael Love & Associates

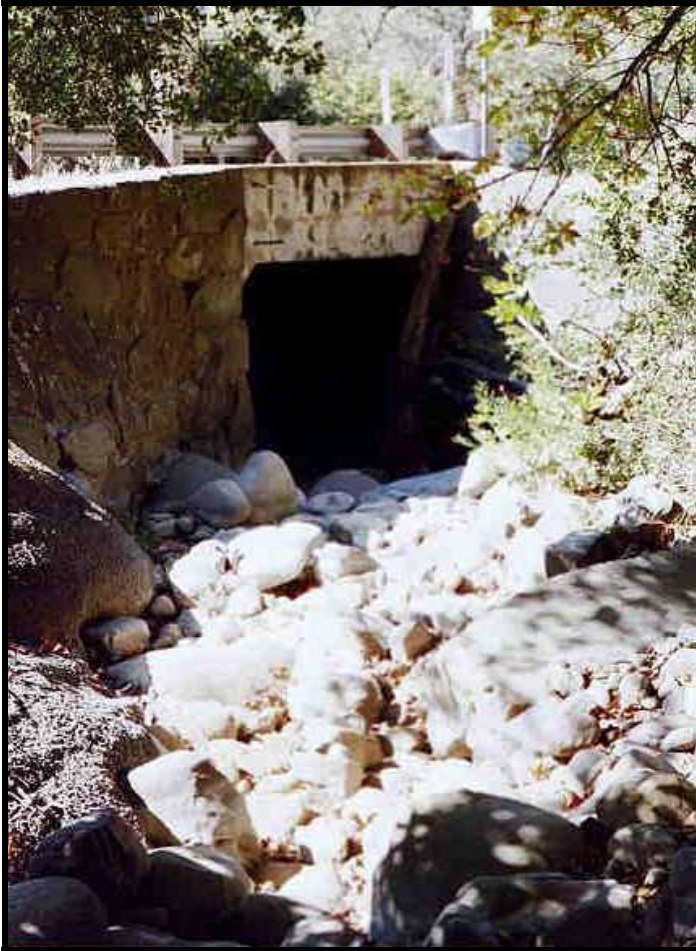
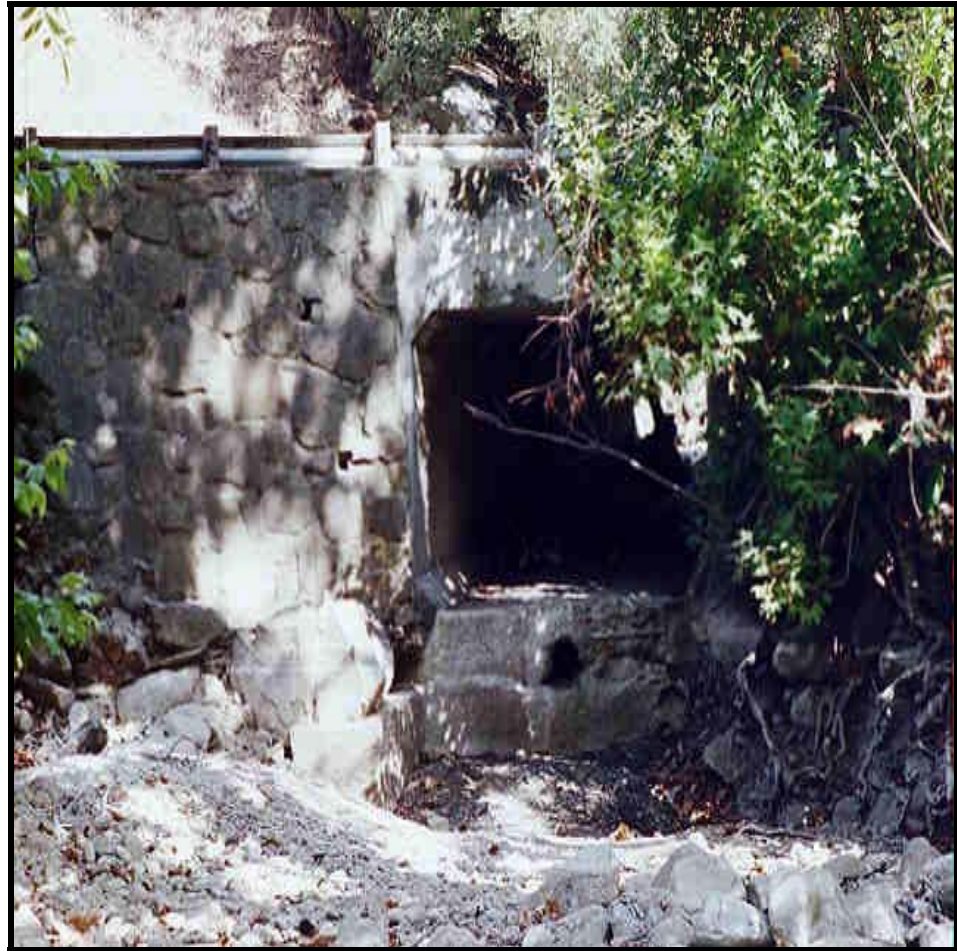
**Stream Mile 0.00 (Stobk#1): Highway 84 CalTrans Culvert
(Niles Canyon Road), Milepost 12.90**

0.00	CalTrans (Highway 84)	Culvert: 57.5' long, 10'x7' concrete box. (Stobk#1).	Complete Barrier ¹	Complete Barrier ¹
0.17	Private	Culvert: 16' long, triple 7' dia. RCP.	Complete Barrier ²	54% Passable ²

CalTrans is aware of the fish passage problems at this site and is planning to replace the crossing. Replacement should address the aggraded stream channel immediately upstream of the crossing and the poor alignment of the channel with the culvert inlet. Because this is the most downstream barrier on Stonybrook Creek, it should be given a high priority for replacement. The preferred crossing type, schedule for implementation, and cost for replacement is unknown at this time.

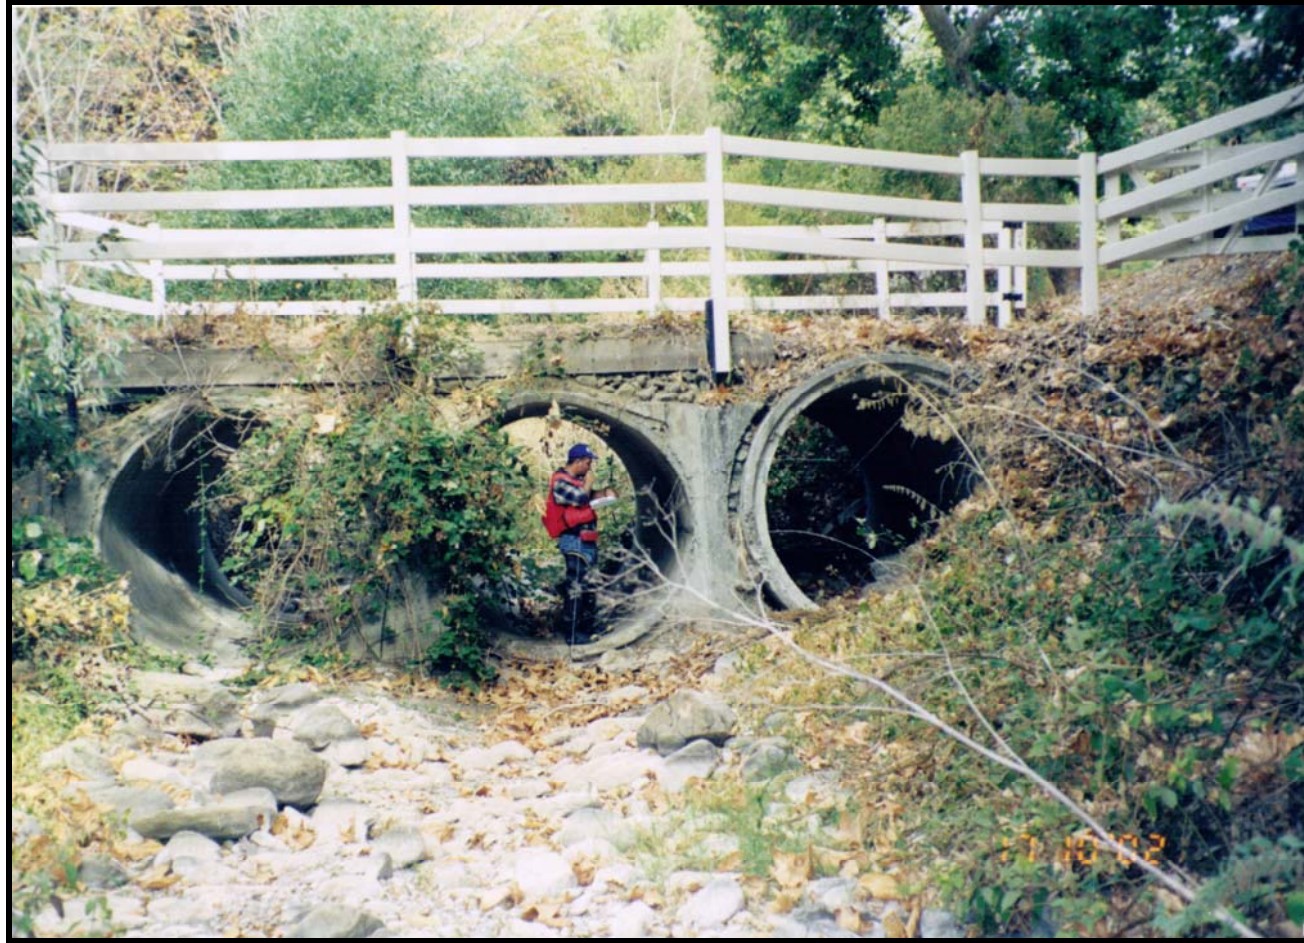
Stream Mile 0.17 Private Culvert

The crossing fails to meet CDFG fish passage assessment criteria for juvenile and resident trout at all flows, and is a barrier for adult steelhead 54% for of the migration flows. The radio tagged adult steelhead released into Alameda Creek in 1999 were able to pass through this crossing.

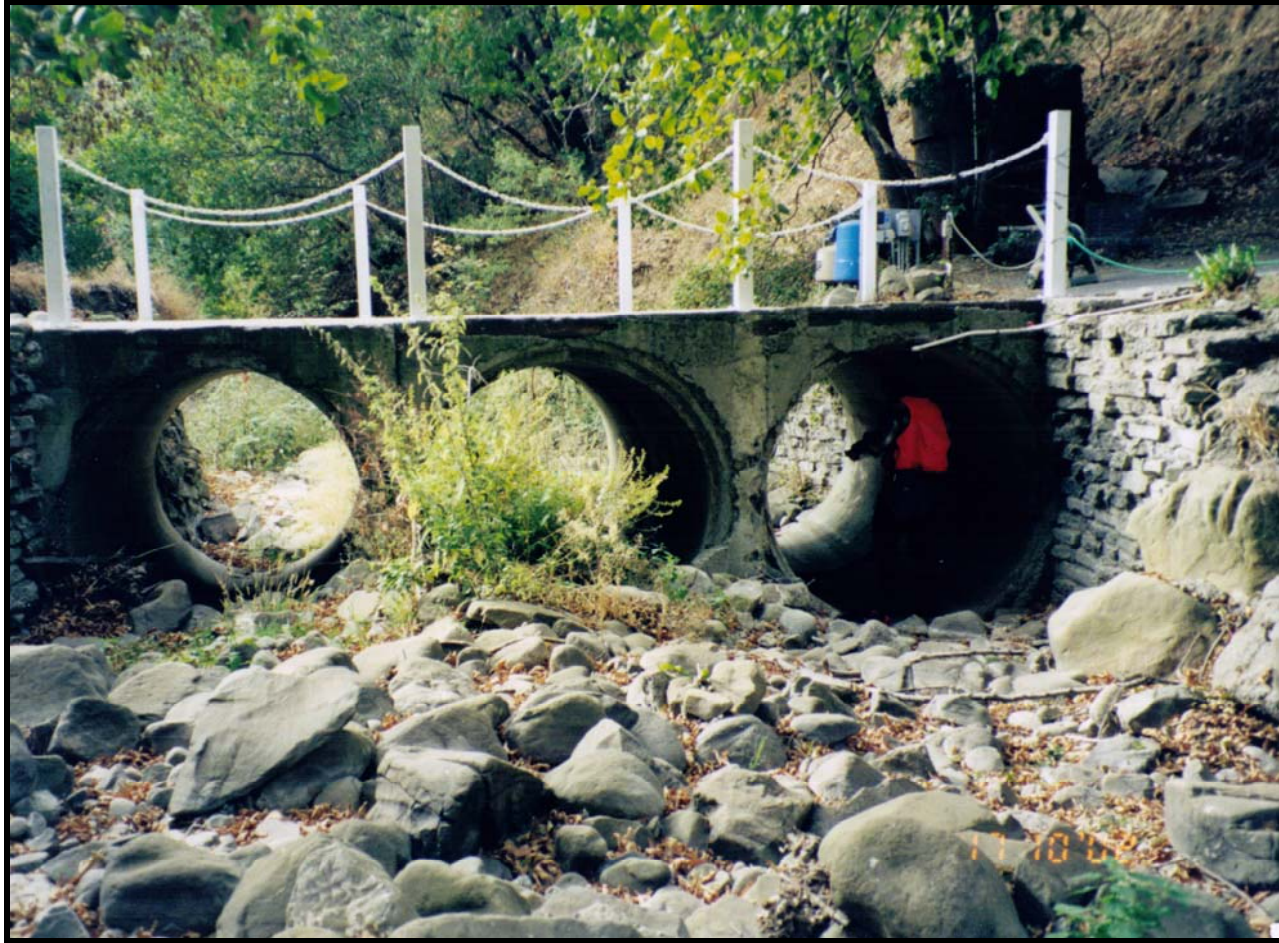
Stream Mile 0.23 Private Culvert

The crossing fails to meet CDFG fish passage assessment criteria for juvenile and resident trout at all flows, and is a barrier for adult steelhead for 45% of migration flows. The pair of radio tagged adult steelhead released into Alameda Creek in 1999 were able to pass through this crossing.

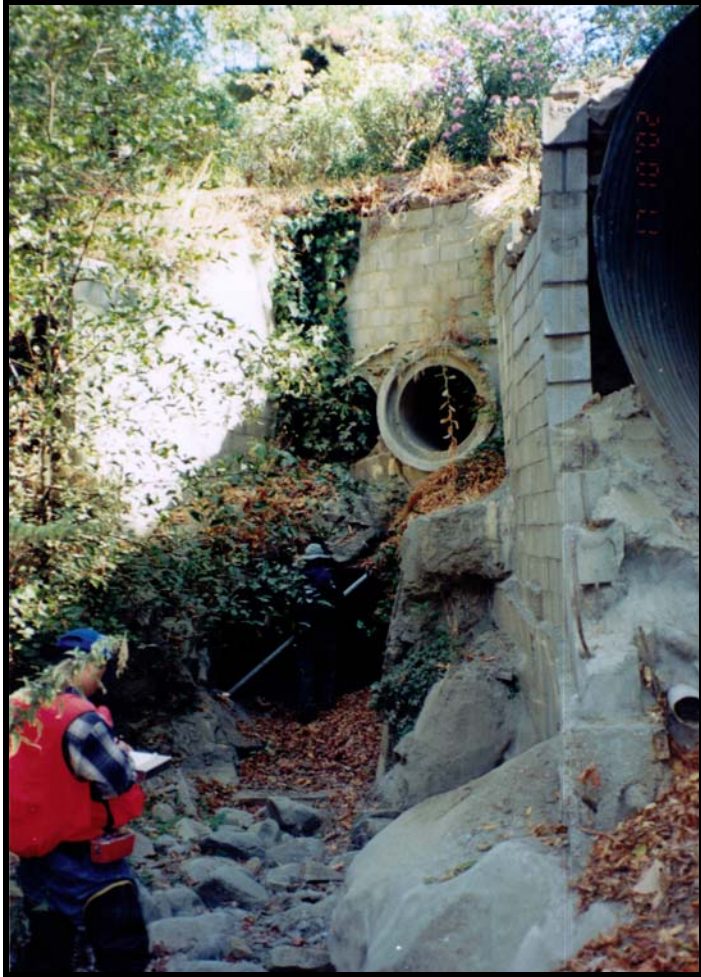
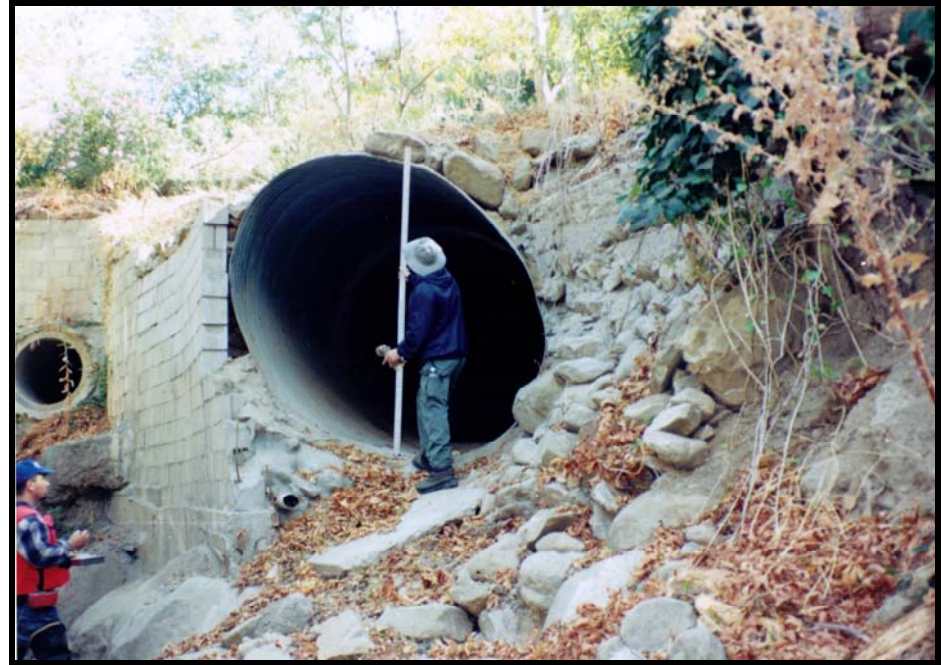
Stream Mile 0.58 Private Culvert

This crossing was only assessed visually for fish passage. It appears passable for adult steelhead at moderate fish passage flows, though water velocities through the single undersized culvert will likely be too great at higher fish passage flows. Accumulated sediment at the upstream end of the crossing may cause an impediment for passage. This crossing is likely not passable for juvenile trout at any flow. The pair of radio tagged adult steelhead released into Alameda Creek in 1999 were able to pass through this crossing.

Because this crossing was not surveyed, developing planning level recommendations and cost estimate was limited to assuming this replacement crossing would be similar to the replacement of

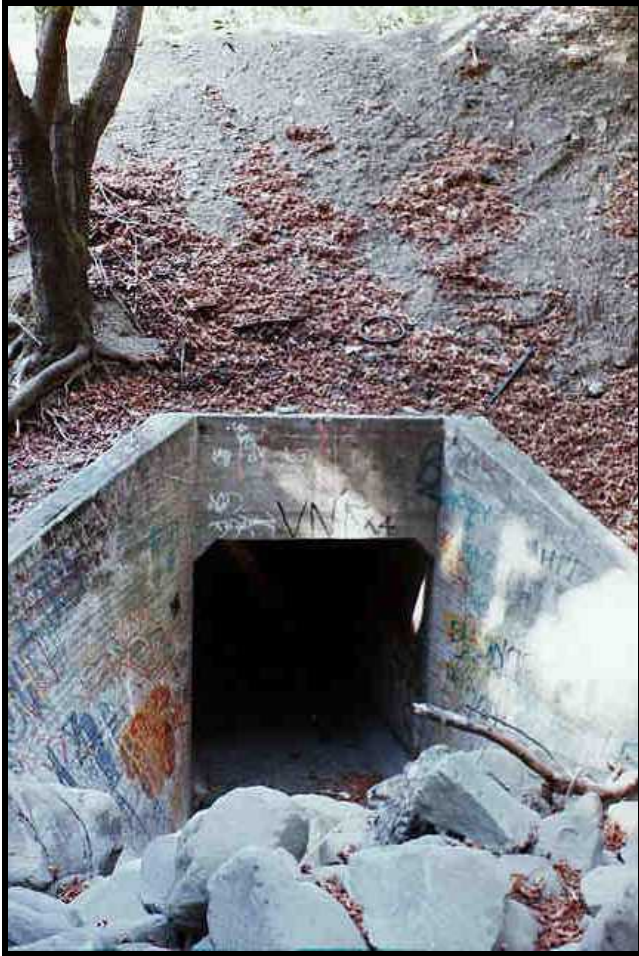
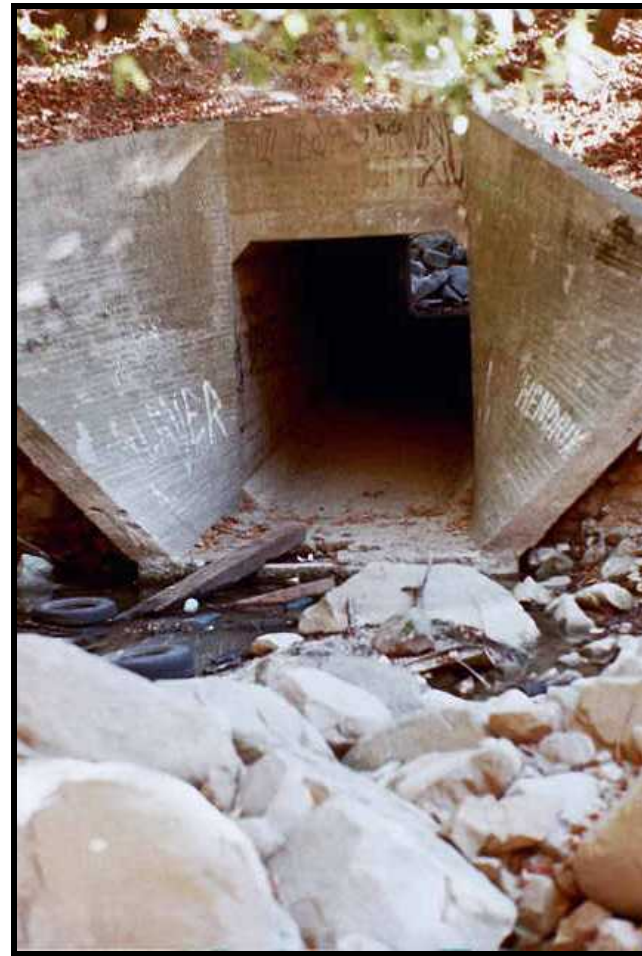
**Stream Mile 1.04 (Stobk#2): Alameda County Culvert
Palomares Road, Milepost 8.75**

The Palomares Road crossing at Mile Post 8.75 is located approximately 5,500 feet upstream from the confluence with Stonybrook Creek and Alameda Creek. The crossing was surveyed and assessed for fish passage in 2000 (MLA, 2001). The existing crossing consists of an 89-foot long 8-foot by 8-foot concrete box culvert in good condition, and with a large amount of road fill above it. The existing culvert is undersized; able to convey less than the 10-year peak flow before the inlet becomes submerged. The culvert creates a backwater during large flows, which has caused boulders to deposit in front of the culvert inlet, and created an 11-foot drop in the channel profile over a short distance.

Conceptual designs for this crossing were prepared in 2005 (CEMAR et. al, 2005). The conceptual design includes replacement of the culvert with an 80-foot span pre-fabricated steel bridge with a sheet-pile retaining wall foundation. The conceptual design also included regrading 250 feet of stream channel to a similar slope and morphology as the stable channel upstream and downstream of the crossing. A steel bridge was selected for this site because the roadway elevation is well above the 100-year water-surface elevation, therefore not likely to collect debris. Steel bridges are substantially less expensive than pre-stressed concrete structures.

Although there has not been a geomorphic assessment of the downstream channel, it appears that the existing culvert may substantially reduce the amount of large boulder-sized bedload transported downstream. There is a concern that replacing this crossing may cause the downstream private crossings, if not replaced, to become overwhelmed by the bedload. The first crossing downstream, at Stream Mile 0.58, is most at risk.

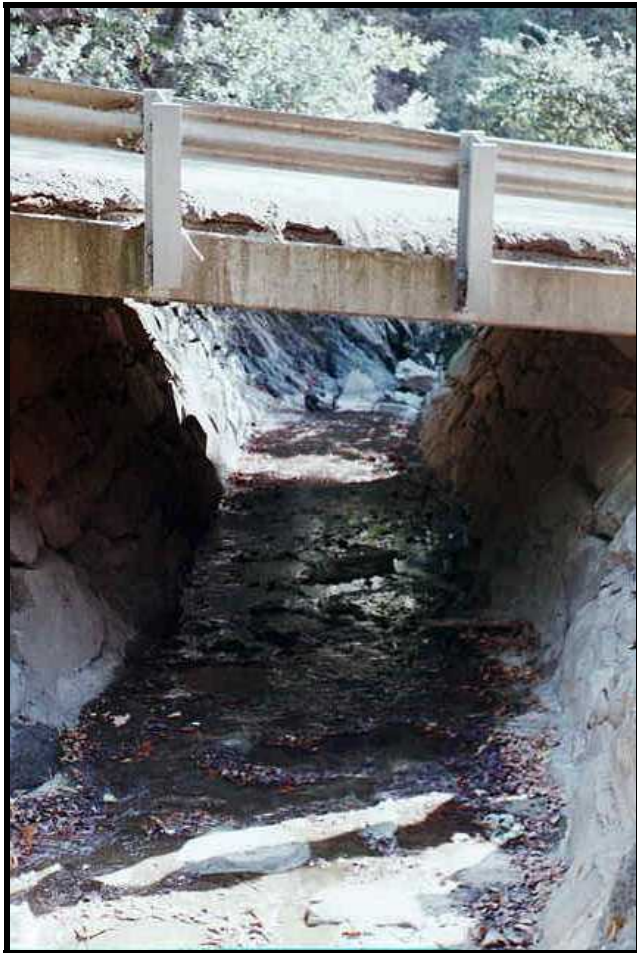
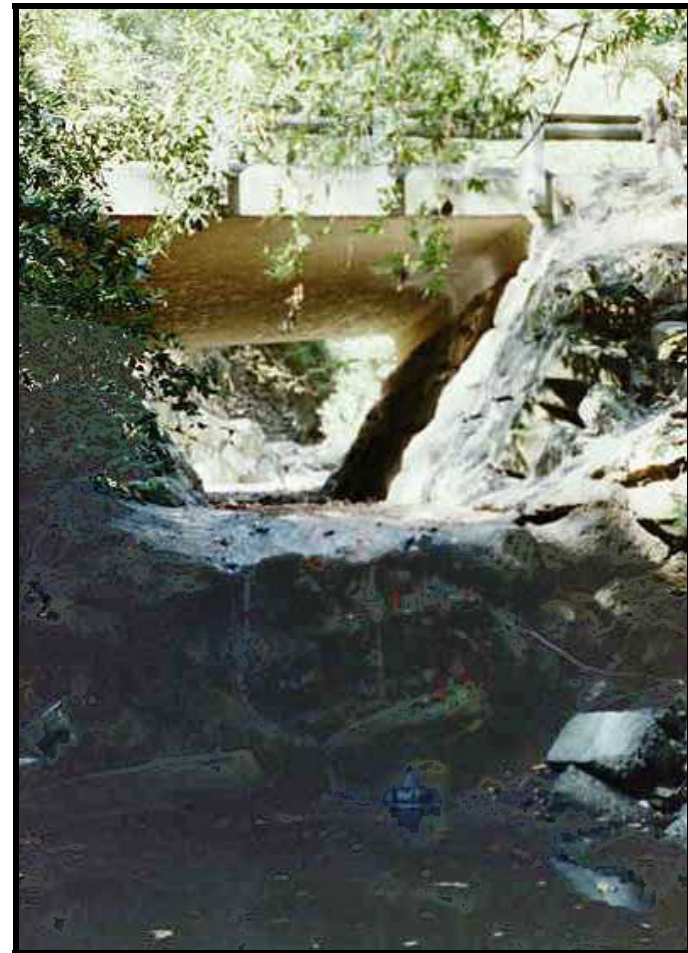
**Stream Mile 1.21 (Stobk#3): Alameda County Bridge
Palomares Road, Milepost 8.60**

The Palomares Road crossing at Mile Post 8.60 is located approximately 6,400 feet upstream from the confluence of Stonybrook Creek and Alameda Creek. The crossing was surveyed and assessed for fish passage in 2000 (MLA, 2001). The existing crossing consists of grouted masonry channel and a concrete bridge deck in good condition. The masonry channel under the bridge was constructed in the 1930's and has since been grouted. The concrete bridge deck has been more recently replaced. The existing crossing is substantially undersized, conveying less than the 10-year peak flow before the inlet becomes submerged. The road prism for Palomares Road encroaches into the stream channel upstream of the crossing.

Conceptual designs for this crossing were prepared in 2005 (W&K et. al, 2005). The conceptual design includes replacement of the culvert with a 32-foot span pre-fabricated concrete bridge with strip footings keyed into bedrock. The concept plan also included regrading 140 feet of stream channel to a similar slope as the stable channel upstream and downstream of the crossing.

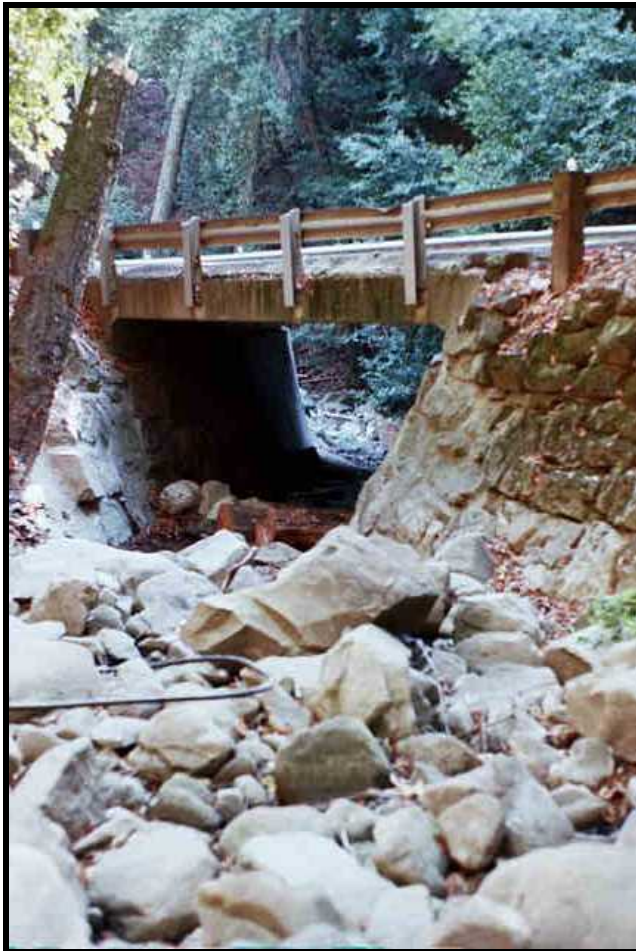
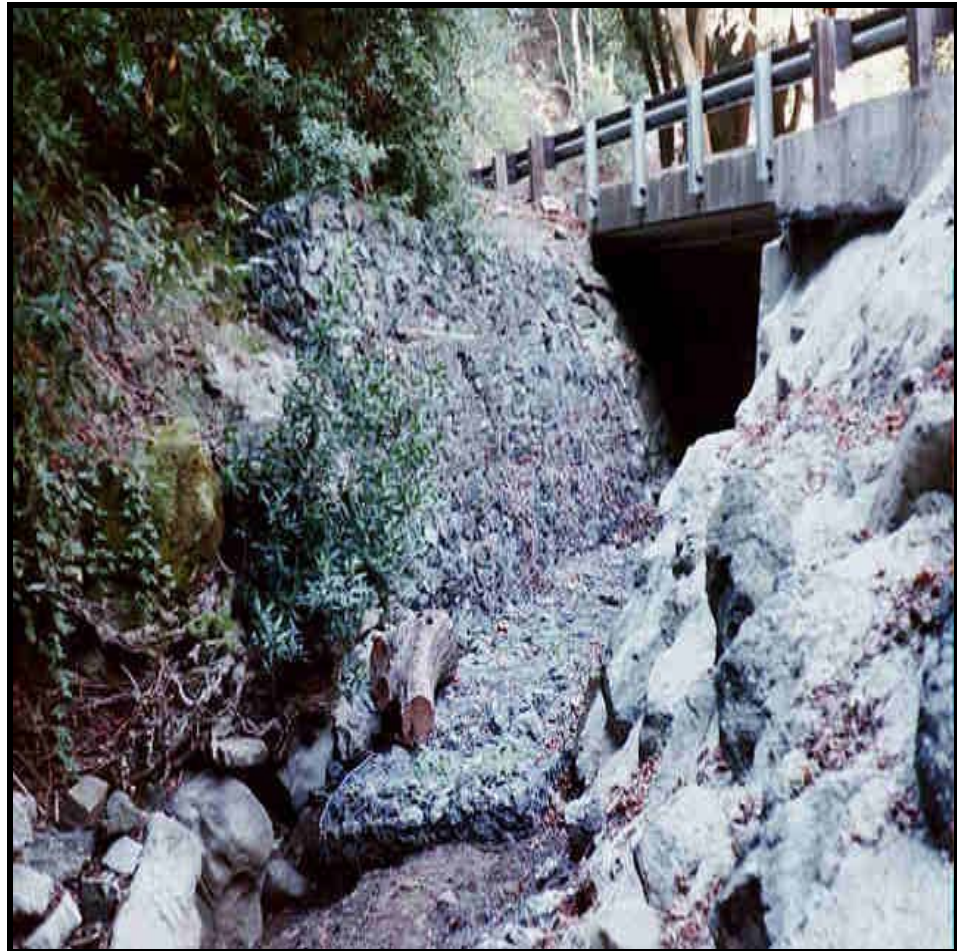
**Stream Mile 1.65 (Stobk#4): Alameda County Bridge
Palomares Road, Milepost 8.16**

The Palomares Road crossing at Mile Post 8.16 is located approximately 8,700 feet upstream of the confluence of Stonybrook Creek and Alameda Creek. The crossing was surveyed and assessed for fish passage in 2000 (MLA, 2001). The existing crossing consists of grouted masonry channel and a concrete bridge deck. The masonry channel under the bridge was constructed in the 1930's. Since then, the channel has been grouted and rip-rapped, and a gabion apron placed at the outlet. This gabion apron was failing during the time of the survey. The concrete bridge deck has been more recently replaced.

A 36-foot span, 8-foot high, prefabricated concrete bridge will convey the 100-year flow at this site. Approximately 240 feet of stream channel restoration is recommended to restore the channel profile and remove the bedload aggradation upstream of the crossing.

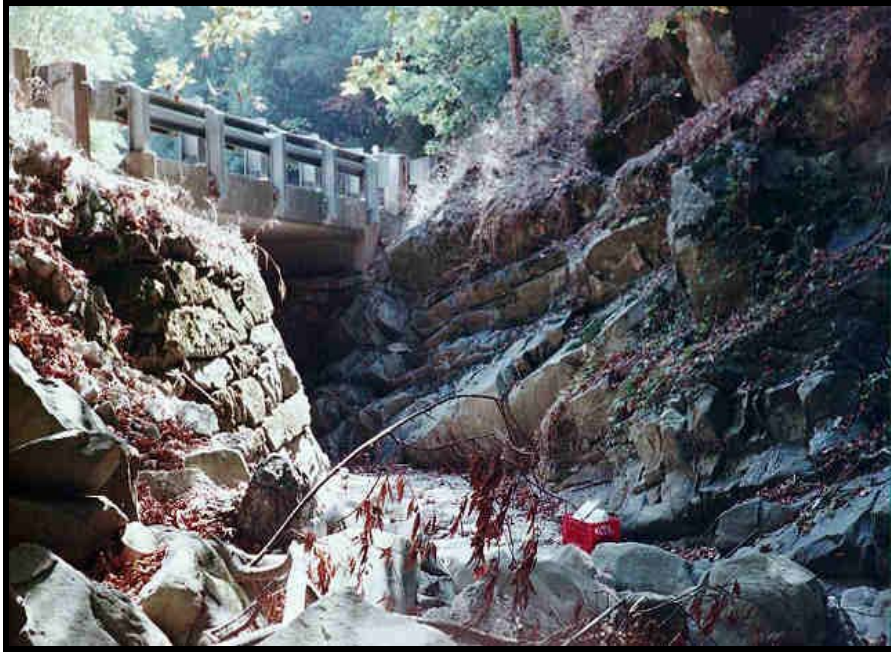
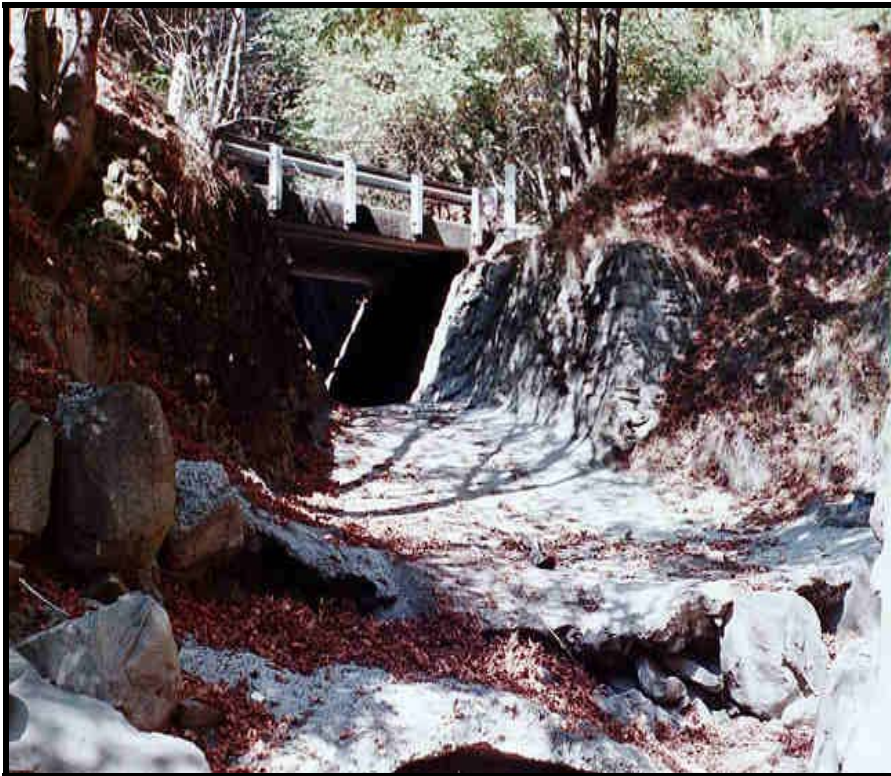
**Stream Mile 1.84 (Stobk#5): Alameda County
Bridge Palomares Road, Milepost 8.00**

The Palomares Road crossing at Mile Post 8.00 is located approximately 9,200 feet upstream from the confluence of Stonybrook Creek and Alameda Creek. The crossing was surveyed and assessed for fish passage in 2000 (MLA, 2001). The existing crossing consists of grouted masonry channel and a concrete bridge deck. The masonry channel was constructed in the 1930's. Since then, the channel bottom under the bridge has been grouted. The concrete bridge deck has been more recently replaced. The grouted outlet apron is severely undercut.

A prefabricated concrete arch culvert with a 16-foot span and 13-foot rise will convey the 100-year flow at this site. Approximately 135 feet of stream channel restoration is recommended to restore the channel profile through the crossing. The concrete rubble in the channel approximately 200 feet upstream of the crossing should be removed as part of the crossing replacement project

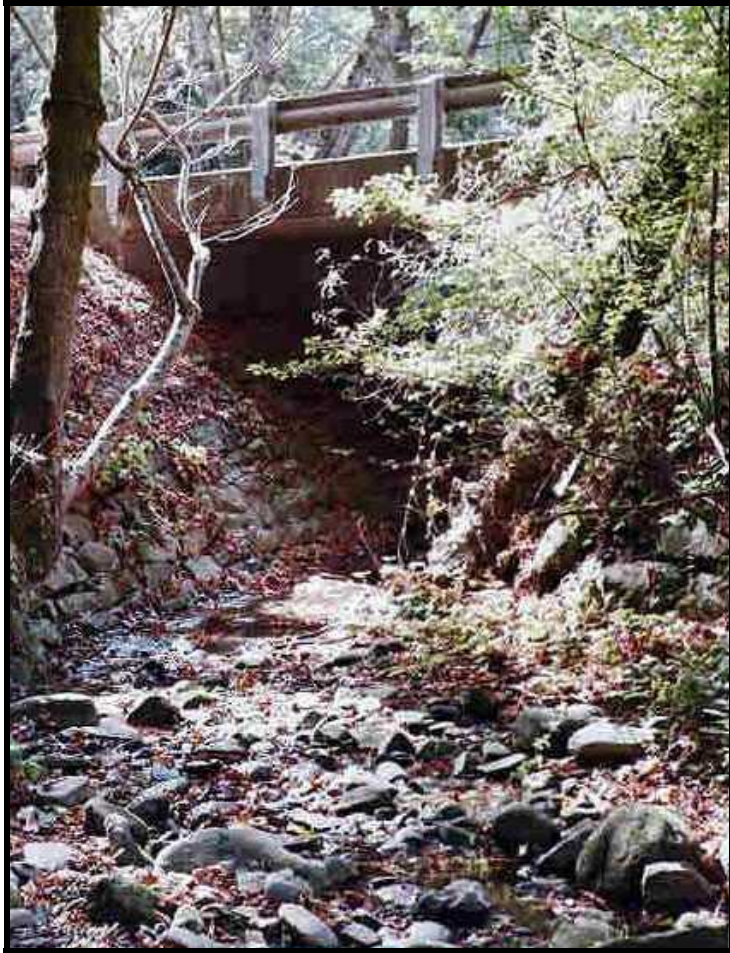
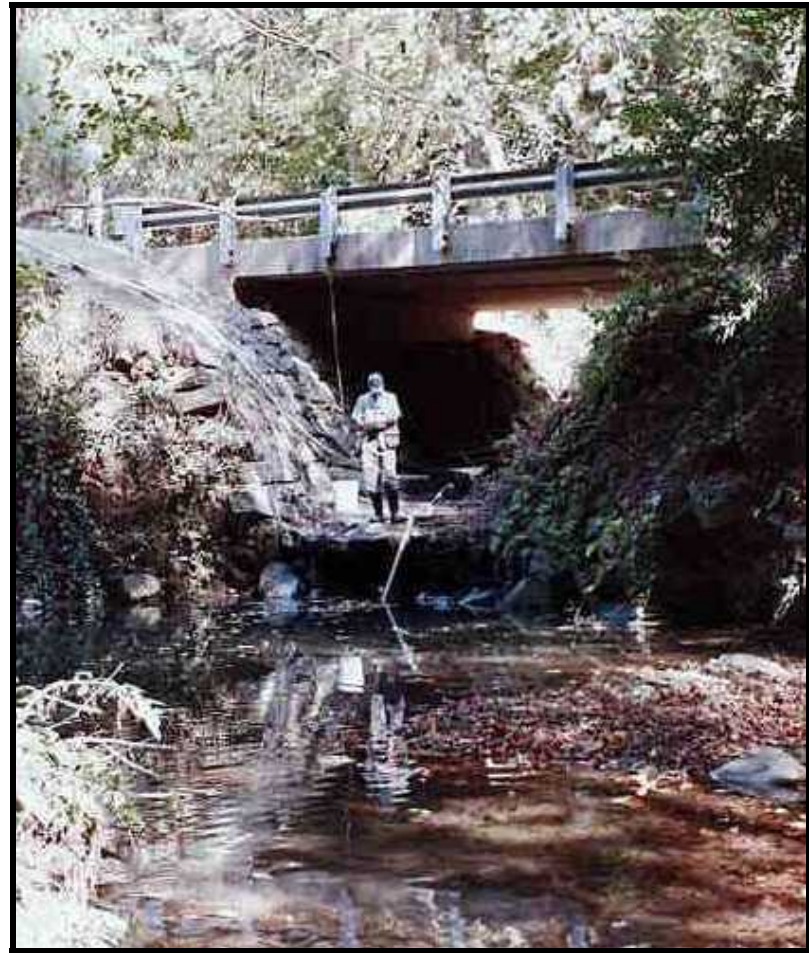
**Stream Mile 2.25 (Stobk#6): Alameda County Bridge
Palomares Road, Milepost 7.57**

The Palomares Road crossing at Mile Post 7.57 is located approximately 12,000 feet upstream from the confluence of Stonybrook Creek and Alameda Creek. The crossing was surveyed and assessed for fish passage in 2000 (MLA, 2001). The existing crossing consists of grouted masonry channel and a concrete bridge deck. The masonry channel was constructed in the 1930's. Since then, the channel bottom under the bridge has been grouted and the concrete deck replaced. The outlet apron is severely undercut.

The preferred treatment for this site is replacement of the crossing with an open bottom structure. However, it is feasible to retrofit the structure to eliminate the outlet drop and improve hydraulic conditions within the crossing.

Replacement of the crossing could utilize a 20-foot span and 11-foot rise prefabricated concrete arch that conveys the 100-year peak flow at this site. Approximately 200 feet of stream channel restoration is recommended to restore the channel profile through the crossing.
