# **Fish Passage Assessment of Private Stream Crossings on Lower Stonybrook Creek**

**Prepared by:**  
***Michael Love & Associates***

**December 27, 2005**

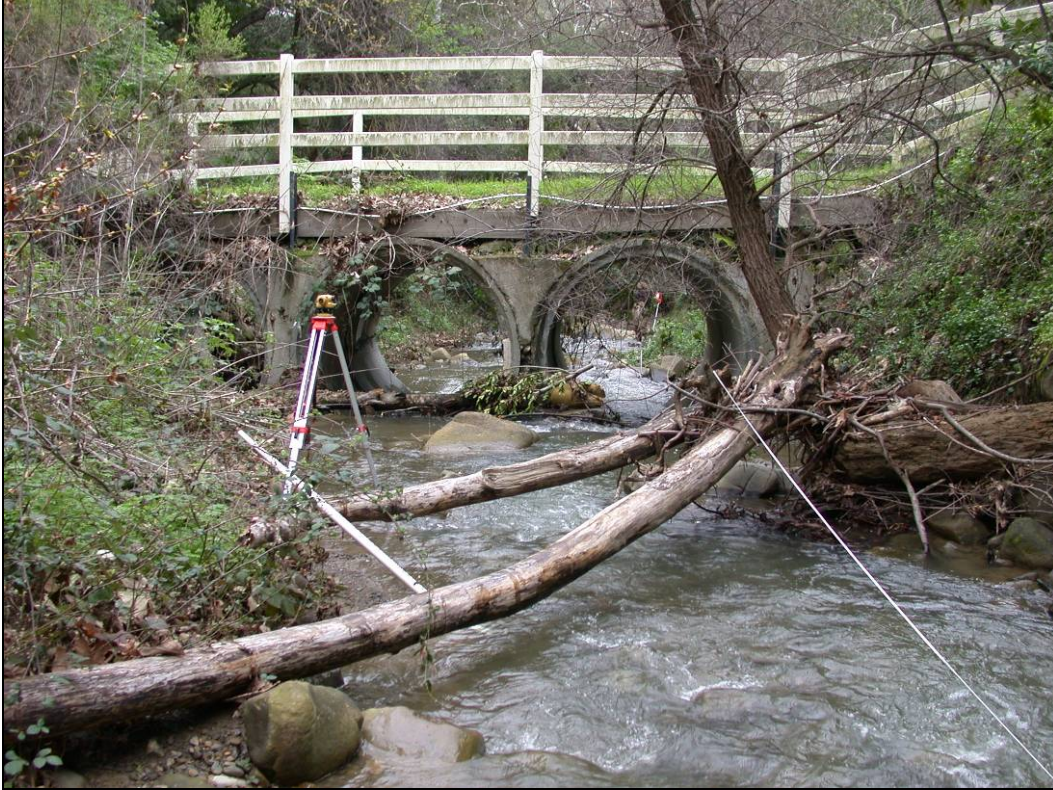
The lower crossing consisted of three 7-foot diameter circular concrete culverts with approximately 3-feet of fill above the culverts (Figure 4). Each culvert was 16-feet long and had slopes of 0.13%, 1.70%, and 2.20%. The outlets of all three culverts were at stream grade, allowing fish to swim, rather than leap, into the culvert.

Figure 4 - Inlet of Lower Crossing, consisting of three 7-foot diameter concrete culverts.

During the field visit we found several small diameter logs lodged across the inlet of the left and center culverts (Figure 4). There was a substantial amount of large bedload aggraded at the culvert inlets, which is often associated with backwater effects resulting from undersized or debris plugged culverts. Although the flows were relatively high during the field visit, no flow was observed in the left (looking downstream) culvert due to the aggraded material at the inlet. The average actively scoured channel width was 27-feet while the combined width of the culvert openings was 21-feet, constricting the active channel by 22%.

Assessment of the crossing using FishXing found that it satisfied adult steelhead passage criteria between 32 and 131 cfs (Table 6). This represents 54% of the flows between the lower and upper fish passage flows of 3 and 66.4 cfs. This is a relatively good window of passage in comparison to the majority of stream crossings on Stony brook Creek. Unfortunately, there is no passage window for resident rainbow trout and juvenile trout. For these fish, the water velocities become excessive before water depths become sufficient.

Using standard Federal Highways charts the capacity of the crossing was estimated to be 930 cfs when the headwater (water at the inlet) is at the top of the culvert and 1,320 cfs when the headwater is at the top of the road fill. Based on the estimated peak flows in Table 1, the crossing is able to pass the 25-year peak flow without overtopping the road but unable to pass the estimated 50-year peak flow. Additionally, having multiple culverts generally increases the likelihood of plugging by debris and becoming overwhelmed by large slugs of sediment moving down the channel (Furniss et. al, 1998).

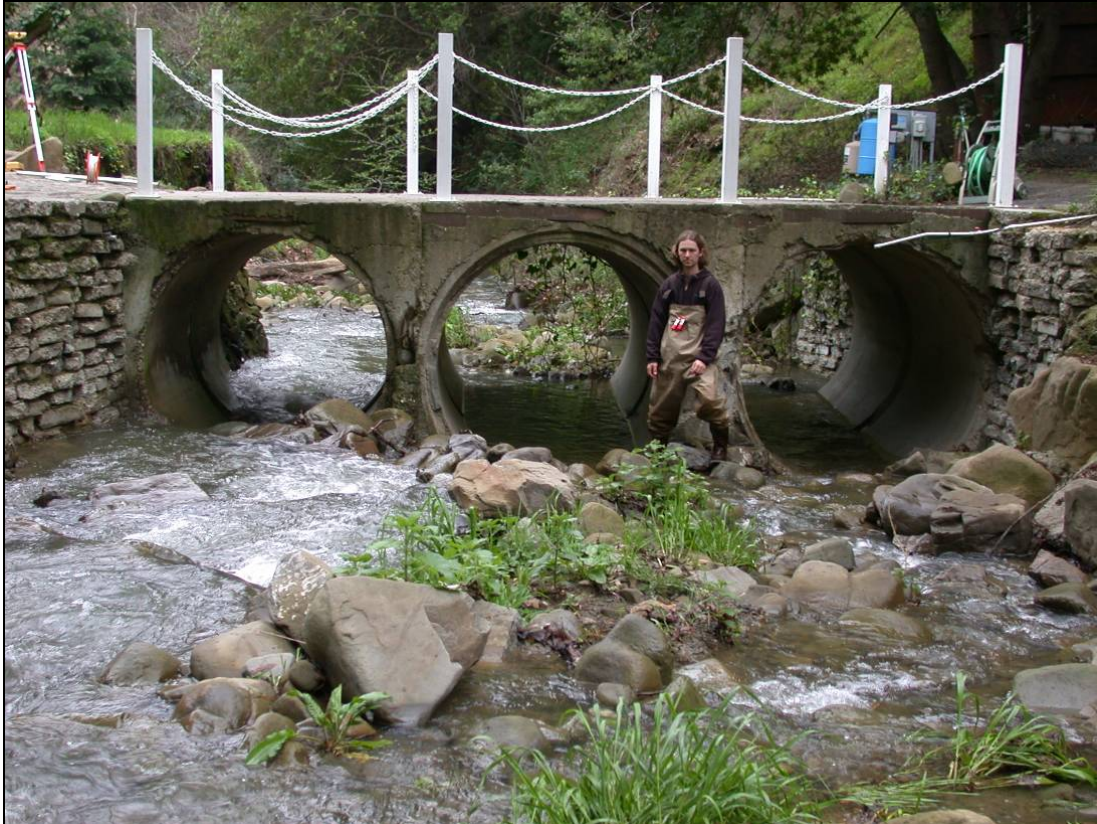
The upper crossing consisted of three 6-foot diameter circular concrete culverts with approximately 1-foot of fill placed above the culverts (Figure 5). Each culvert was 16-foot long and had slopes of -0.70%, 2.41%, and 7.97%. The outlet of the left culvert was at stream grade, allowing fish to swim, rather than leap, into the culvert. The other two culverts were perched about 0.3-feet above the downstream channel and are within the leaping ability of juvenile trout.

Assessment of the crossing using FishXing found that it satisfied adult steelhead passage criteria between 32 and 131 cfs (Table 7). This represents 45% of the flows between the lower and upper fish passage flows of 3 and 66.4 cfs. This is a relatively good window of passage in comparison to the majority of stream crossings on Stonybrook Creek examined in previous assessments. Unfortunately, there exists no passage window for rainbow trout and juvenile trout. For these fish, the water velocities become excessive before the water depths become sufficient.

Figure 5- Inlet of Upper Crossing, consisting of three 6-foot diameter concrete culverts.

The channel immediately upstream of the crossing showed obvious signs of aggradation, with large bedload deposited and a steep drop in the channel bed at the culvert inlets. The average actively scoured channel width was 27-feet while the combined width of the culvert openings was 18-feet, constricting the active channel by 33%. Although not accounted for in the FishXing analysis, this artificially steep slope near the culvert inlet along with the backwater affects caused by the constriction of the channel likely impedes fish passage too.

Using charts provided in the CDFG fish passage assessment protocol the capacity of the crossing was roughly estimated to be 624 cfs when the headwater (water at the inlet) is at the top of the culvert and 720 cfs when the headwater is at the top of the road fill. Based on the estimated peak flows in Table 1, the crossing is unable to pass the 10-year peak flow without overtopping the road. The land owner, as well as observations of debris lines made at the site, confirmed that the crossing has been overtopped at least once within the past five years. The potential increase in bedload size and volume transported downstream as a result of upstream culvert replacement projects could overwhelm this crossing, leading to frequent plugging and overtopping.
