Final Report
Emergency Action - Castlewood Broken Concrete Debris Removal

1. Project Purpose

Zone 7 of the Alameda County Flood Control and Water Conservation District (Zone 7) set out to remove the detached and suspended portions of the failing in-stream concrete structure located in Arroyo de la Laguna at the Castlewood Country Club pedestrian crossing. These pieces of the failed structure presented an obstruction to channel flow, and an imminent flood threat. There was serious concern that large pieces would migrate downstream and cause a threat to public health and safety. Work was conducted by a contractor under agreement with Zone 7 to assure permit conditions are met.

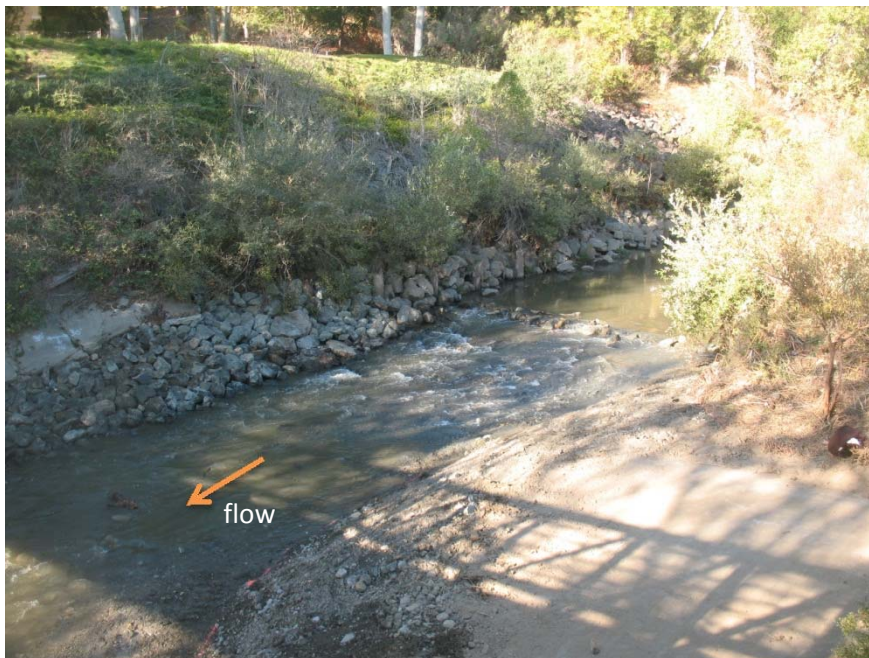
Post-Construction view. Note that all in-stream concrete debris has been removed while stable sections remain on either bank.

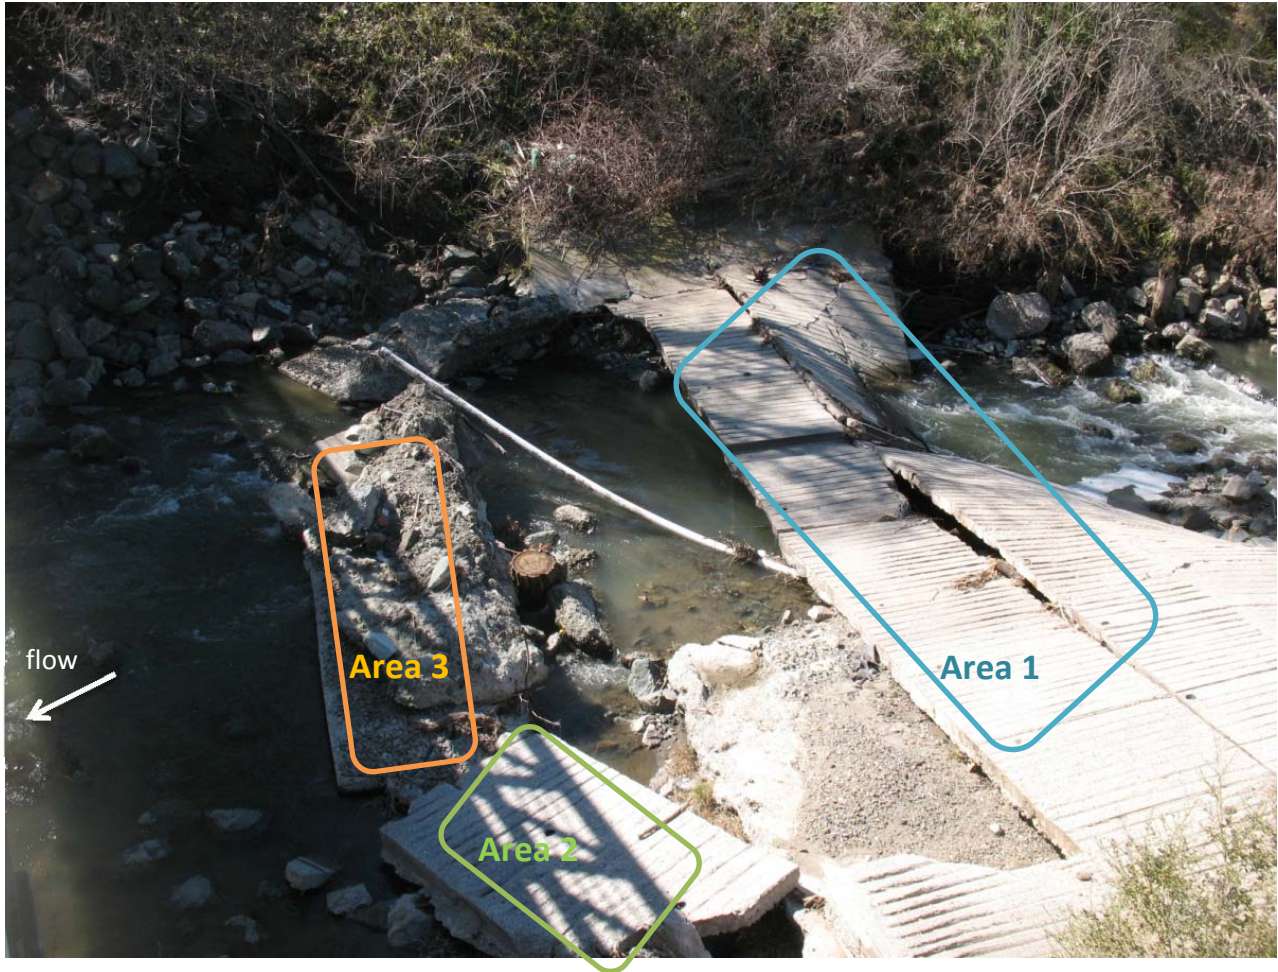
This failed concrete structure was unstable. Large sections of the concrete slab were either completely detached - or attached only along the sides but no longer supported underneath, such that typical summer flow was completely below the suspended structure. Portions had apparently been mobilized in higher flow events. In this condition, it doesn't function as an apron, grade control structure, or otherwise.

Work Area	Description	Approximate size
1	Unsupported, suspended section of concrete slab; partially broken and with flow beneath	50-ft. x 18-ft. x 7-in.
2	Detached section of concrete slab mostly out of waterline	11-ft. x 7-ft. x 7-in
3	Detached section of concrete slab and grout, resting top side down, with flow beneath	35-ft. x 7-ft. x 4-ft.

Figure 1. Castlewood Concrete Structure Proposed Work Areas
Photo date: 2/25/2013

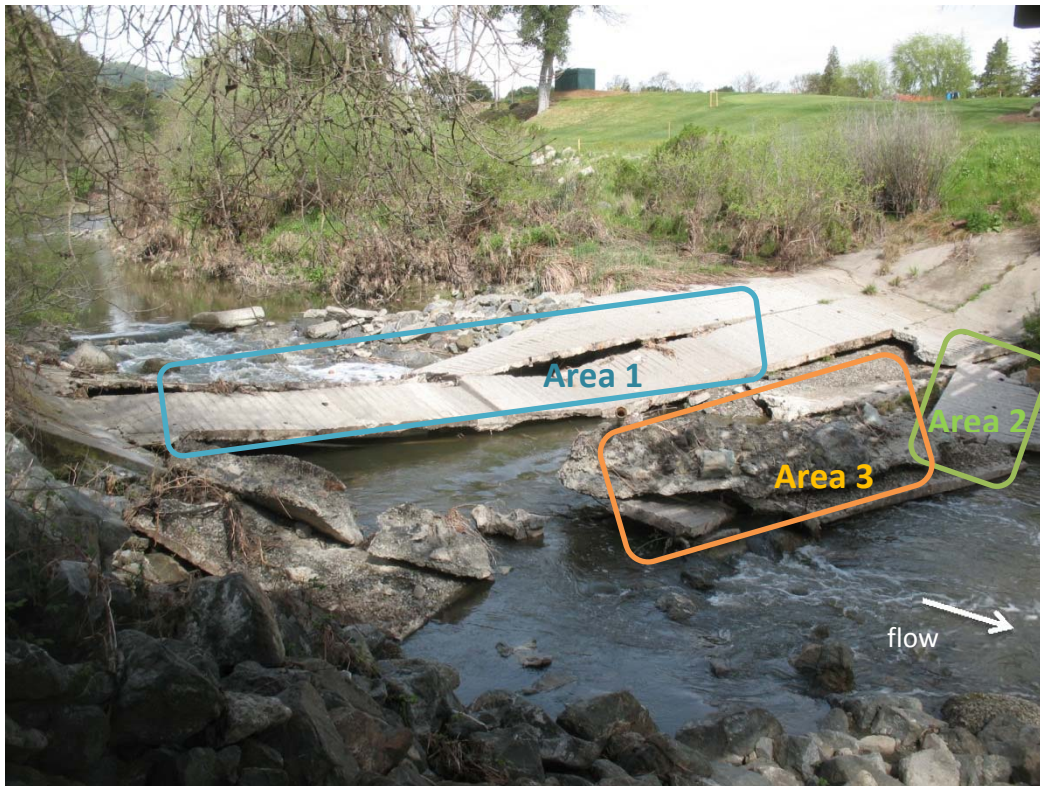
Figure 2. Upstream View of Castlewood Concrete Structure Work Areas

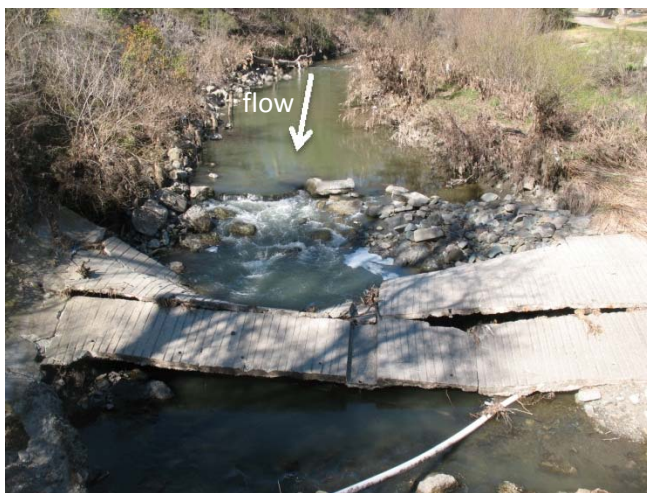
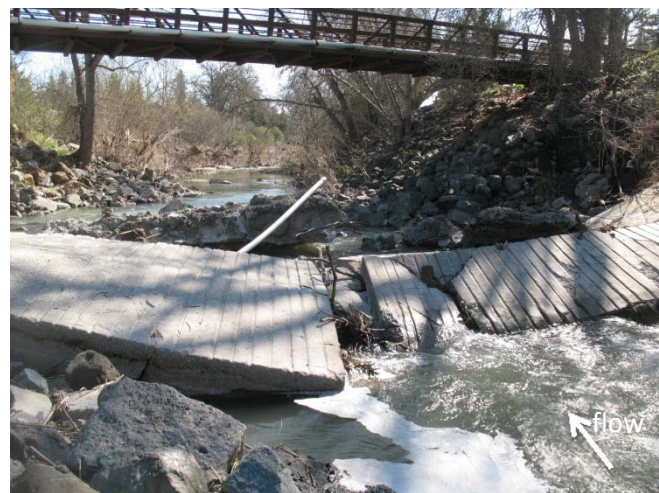
Both upstream and downstream of the concrete structure, there were significant areas of riprap and miscellaneous concrete debris concentrated along the channel banks and throughout the channel bottom (Figure 3). We expected to find similar riprap and debris along the channel bottom beneath the structure.

Figure 3. Upstream (left) and Downstream (right) Surroundings. Notice the abundant rip rap and concrete material in stream that is not associated with this concrete structure.

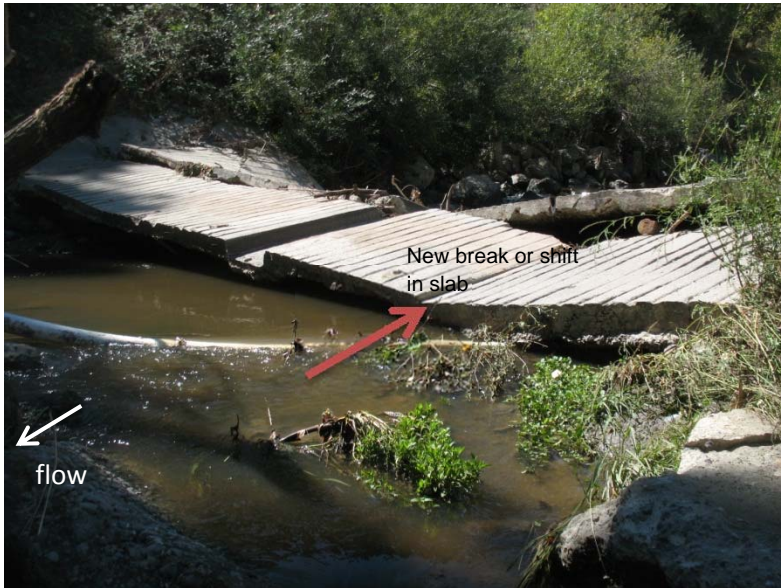
These changes occurred as a result of a slight increase in flow.

For reference, flow in Arroyo de la Laguna peaked at 429 cfs on September 21; a two-year storm event would be about 4,200 cfs.

Figure 4. New crack in slab. In Work Area #1, the downstream side of this section has dropped or shifted. Photo date: 9/23/2013

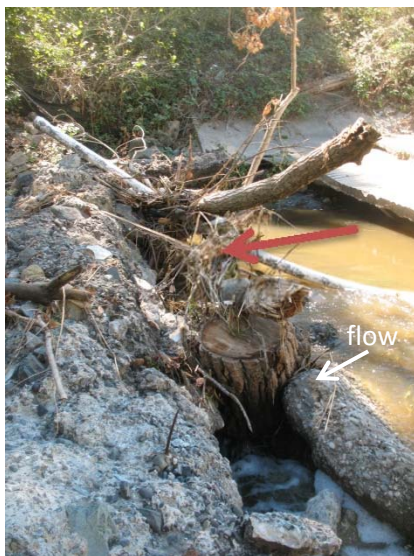
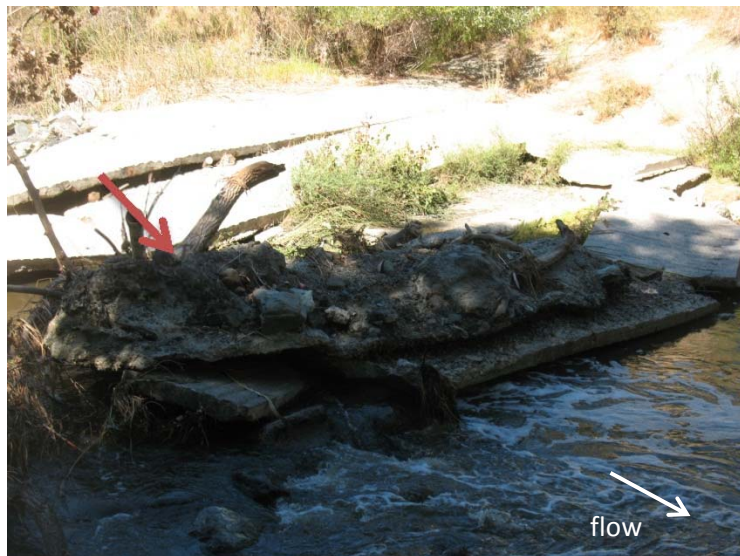
Figure 5. Woody debris jam. Side view (left) and upstream view (right) of Work Area #3, where four trees or limbs have become wedged and could cause a beaver dam effect. Photo on right further demonstrates how water is able to maneuver underneath the slab likely due to rip rap on channel bottom. Photo date: 9/23/2013

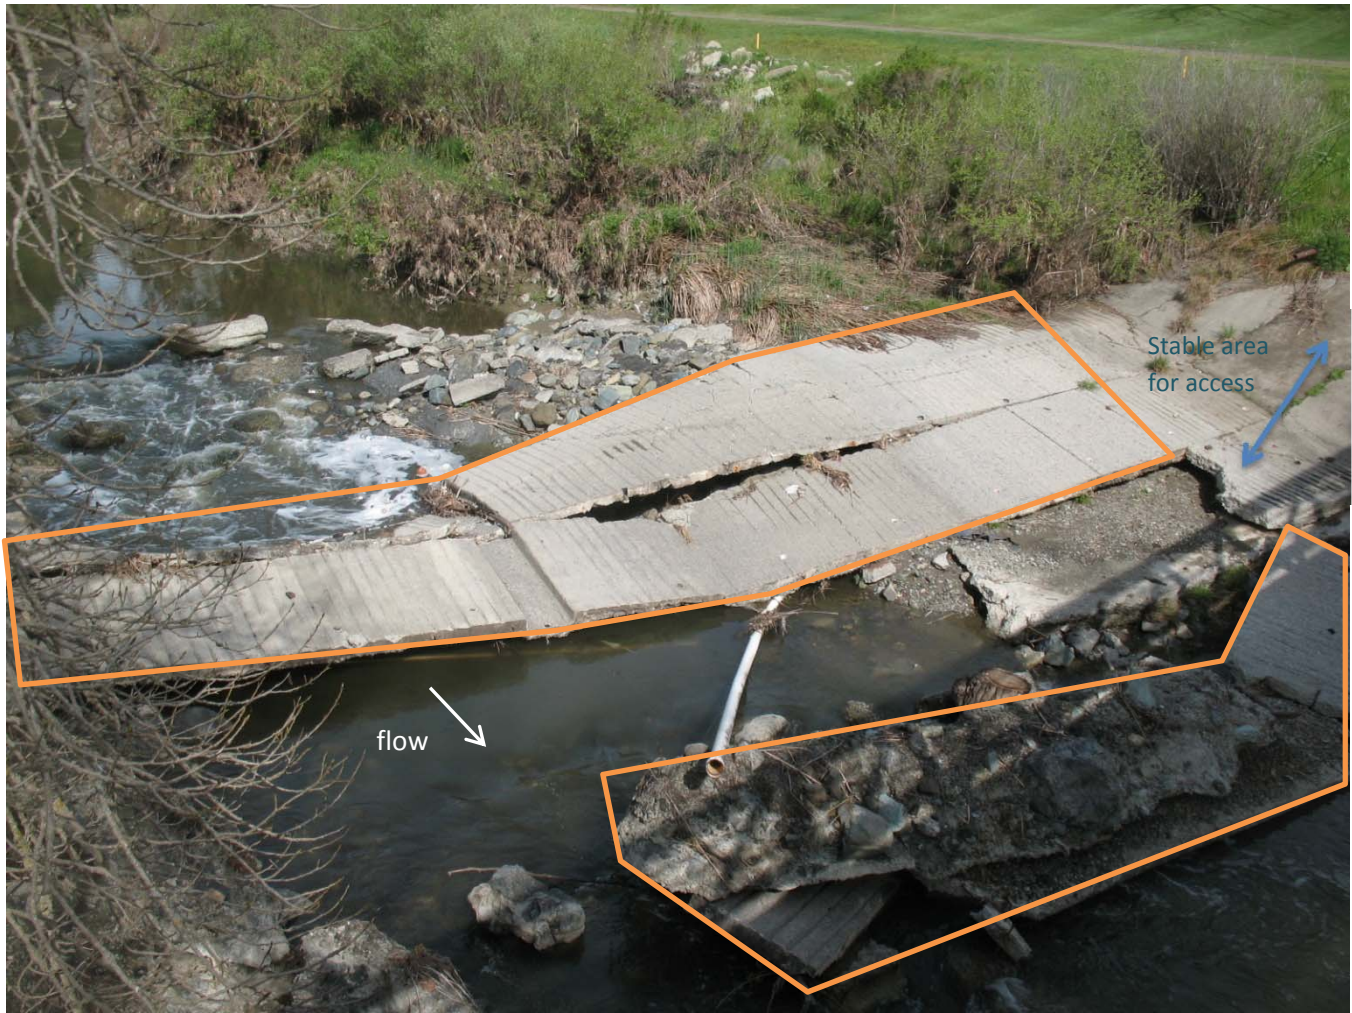
Figure 6. Limits of Work. The attached, stable areas of concrete on either bank will not be removed or altered.
Photo date: 3/20/2013

- i. Work will be limited to the removal of detached and/or unsupported concrete pieces in the channel (see limits of work shown Figure 6). Areas with intact and stable concrete, particularly along the banks, will be avoided so as to preserve any stabilization benefits those sections of concrete may have.

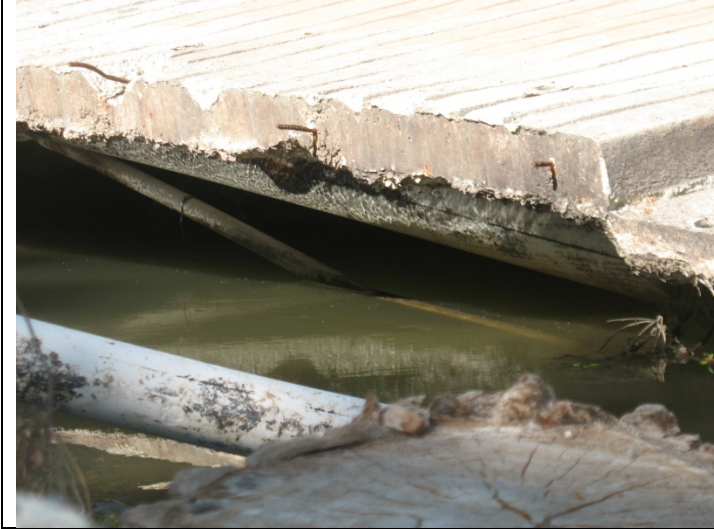
Figure 7. Additional perspective on Work Area #1. Notice how the section is suspended above the waterline. The PVC pipes in view are no longer in use.

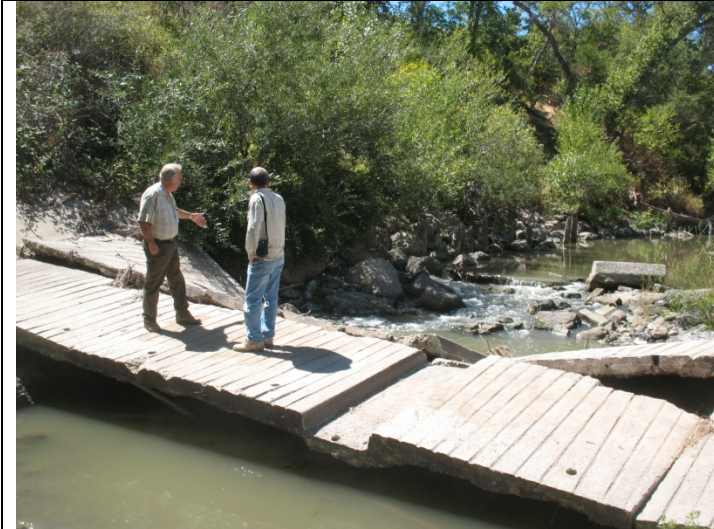
Figure 8. Additional perspective on Work Area #1, looking upstream. Notice how the section is suspended above the waterline and that there is little grade difference immediately upstream and downstream of the structure.

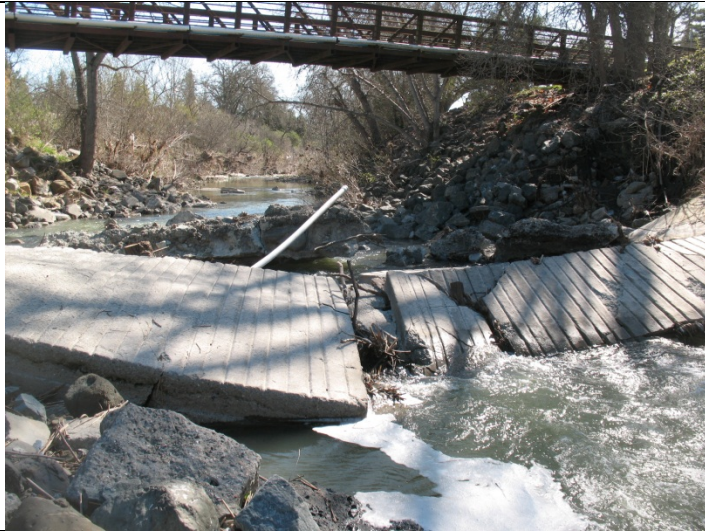
Figure 9. Additional perspective on Work Area #1, looking downstream. Notice that the uppermost part of this suspended section has broken apart midway due to lack of support underneath.

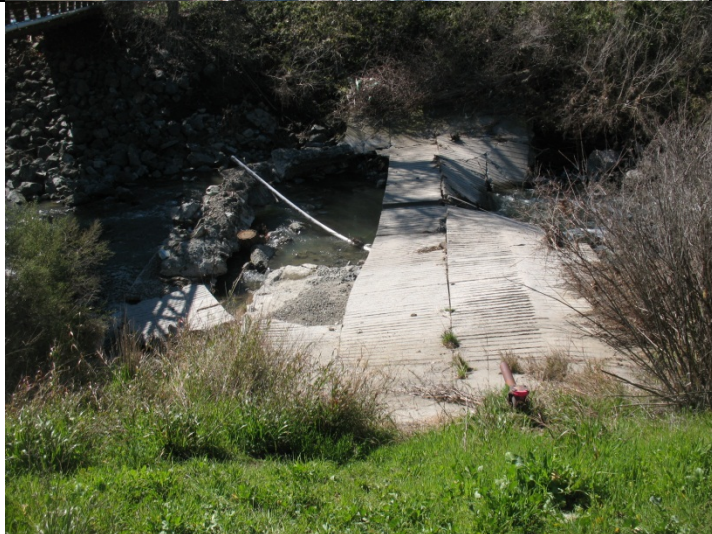
Figure 10. View across the channel. Flow is from right to left in this view, and notice that summer flow passes underneath the main structure.

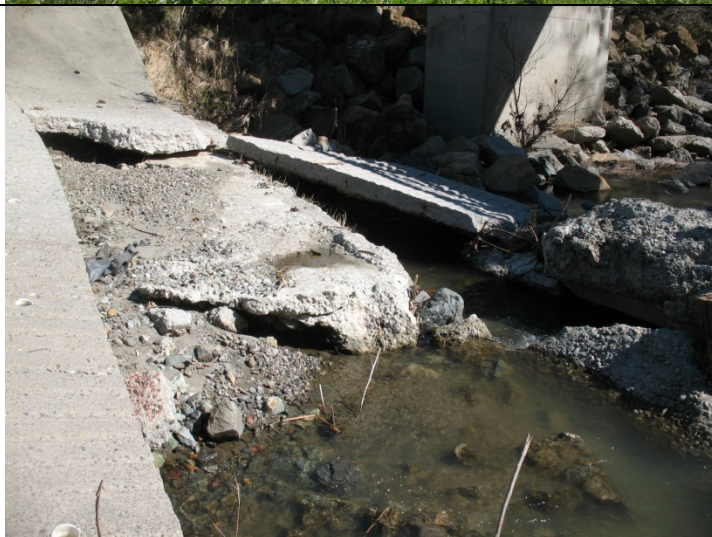
Figure 11. View of Work Area #2. Notice that this slab is fully detached from the main structure and resting at an angle upon other materials, above the channel bottom and above the water line.

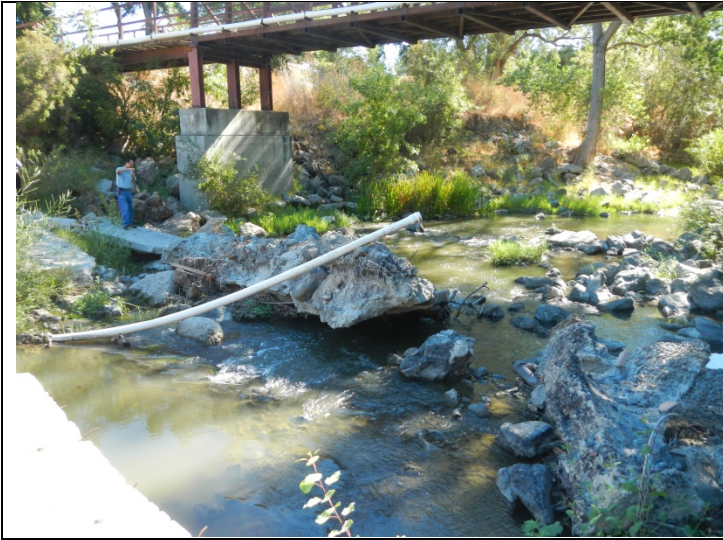
Figure 12. View of Work Areas #2 and #3. Notice that this slab (work area #3) was overturned by the force of the channel flow last winter, and its mostly resting atop sediment and other rocks.
