# 2022-23 Annual Report for the Alameda Creek Fish Ladder Operations and Water Stewardship (FLOWS) Monitoring Program

November 9, 2023

This document is the annual report for the reporting period 1 October 2022 – 30 September 2023, to be submitted to NMFS. ACWD has confirmed with NMFS that an electronic submittal is permitted, and that submittal of this year's annual report is permitted to be submitted on 9 November 2023. In the event that the annual report contains requirements that conflict with the BiOp, the BiOp requirements shall govern.

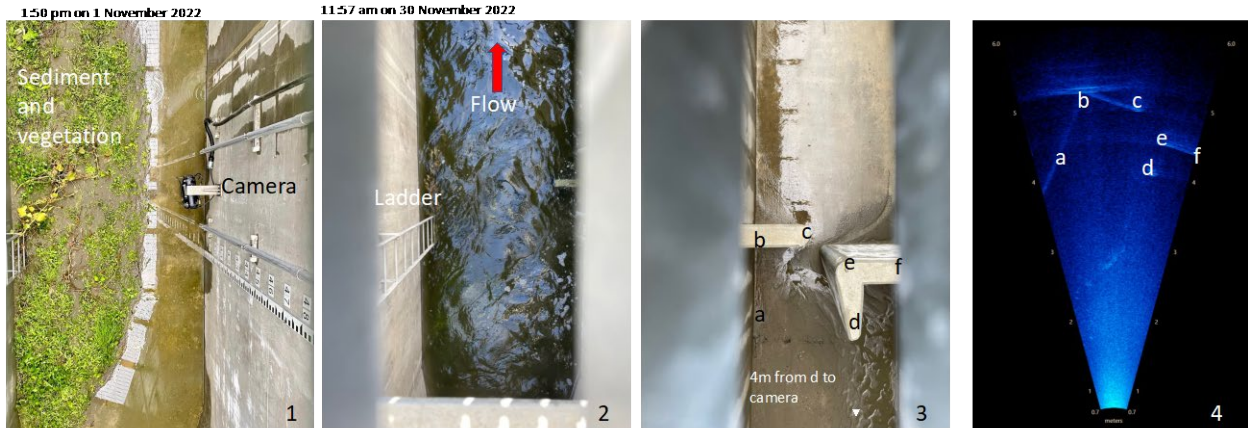
*Figure 4-13: Image 1 demonstrates ARIS bay dry. Note sediment and moisture allow terrestrial vegetation colonization (taken 1 November 2022). SONAR camera is facing downstream. Camera mount is ~ 61 cm above concrete floor. Image 2 demonstrates the ARIS bay with passage flow; Camera and mount submerged. Water depth is ~65 cm. Image 3 shows demonstrates downstream opening to ARIS bay. Note corresponding letters in SONAR image (Image 4).*

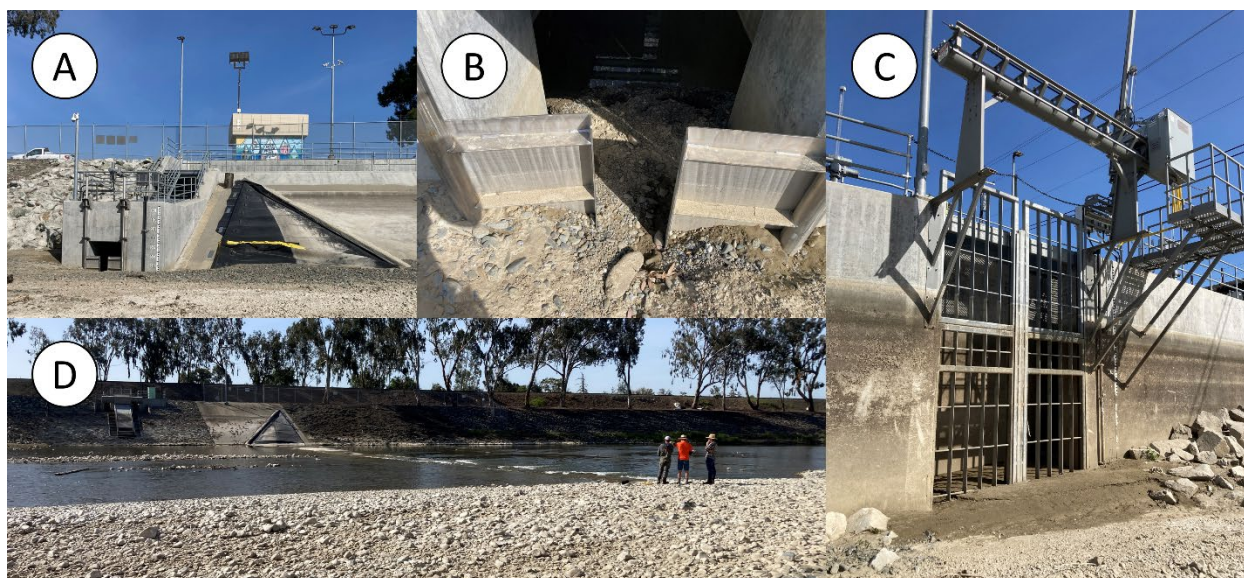
*Figure 5-3: Sediment deposition at RD3 fish ladder. In clockwise order: A) entrance gate and river right side of buried RD3 dam apron; B) entrance gate buried in sediment; C) exit gate and trash rake; and D) dam apron with flow over top, buried in sediment.*

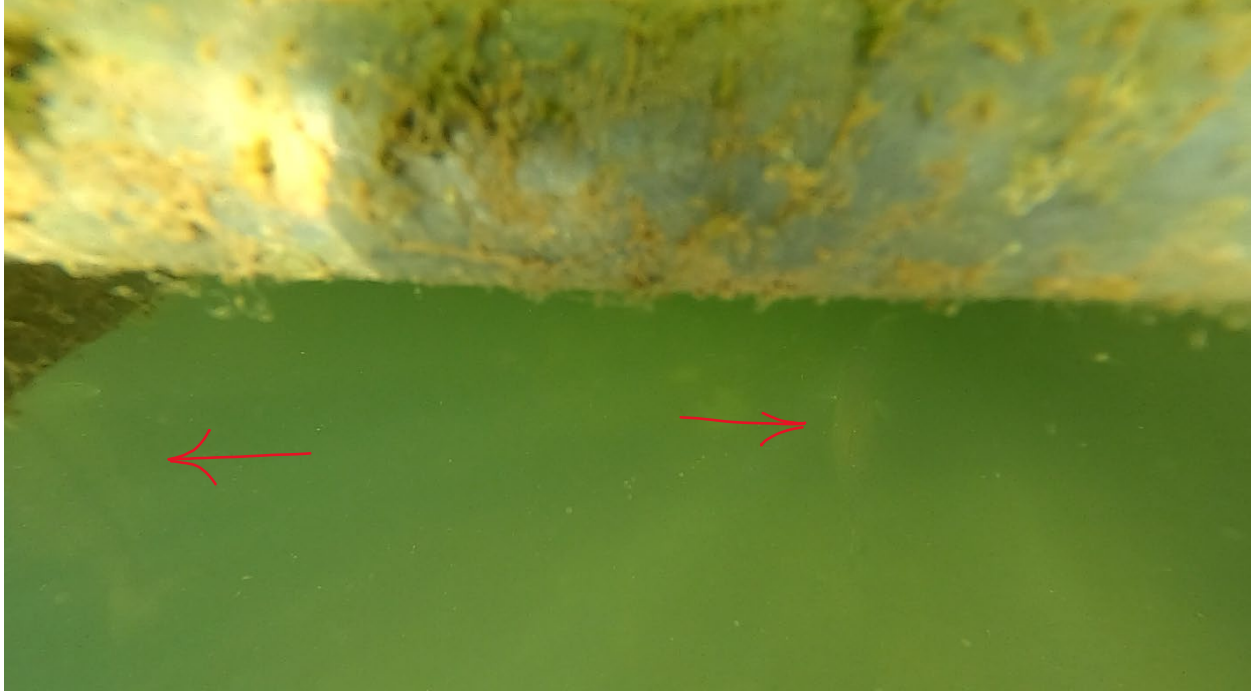
*Figure 5-8. Largemouth Bass (red arrows) observed in front of the RD1 Fish Ladder Trash Rack from Video 3; 21 August 2023.*

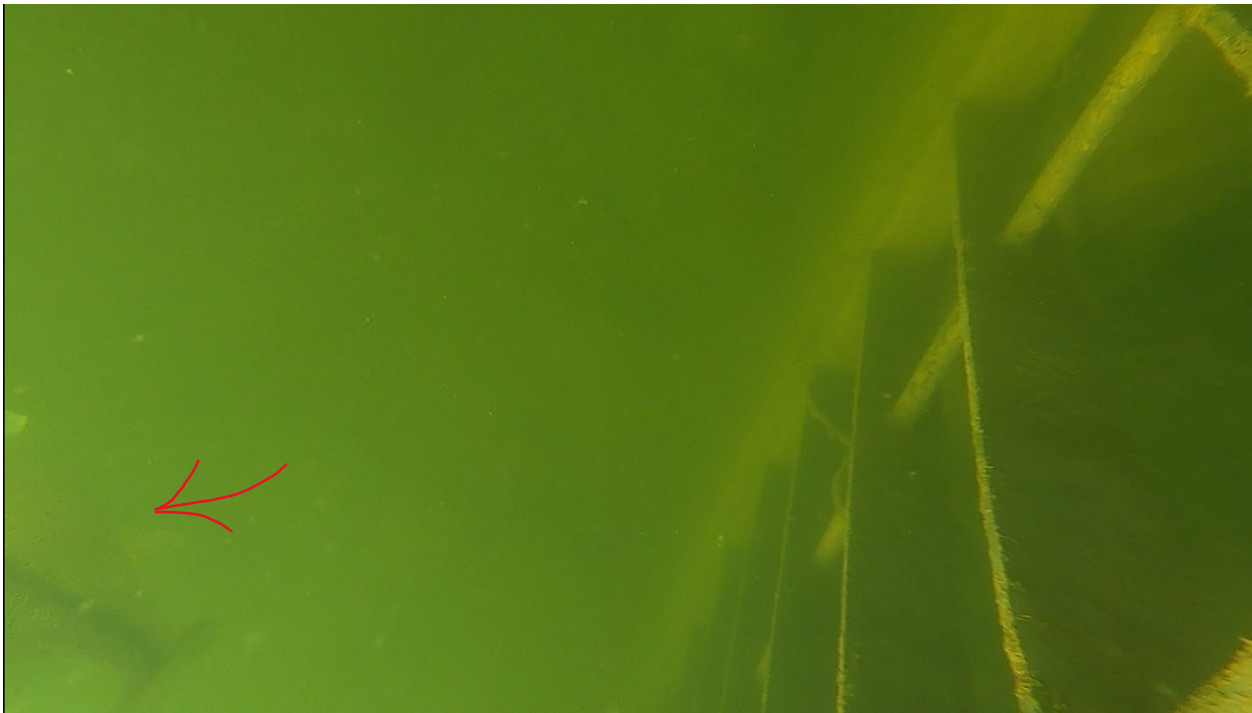
*Figure 5-9. Largemouth Bass (red arrow) observed in front of the RD1 Fish Ladder Trash Rack. From Video 3, 21 August 2023.*

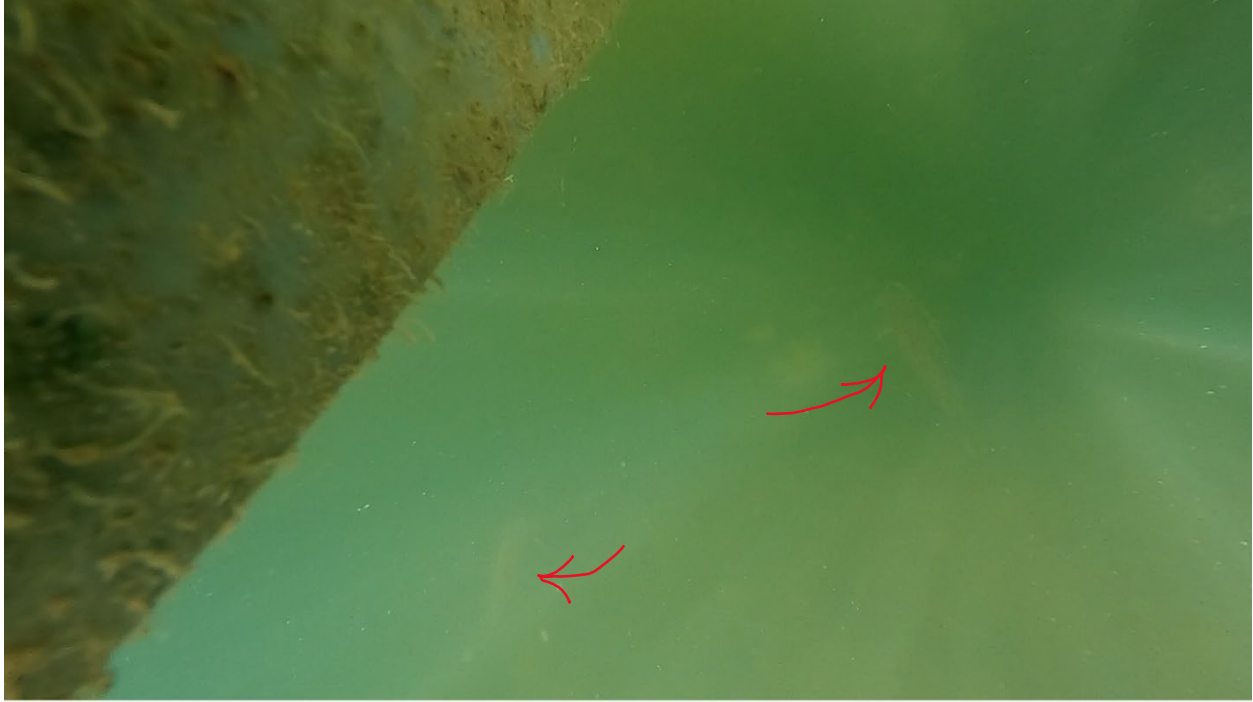
*Figure 5-10. Largemouth Bass (red arrows) observed in front of the RD1 Fish Ladder Trash Rack. From Video 3, 21 August 2023.*

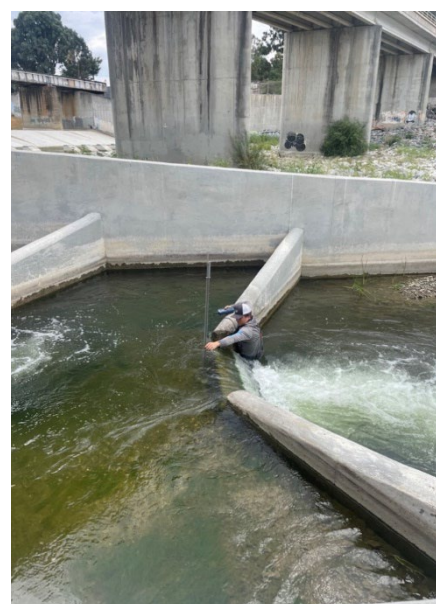
Figure 5-14: Site 4 in middle of lower fish ladder. Notice the large amounts of sediment on the downstream river left of the pool BHF is standing in. This sediment is blocking the weep holes which facilitate downstream juvenile migration.

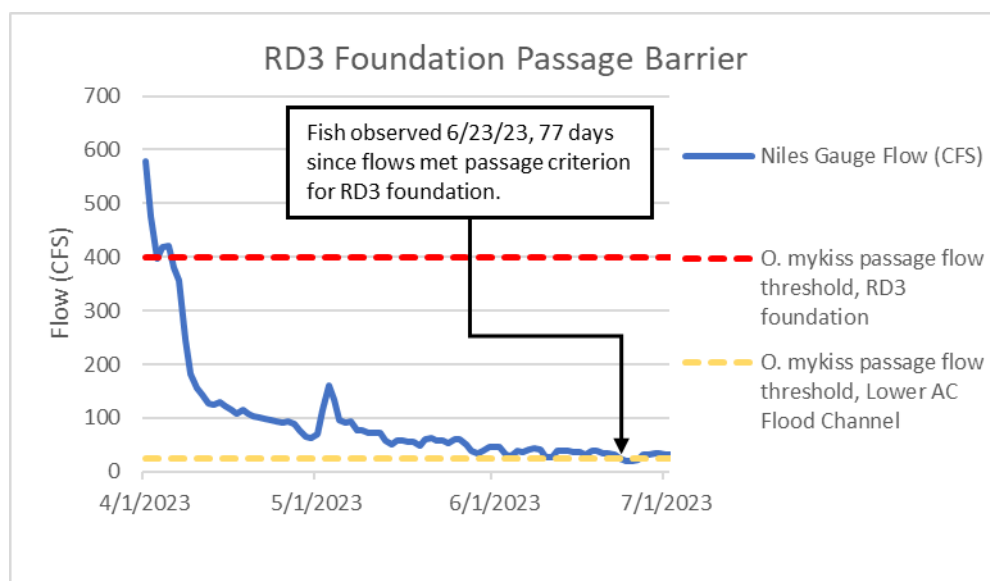
*Figure 5-41: Niles gauge flow data (cfs). RD3 ruptured and has been out of service since January of 2023. The RD3 fish ladder is designed to provide passage with 25 cfs of flow (yellow broken: lower AC Flood Channel passage threshold). However the ladder is inoperable if RD3 is deflated. Staff assessment of the deflated RD3 and its foundation concluded that ~400 cfs (red broken: *O. mykiss* passage threshold at RD3 foundation) is needed to provide the minimum flow depth of 0.6 ft for adult *O. mykiss* passage; adult passage needed in the lower channel is only 25cfs. This chart reveals that conditions have been suitable for adults to in-migrate as far as the RD3 foundation for 77 days prior to the observation on June 23, but insufficient to ascend the RD3 foundation.*
