## Road Safety Assessment (RSA)

SR 84 – Niles Canyon Corridor  
Alameda Co., California  
May 2012

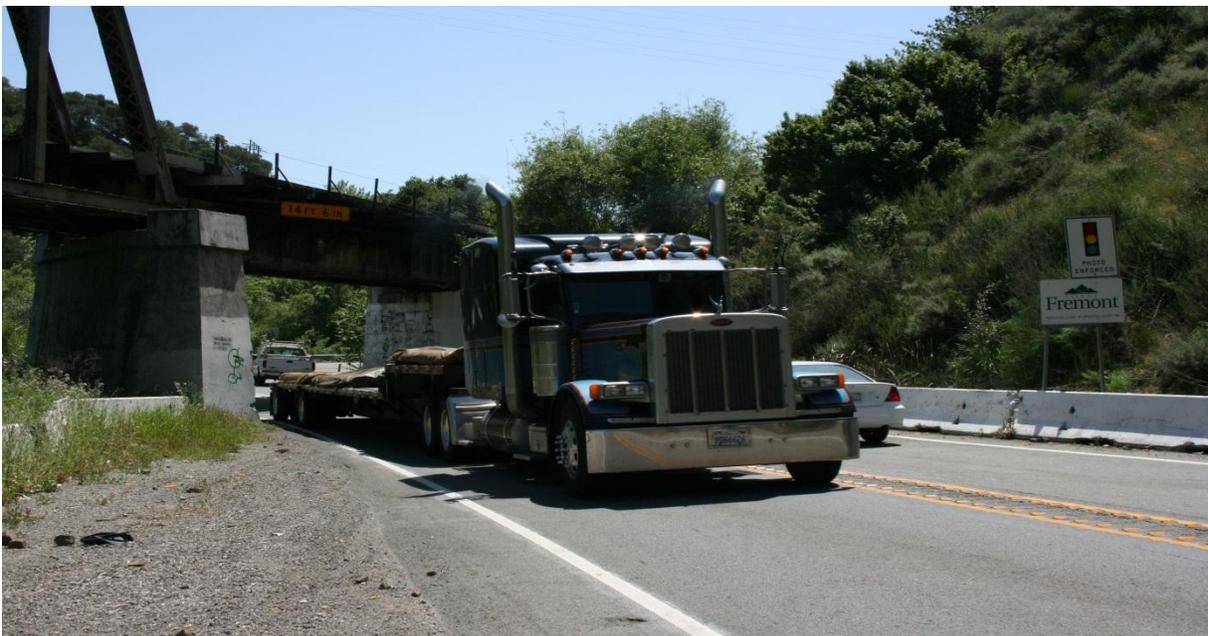
There is little question that the presence of large trucks in the traffic stream makes it difficult to share the road with bicyclists, particularly along stretches of SR 84 where shoulders are narrow and bicyclists must ride in the travel lane.

**Figure 5: Trucks compete for road space**

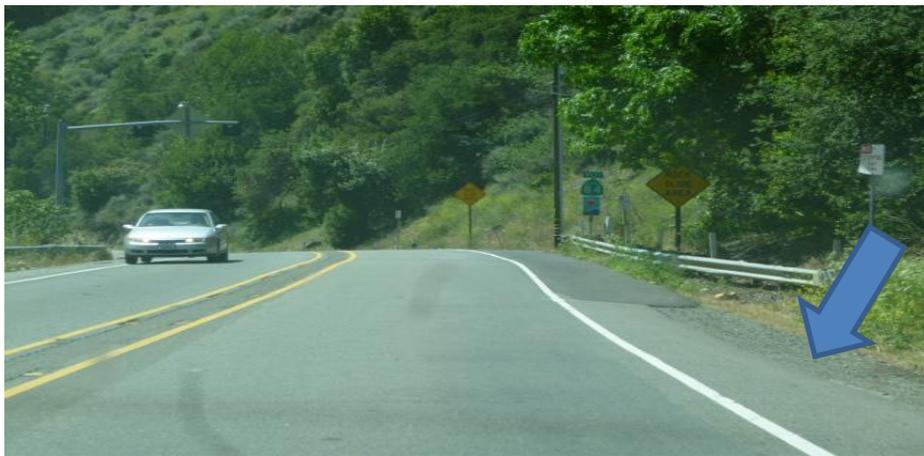
While the natural topography of the canyon makes shoulder widening difficult, *there already exist many locations where gravel borders (“shoulder backing”) could be made more functional without widening (Figure 10).*

**Figure 10 Gravel area can be paved without widening**

Stabilizing or paving these areas could provide all the benefits of a widened shoulder without widening the existing “footprint” of the facility.

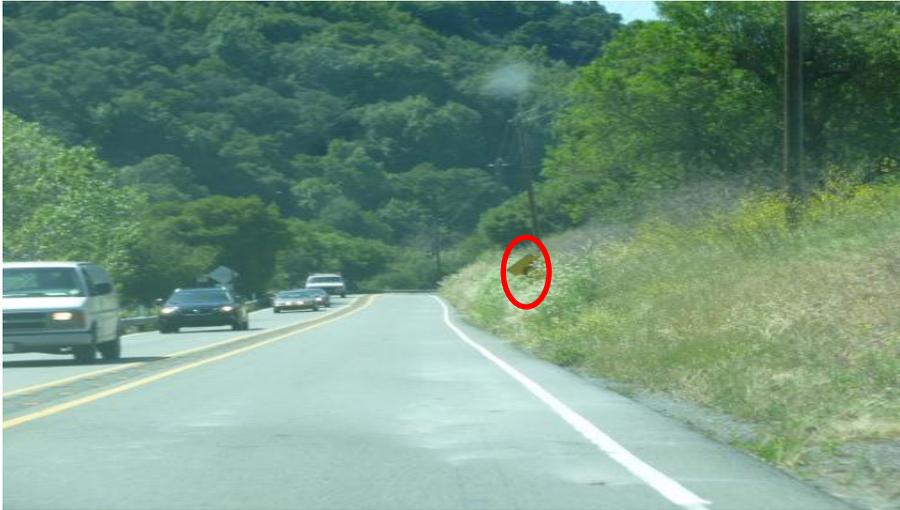
A number of signs were at least partially obscured by overgrown foliage. Consequently, a driver's ability to discern the sign message and respond appropriately may be impaired.

Figure 12: Curve warning sign partially obscured by vegetation

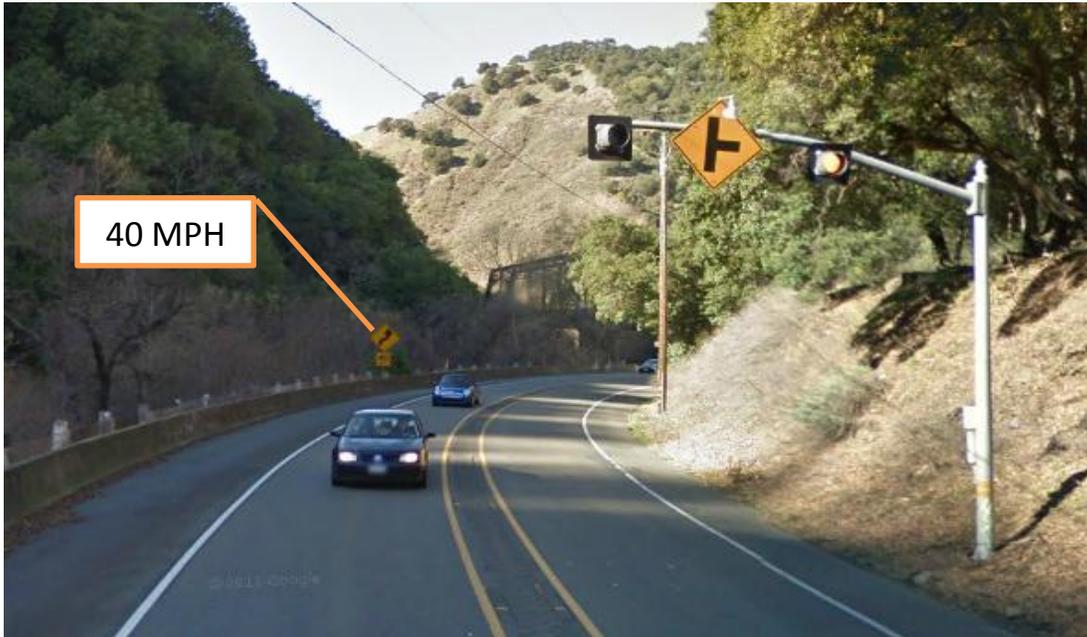
Figure 13: Adjacent signs sending mixed messages (?)

In still other locations, the proximity of two signs with seemingly contradictory messages may confuse drivers.

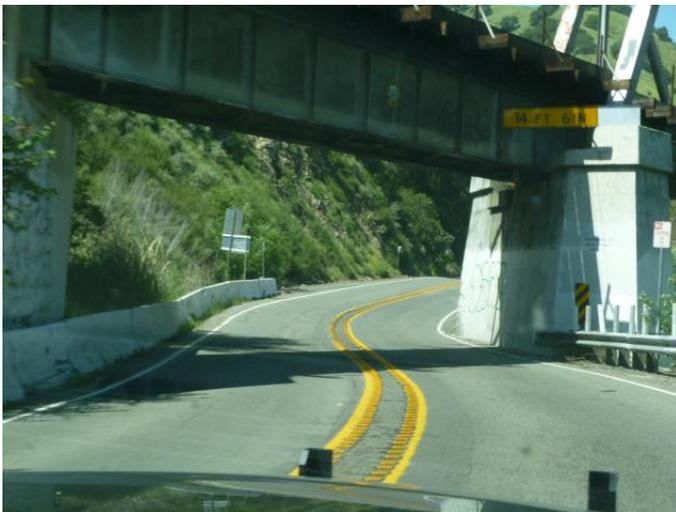
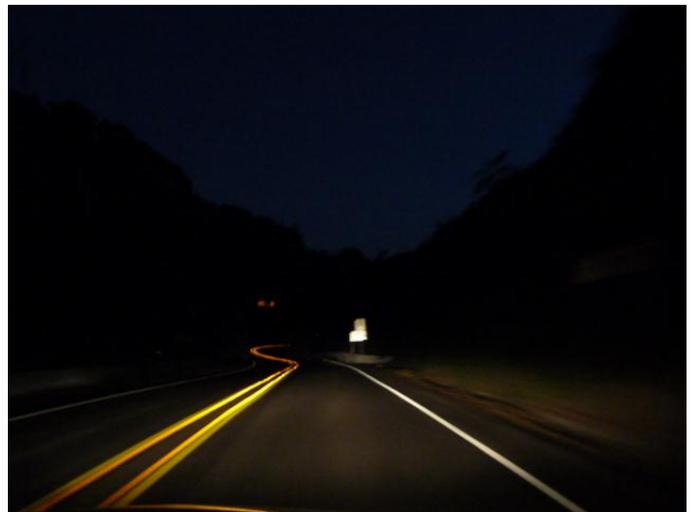
The centerline rumble strips installed in the immediate vicinity of several of the sharper curves along the corridor provide very effective delineation of the upcoming change in alignment. The distinct contrast with the less bright upstream markings clearly communicates to the approaching driver that he is approaching a much different condition.

Figure 14: Centerline Rumble Strips effective, day and night

*Avoid the temptation to “upgrade” other stretches of the corridor to this particular design detail, as making the entire corridor the same will negate the effect of the contrasting brightness. (If pavement markings are maintained by Caltrans maintenance forces, this advice should be communicated to them so that other stretches of the centerline are not inadvertently “upgraded” resulting in unintended consequences.)*

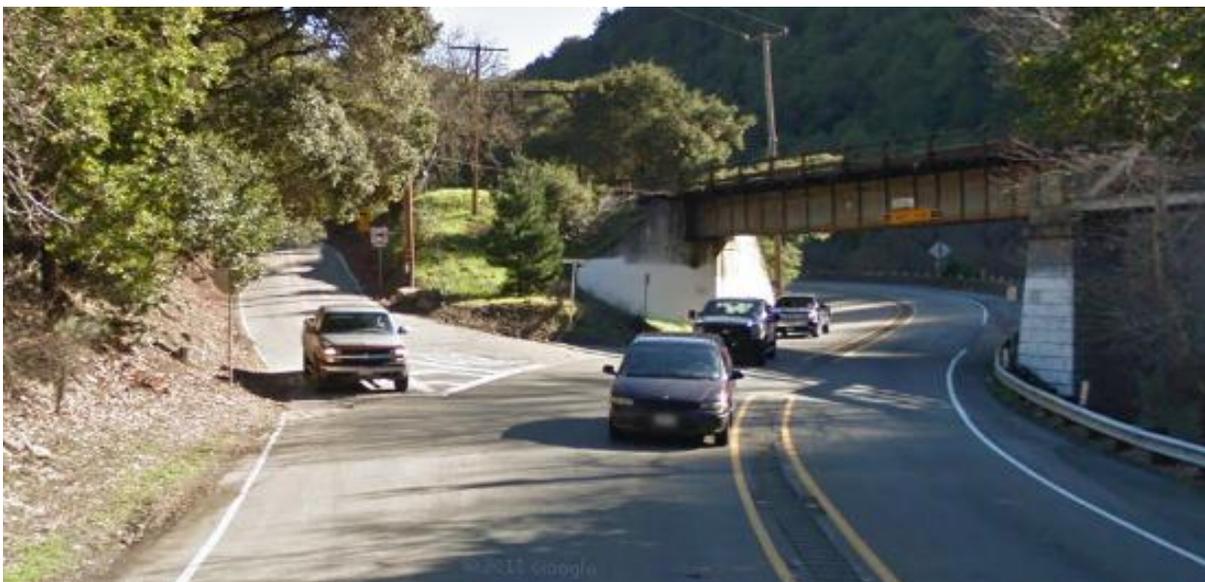
Line of sight to/from this intersection is blocked by the north bridge support of the adjacent Farwell Undercrossing. This makes it difficult for drivers turning into or out of Palomares Rd. from being seen until the last minute. The lack of sight distance also makes left turns from Palomares Rd. very difficult, as these drivers do not have sufficient preview distance to choose gaps with confidence.

Palomares Rd. intersects SR 84 at a very severe skew angle. This means that drivers must turn their head or torso beyond 90 degrees to look for gaps in traffic. This is particular difficult for older drivers with limited head and neck mobility.

**Figure 15: Palomares Rd. Intersection and Farwell Undercrossing**

*Consideration should be given to realigning the intersection by moving the access point so as to “tee” it up closer to a right angle. Doing so would help increase available stopping sight distance as well as mitigate the skew.*

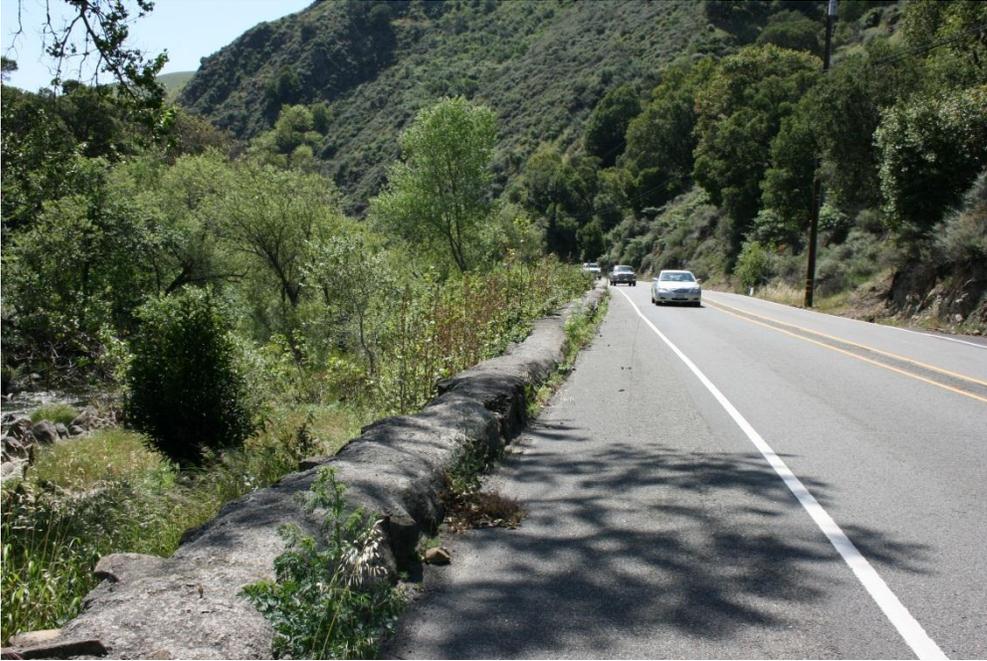
While not technically a roadside “barrier”, there are several locations within the corridor where variable height masonry walls exist. *If they are meant to act as roadside barriers, they may need to be modified to conform to current crashworthiness criteria. If not, they should probably be viewed as roadside fixed objects and treated accordingly.*

Figure 16: Variable height masonry walls

Specific guidance can be found in the AASHTO Roadside Design Guide and the Manual on Assessing Safety Hardware.

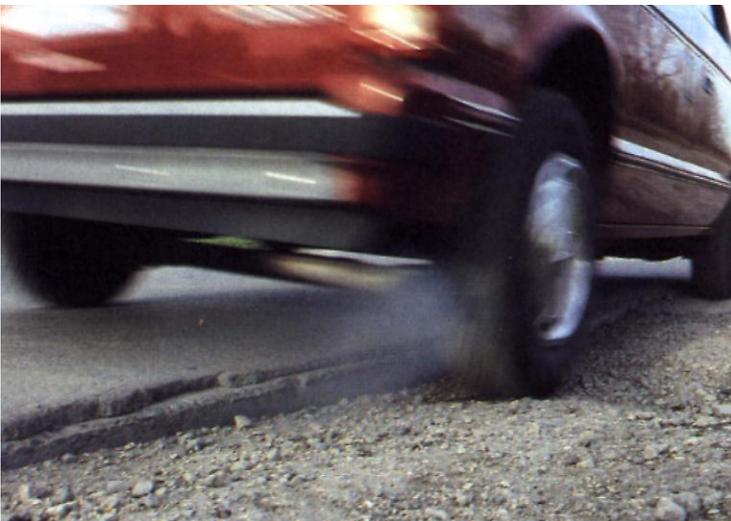
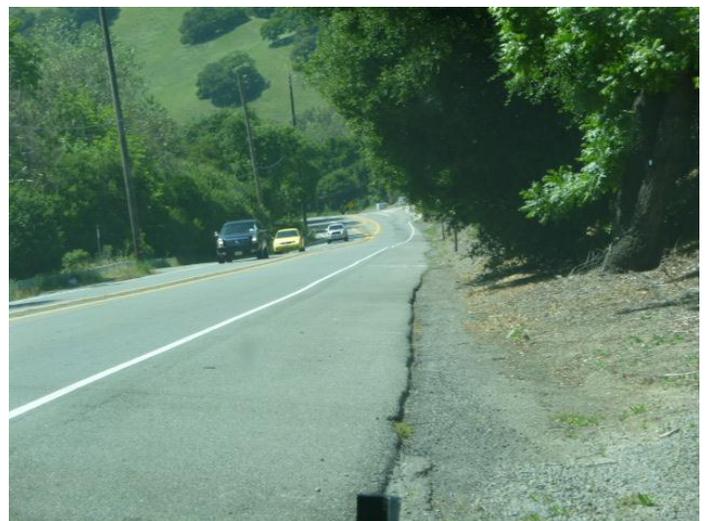
Over time, gravel shoulders (shoulder “backing”) can subside, thus exposing the outer edge of the abutting pavement. This exposed edge or "drop-off" can cause a driver to lose control of his vehicle should he stray off the pavement onto the gravel and attempt to steer back onto the pavement.

Figure 18: Shoulder drop-offs can lead to crashes

Wherever the pavement (travel lane or shoulder) is planned to be widened, the outer edge of the paving should be finished with a “Safety Edge” and the gravel backing graded flush with the paved surface.

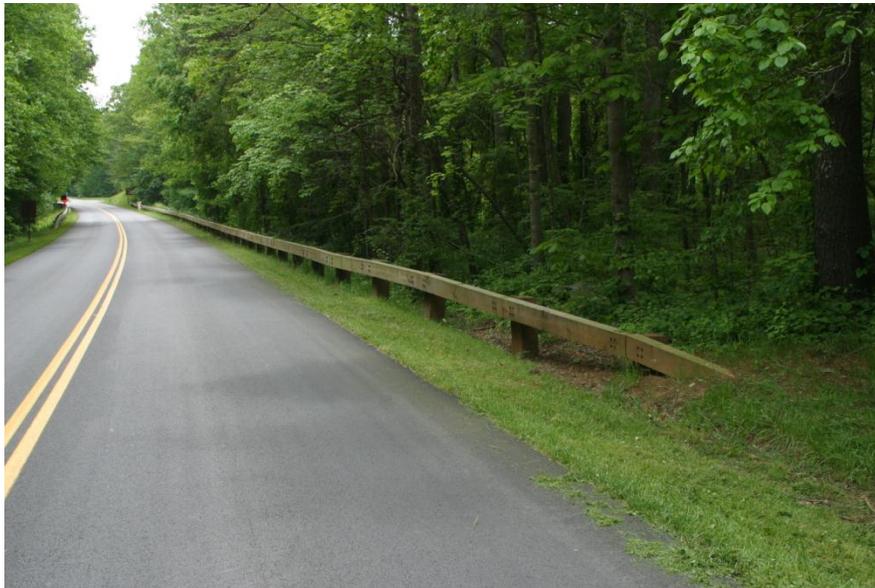
For example, the row of eucalyptus trees that define “The Spot”, a site with considerable historic and community value, are very close to the edge of the traveled way and show evidence of having been struck..

Here, a properly-documented context-sensitive decision might be to spare these particular specimens by shielding them with a barrier.

Figure 19: Roadside barrier shielding trees
