# **Stonybrook Creek Watershed**

## **A Strategic Plan for Eliminating Barriers to Steelhead Migration**

June 4, 2010

**Michael Love & Associates**

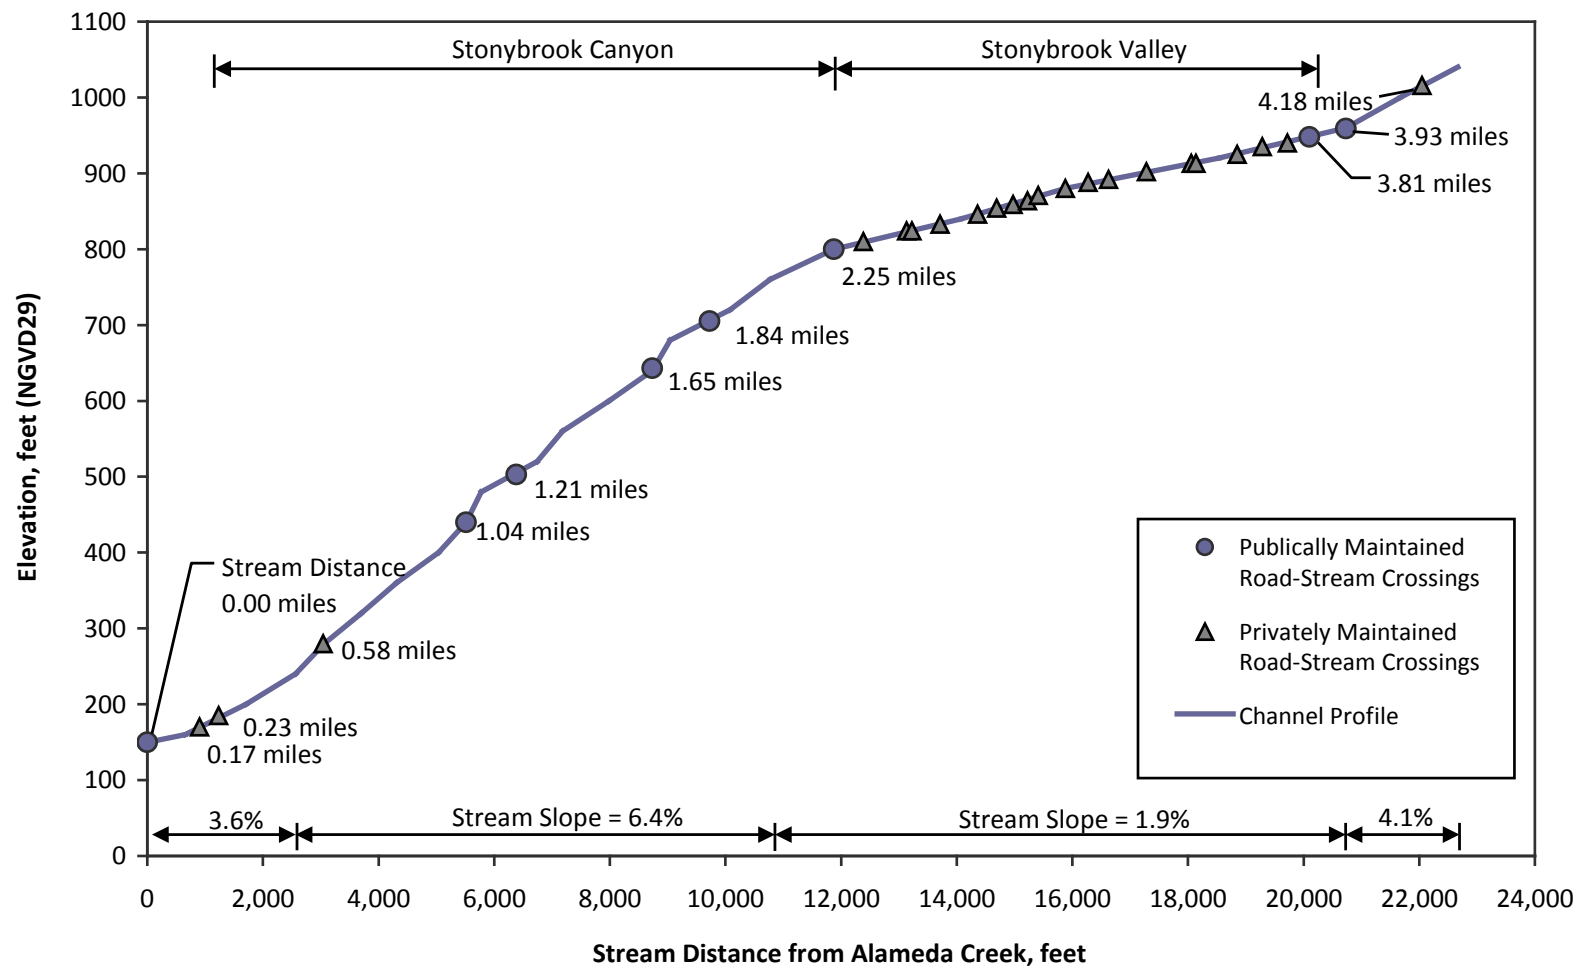
Figure 2. Longitudinal profile of Stonybrook Creek based from the USGS Niles and Dublin Quadrangles with 40-foot contour spacing. Location of public and privately maintained road-stream crossings, given in Stream Miles, is based on hip-chain distance measured by ACPW (2002).
