The California Department of Transportation (Caltrans) approved the <u>Niles Canyon Safety</u> <u>Improvements Project</u> to improve safety along State Route (SR) 84 within the Niles Canyon corridor in Alameda County. Improvements will include replacement of the reinforced box culvert at Stonybrook Creek with a single-span bridge and associated creek channel improvements.

Niles Canyon Safety Improvement Project Alameda County, California Proj ID 0414000039 EA 04-2A3321

Stonybrook Creek Geomorphic Assessment

Stonybrook Creek Culvert Replacement Bridge Design Report Niles Canyon Safety Improvements Project (04-2A332)

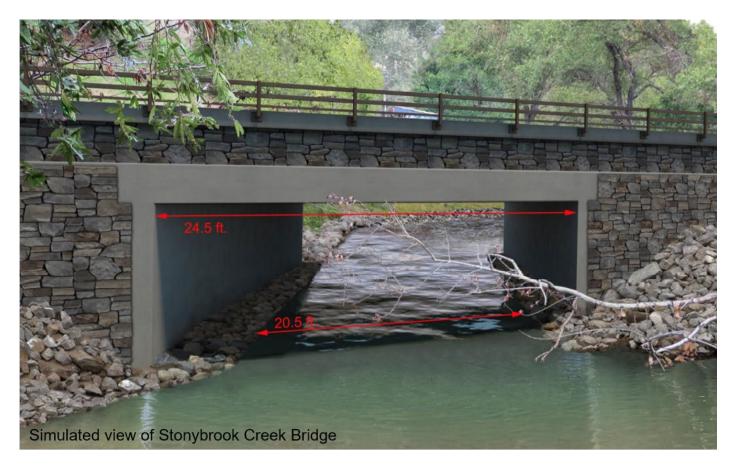
The existing culvert is located on SR 84, just upstream of Stonybrook Creek's confluence with Alameda Creek. The culvert is approximately 10 feet wide and is undersized for the amount of water flow that occurs during most winters. During moderate and high flows, water moves through the culvert at such high velocities that it has created a scour hole at the downstream end that can be up to five feet deep. With the scour hole, the downstream water level typically sits at a lower elevation than the culvert bottom, creating a physical fish passage barrier that blocks fish from traveling upstream. When water submerges the culvert bottom during winter, the high flow velocities through the culvert continue to make upstream fish passage impossible.

View upstream showing fish passage barrier at culvert outlet

The existing Stonybrook Creek culvert that drains Stonybrook Creek into Alameda Creek will be replaced with a new, single-span bridge, removing the fish passage barrier and the main source of scour. The bridge abutments will be skewed to be more in line with the creek, and the vertical bridge abutments will be spaced wider than the active channel width to allow unimpeded bed-load transport under the bridge. This will allow the creek to flow at a more natural rate that would allow fish to swim upstream during high flows.

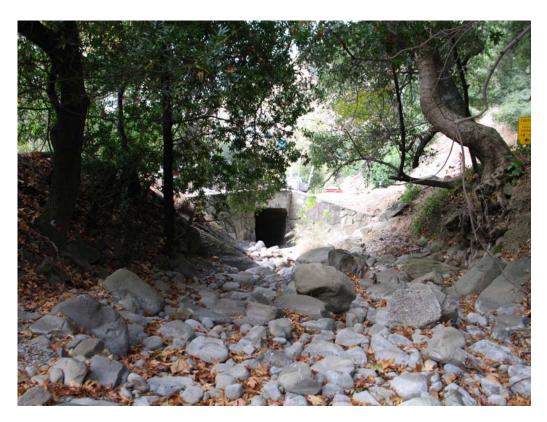
Cobble-boulder substrate of channel upstream of culvert inlet. Channel grade estimated to be 7-8%.

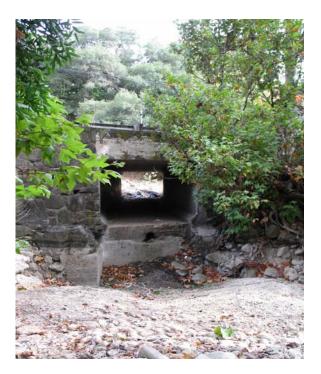
Culvert outlet and downstream scour hole.

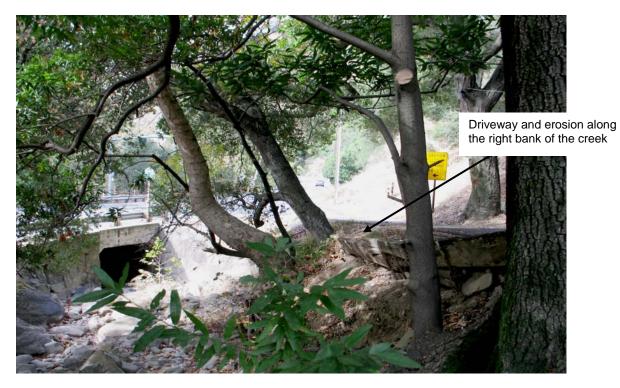
Channel upstream of culvert showing skew of the culvert inlet to the alignment of the channel, the location of the driveway, and the bank erosion along the right bank of the creek.

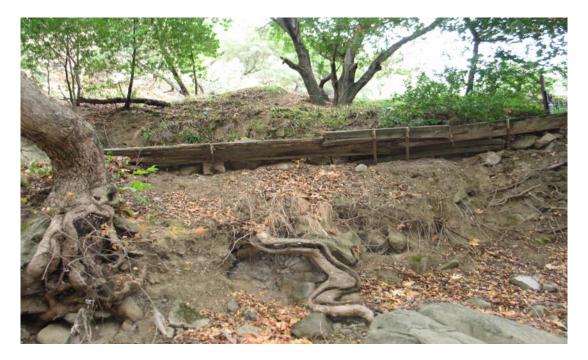
Detail of bank erosion between the driveway and right bank of Stonybrook Creek.

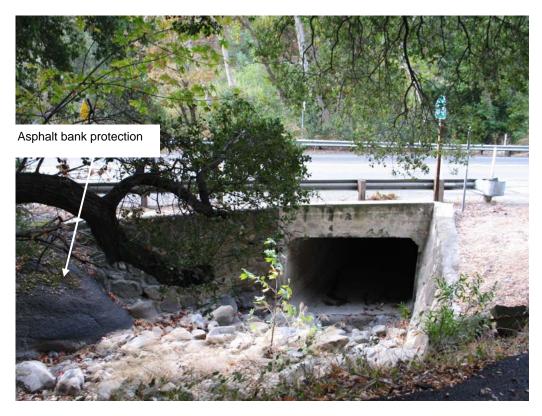
Culvert inlet showing skew of the culvert to the alignment of the channel. Note use of asphalt on the bank at the interface between the bank and left abutment of the culvert.

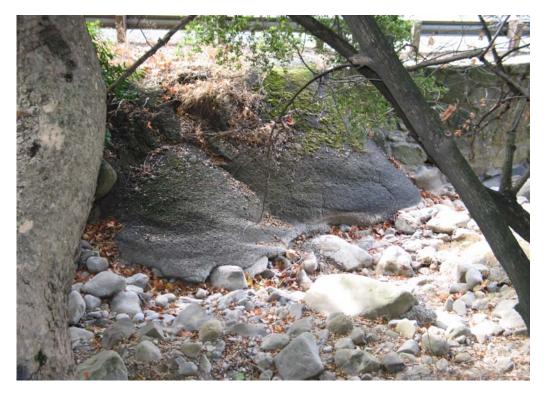
Detail of asphalt bank protection used on the left bank of the creek.

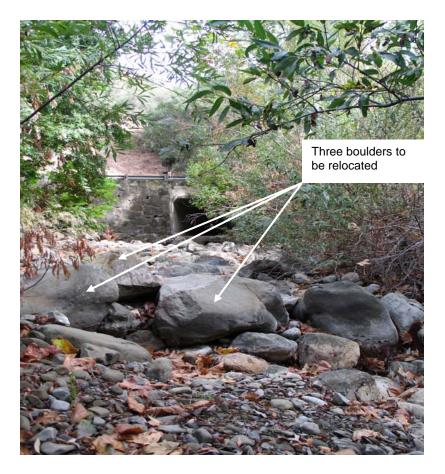
Downstream of the scour hole, sediment trapped by an old grade control structure has formed an overly wide channel that is likely a barrier to fish passage during low flow conditions. The channel downstream of the grade control structure is a well-defined and fish passable boulder cascade.

Old grade control feature downstream of culvert outlet. This feature spans the channel and is trapping finer gravels. Between the scour hole at the culvert outlet and these boulders the creek bed is flat and overly wide with no defined low flow channel. Downstream of the boulders the channel is a steeper boulder cascade with a well defined, fish-passable low flow channel.

- 4. Redesign or redistribute the boulders forming the boulder grade control feature downstream of the culvert outlet (see Attachment). It seems likely that sometime in the past a high flow event evacuated sediment that had accumulated in the channel at this location, and that the grade control was built to prevent the channel degradation from migrating upstream to the culvert outlet and further deepening the scour hole and undermining the crossing. The channel downstream of the grade control is steeper, but appears to be quite stable. As noted above, this grade control structure is trapping sediment to the detriment of upstream channel form, habitat diversity and fish passage. Redistributing the boulders will allow the substrate elevation to naturally fluctuate with changes in flow and sediment supply. Alternatively, if the change in grade is too great to even out over the project reach, and it becomes necessary to keep some form of grade control at this location, then the structure should be redesigned to include a low flow channel notch consistent with the location and shape of the low flow channel immediately downstream.

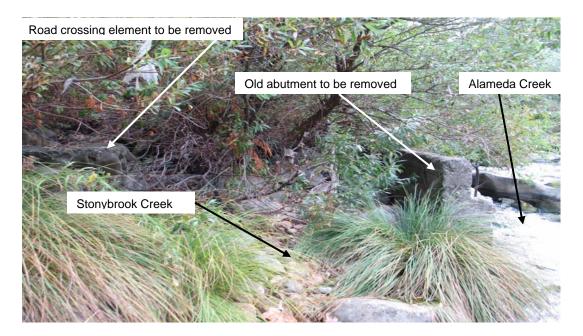
Old bridge abutment and road crossing remnant at the confluence of Stonybrook Creek with Alameda Creek.

5. Remove the old road remnant and the bridge abutment at the confluence of the creeks (see Attachment). As noted above, these structures are impeding the movement of sediment from the tributary into Alameda Creek. The removal of these structures will help maintain the form of the low flow channel and fish passage through the project reach. As we discussed in the field, these structures should be broken down with a jackhammer and the concrete and asphalt debris removed from the stream corridor. Rock from the road remnant that is relatively free of asphalt and concrete may be left on site. The old bridge abutment should be broken off at ground level; the footing of the structure should be left in place and not exhumed from the substrate, and any exposed rebar should be cut off or ground down so that it poses no hazard to fish, wildlife, or human beings.

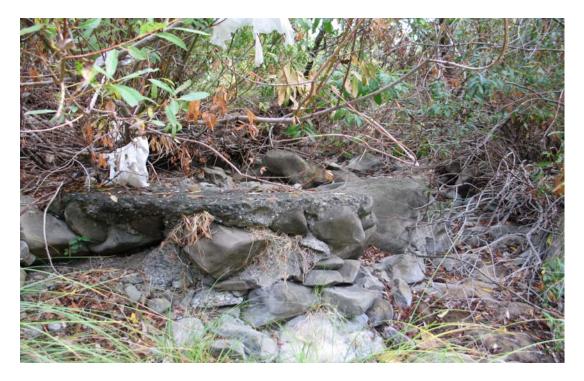
Detail of old crossing remnant on the right bank of Stonybrook Creek at the confluence of Alameda Creek. The crossing element is composed of rock and concrete with asphalt paving on the top surface.

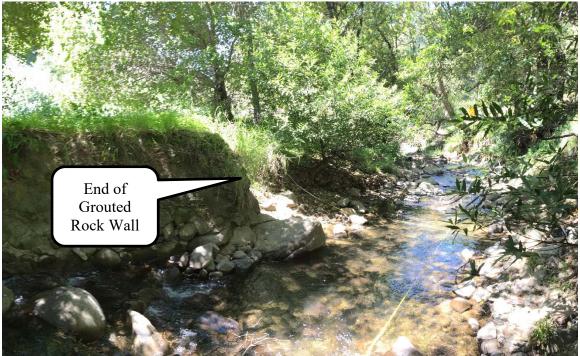
the least is maintained by the presence of the grouted wall, the culvert, and the SR 84 road prism.

Photo 2. Grouted Rock Wall on Left Bank, Facing Downstream (April, 2019)

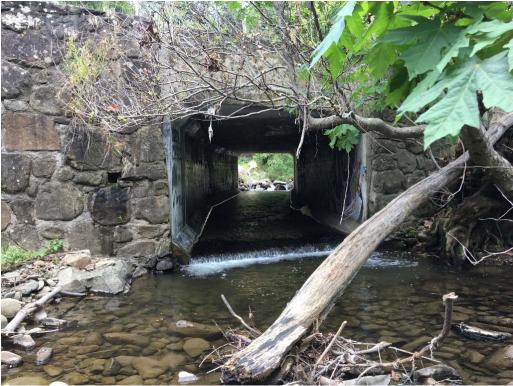
Flow discharging from the existing culvert has formed a scour pool which was about 2 feet deeper than the culvert outfall (see Figure 7). This pool is lined with cobbles (see Photo 5), and a cobble bar has formed a short distance (about 10 feet to the crest of the bar) downstream of the culvert outfall. The cobble bar extends across the channel and in the downstream direction. The right bank is composed of cobbles as well, and the channel Stonybrook Creek follows when Alameda Creek flows are high is composed of well-sorted cobbles and is clear of vegetation.

Photo 5. Downstream Face of Culvert, April 2019

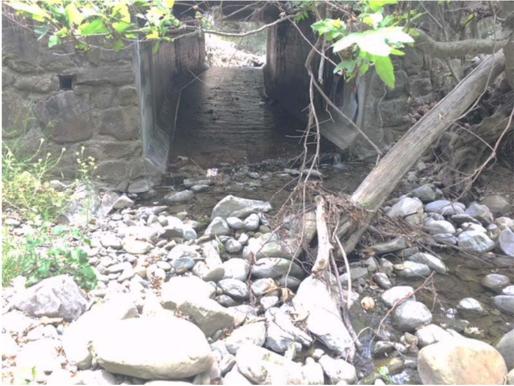
This condition was compared to observations made in 2018 and 2004 (see Photo 6 and Photo 7). The observations made in 2004 found the area immediately downstream of the culvert was lower than the culvert outfall by several feet. These observations show that the geometry of Stonybrook Creek in the vicinity of SR 84 is variable. These observations also show that Stonybrook Creek transports sediment in the size range of large cobbles.

Photo 6. Downstream Face of Culvert, May 2018 Source: Garcia and Associates

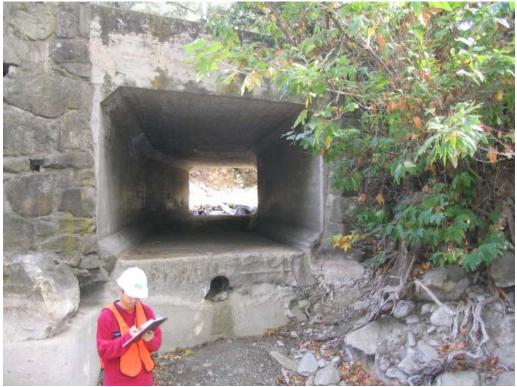
Photo 7. Downstream Face of Culvert, October 2004

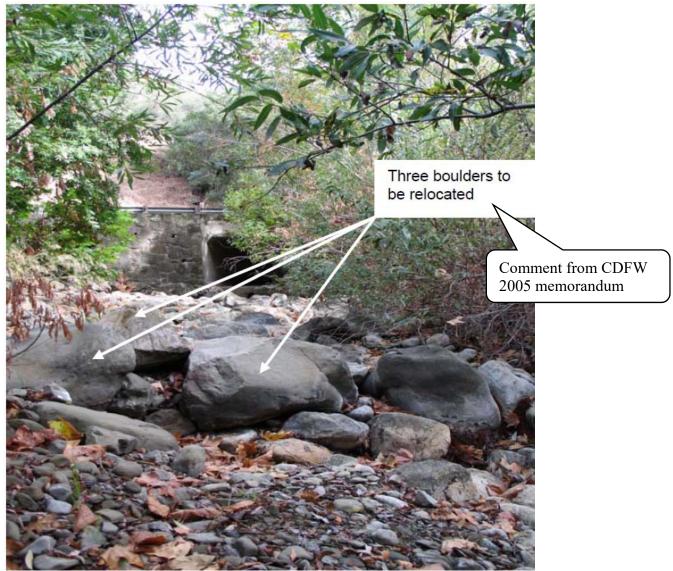
CDFW described the BGCF as being constructed of boulders, and provided a photograph showing the existing boulders sitting on top of the bed of the creek (see Photo 1) with cobbles on the bed of the creek downstream. CDFW reported the BGCF is, "trapping sediment to the detriment of upstream channel form, habitat diversity, and fish passage" and that downstream of the BGCF, "is a well-defined and fish passable boulder cascade." CDFW previously recommended the boulders to be relocated, as shown in the comment added to the photograph reproduced below.

Photo 1. Photo and Comments of the Boulder Grade Control Feature from CDFW Memorandum (2005)

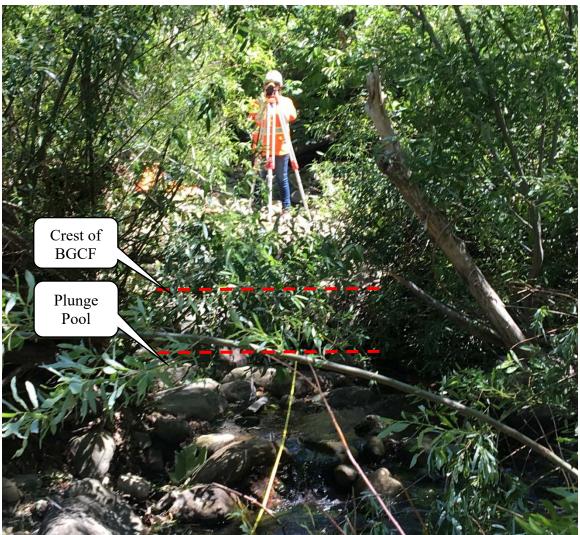
Observations made by WRECO in 2019 found that the boulders of the BGCF were more embedded and interlocked than they appear in the photo from 2005, and that the streambed downstream of the feature was lower in elevation where a plunge pool had formed (see Photo 2). The plunge pool did not contain the cobbles shown in the photo from 2005 (see Photo 3).

Photo 2. Showing Elevation Change at BGCF (June 2019)

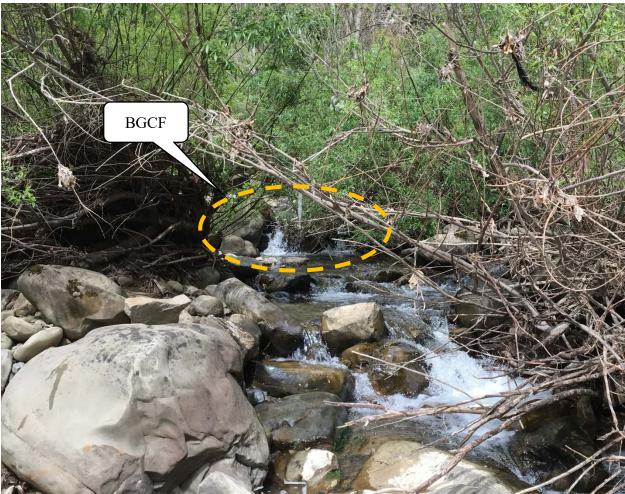
Photo 3. Facing Upstream Towards BGCF (April 2019)

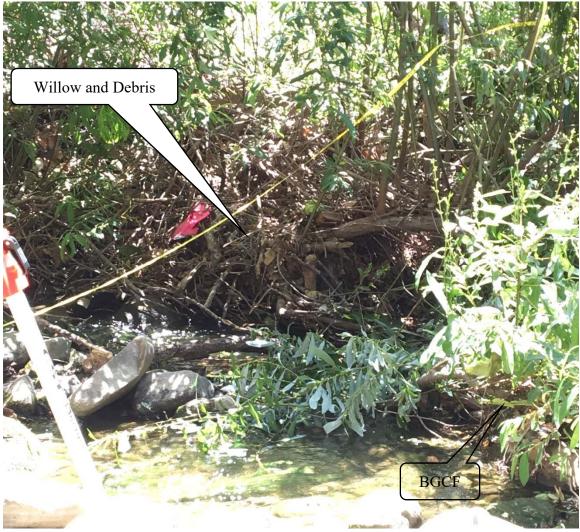
Photo 4. Living Willow and Debris (June 2019)

Downstream of the willow and debris, the channel flowed along a bench of Alameda Creek parallel and opposite to the flow of Alameda Creek. The bench is approximately at the elevation of bankfull flows in Alameda Creek. The flow from Stonybrook Creek along the bench was about 2 feet wide, flat, with a bed composed of fine sediments, fine roots, and few large cobbles (see Photo 5). About 15 feet downstream of the willow and debris, the flow split again with about half flowing off the bench and down the bank directly into Alameda Creek and half continuing along the bench further before dispersing through vegetation along the bench before flowing into Alameda Creek (see Photo 6). Flow along the bench appeared suitable for juvenile fish passage, but where the flow went down the banks of Alameda Creek, it appeared to be too shallow and steep to allow upstream migration of juvenile fish.

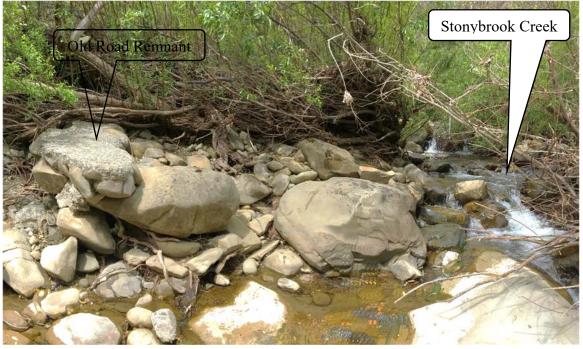
Photo 8. Old Road Remnant, Facing Upstream from Alameda Creek (April 2019)

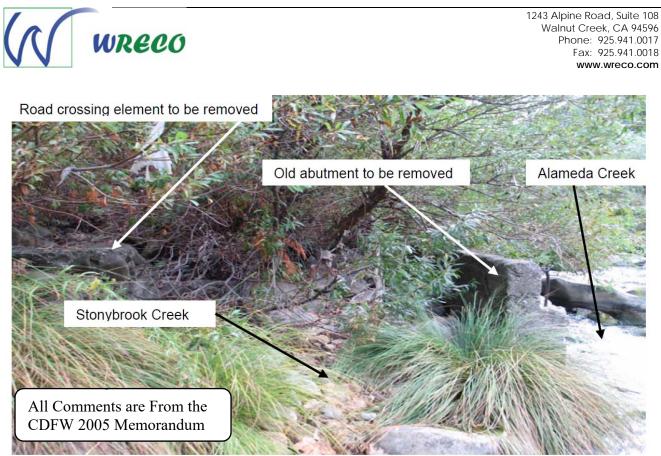
Photo 9. Photo and Comments of the Old Road Remnant and Abutment from the CDFW Memo (2005) (facing upstream)

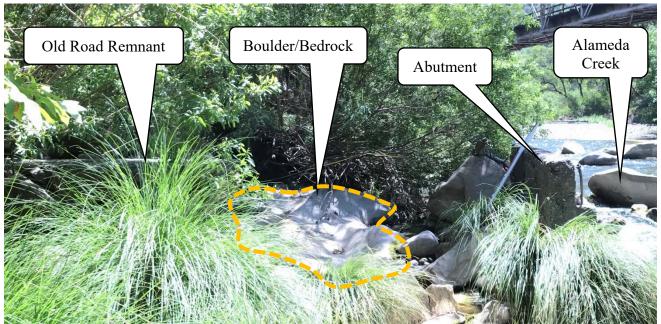
Figure 3 shows the elevation of the base and top of the abutment as compared to the thalweg of Stonybrook Creek. The profile does not appear to show an accumulation of sediment upstream of the abutment. However, most of the reach from the BGCF to the abutment is within the bankfull elevation of Alameda Creek. It is possible that high flows in Alameda Creek have scoured away sediment that had been deposited by Stonybrook Creek. The survey shows that sediment on the Stonybrook side of the abutment sits about 2.5 feet higher than on the Alameda Creek side of the abutment. It is expected that the abutment is influencing sediment deposition of Alameda Creek which in turn, could influence sediment deposition in Stonybrook Creek.

Photo 10. Facing Upstream Towards the Abutment (June 2019)
