## Welch Creek stream survey

Welch Creek is a tributary to Alameda Creek in the northern portion of Sunol Regional Wilderness. A reproducing population of native rainbow trout was documented in lower Welch Creek in 1999. Alameda Creek Alliance volunteers surveyed the lower end of Welch Creek in December 2003 to assess potential fish passage barriers and trout habitat. The survey covered the portion of the creek from its confluence with Alameda Creek 4/10 of a mile upstream on Welch Creek Road, where there is an impassable steep rock falls.

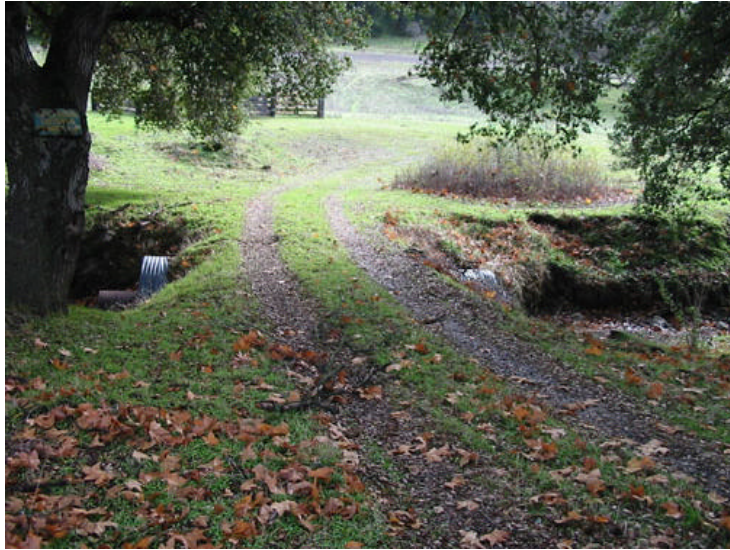
**Ranch road crossing**

Dirt ranch road crossing with two culverts. One culvert is 5 feet in diameter, 20 feet long; the other 3 feet in diameter, 23 feet long. The culverts are essentially at grade and are not thought to be passage barriers.

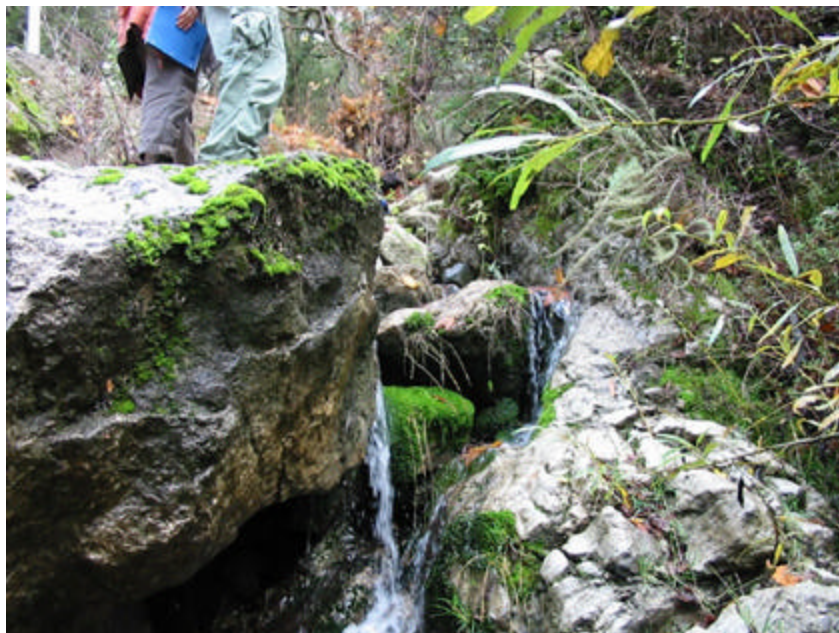
**First rock falls**

Natural rock falls, may be a fish passage barrier.

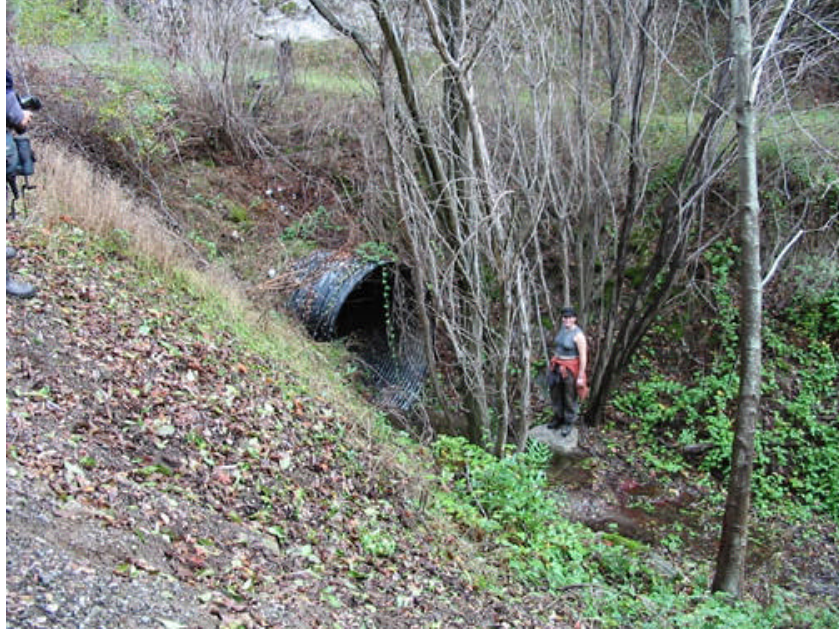
**Downstream end of first Welch Creek road crossing culvert**

Large 45 degree bend culvert under Welch Creek Road crossing, 9 feet in diameter. The estimated rise is 8 feet and the length is about 75'. Likely a fish passage barrier.
