# 2022-23 Annual Report for the Alameda Creek Fish Ladder Operations and Water Stewardship (FLOWS) Monitoring Program

November 9, 2023

This document is the annual report for the reporting period 1 October 2022 – 30 September 2023, to be submitted to NMFS. ACWD has confirmed with NMFS that an electronic submittal is permitted, and that submittal of this year's annual report is permitted to be submitted on 9 November 2023. In the event that the annual report contains requirements that conflict with the BiOp, the BiOp requirements shall govern.

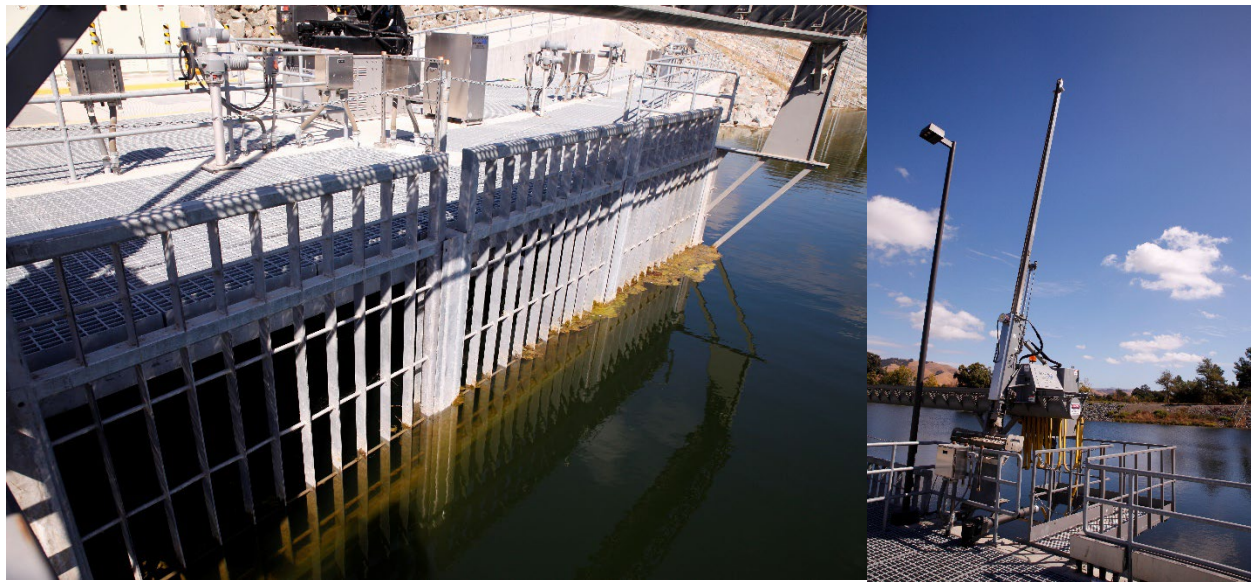
*Figure 4-2: The RD1 Fish Ladder exit channel is screened from debris by the trash rack (left). The rack is cleaned by the trash rake, that operates automatically or manually to scrape debris off the rack (right).*

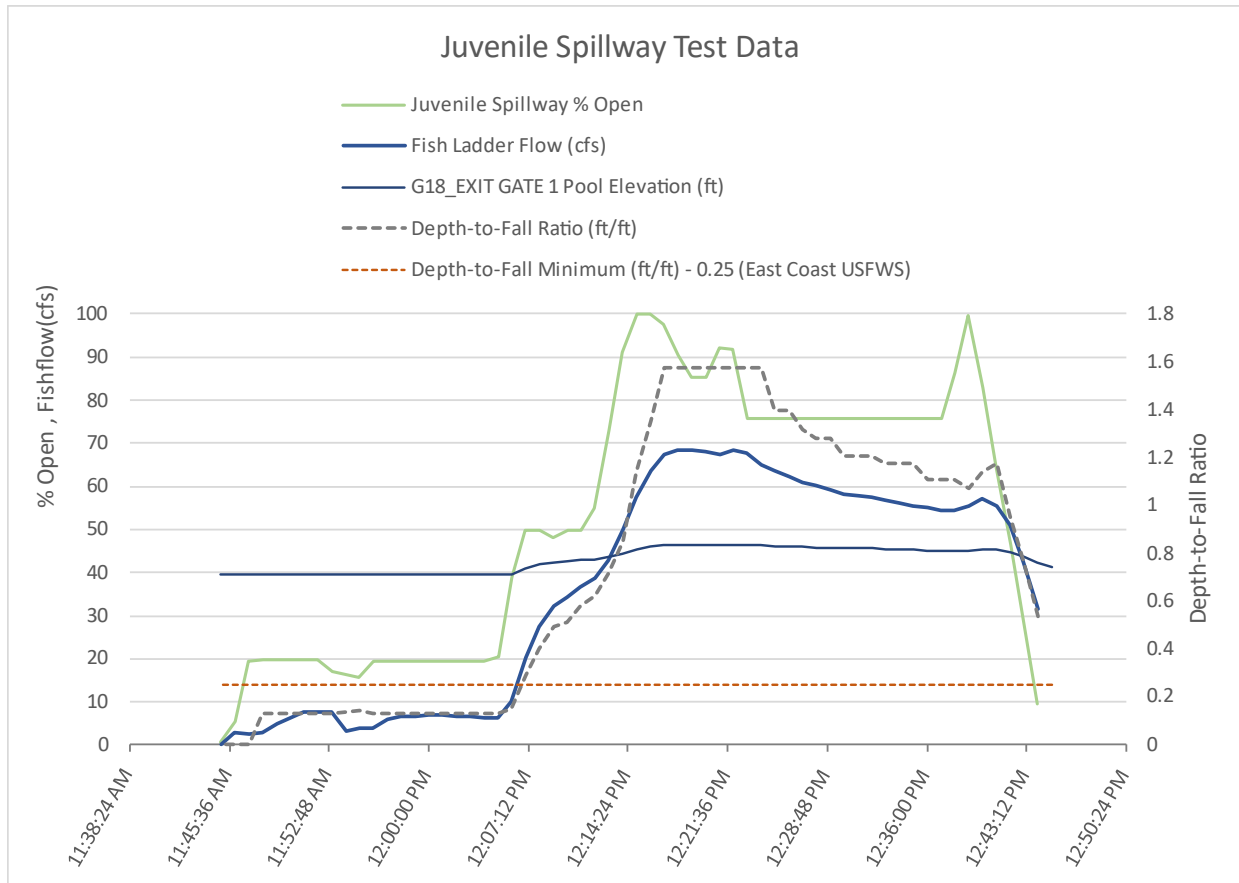
Depth-to-fall ratios calculated during juvenile spillway testing met the fish ladder facility's Draft Basis of Design Report (BODR) minimum threshold of 0.25 ft/ft at juvenile spillway flowrates greater than approximately 18 cfs. The precise minimum flowrate that the juvenile spillway can be utilized will be further refined through additional operational experience, though it is not expected to be used at flow rates below 20 cfs unless additional exit gates are providing flow and additional water depth in the plunge pool (pool 10) below the juvenile spillway. Figure 17 below shows the juvenile spillway testing data collected on 12 December 2022.

Figure 4-6: Juvenile spillway test data to evaluate depth-to-fall criteria. Minimum recommended depth-to-fall ratio is met when flow through Juvenile Spillway is approximately 18 cfs, as measured downstream in the fish ladder.

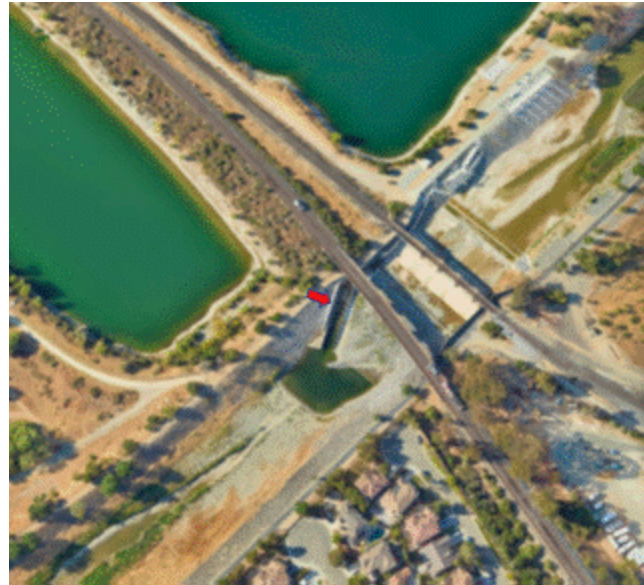
*Figure 4-7: Location of photo documentation during test flows 15 December 2022. Red arrow indications where images were captured at the Rubber Dam 1 lower fish ladder. Note dragon's teeth in image.*

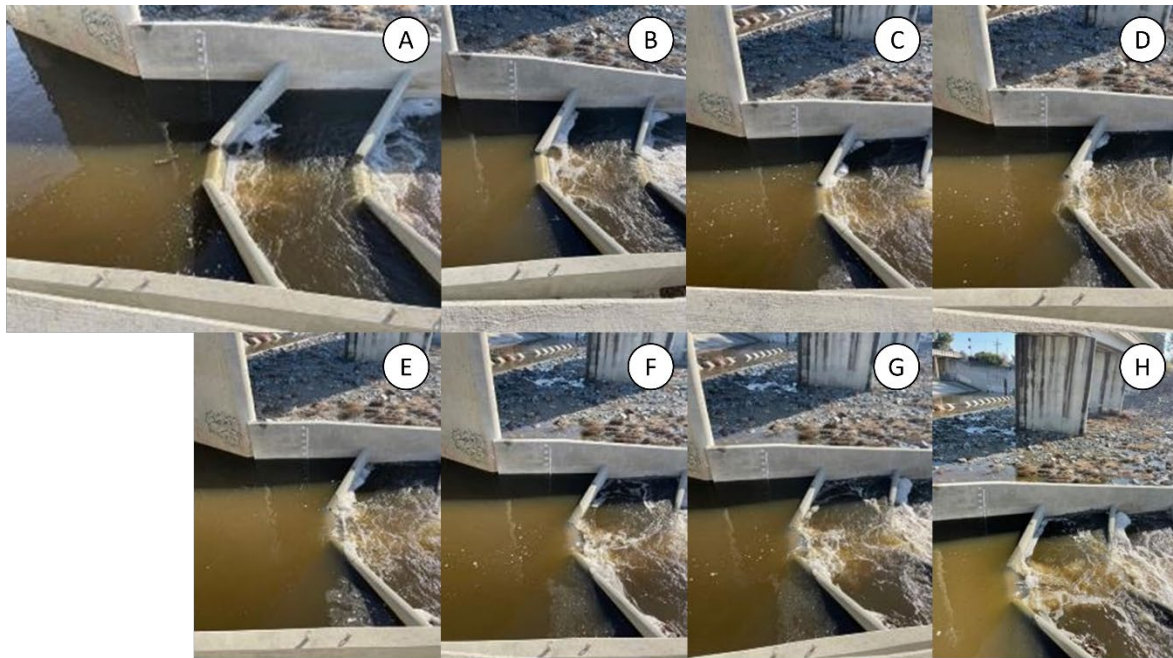
The weir notches begin to flow at about WSE of 35.5 ft (estimated from Figure 4-8A). Inundation of the dragon's teeth begins about WSE 36.0 ft (Figure 4-8C). The notches begin to overtop somewhere around WSE 36.2 ft (Figure 4-8D, E). As flows recede between WSE 37 ft and 36 ft, stranding potential is identified below RD1 (Figure 4-8F,G,H). This assisted ACWD in their understanding of ladder and channel function under a range of test flows. The  $R^2$  between flow in the ladder and WSE was 0.78 (Figure 4-9). While this is a good fit, more measures are needed, and so it is recommended that expansion of monitoring of gauge measurements at flows outside of this range be completed.

Figure 4-8: Water surface elevation changes in the lower fish ladder during start-up testing on 15 December 2022. Time and WSE is recorded for each image in the table at bottom. Notes: C) 36 ft. is the beginning of dragon teeth inundation, F) water beginning to pool in sediment below the dragon teeth apron at 36.3 ft, and G) channel flowing to the south of the ladder above 36.3 ft.

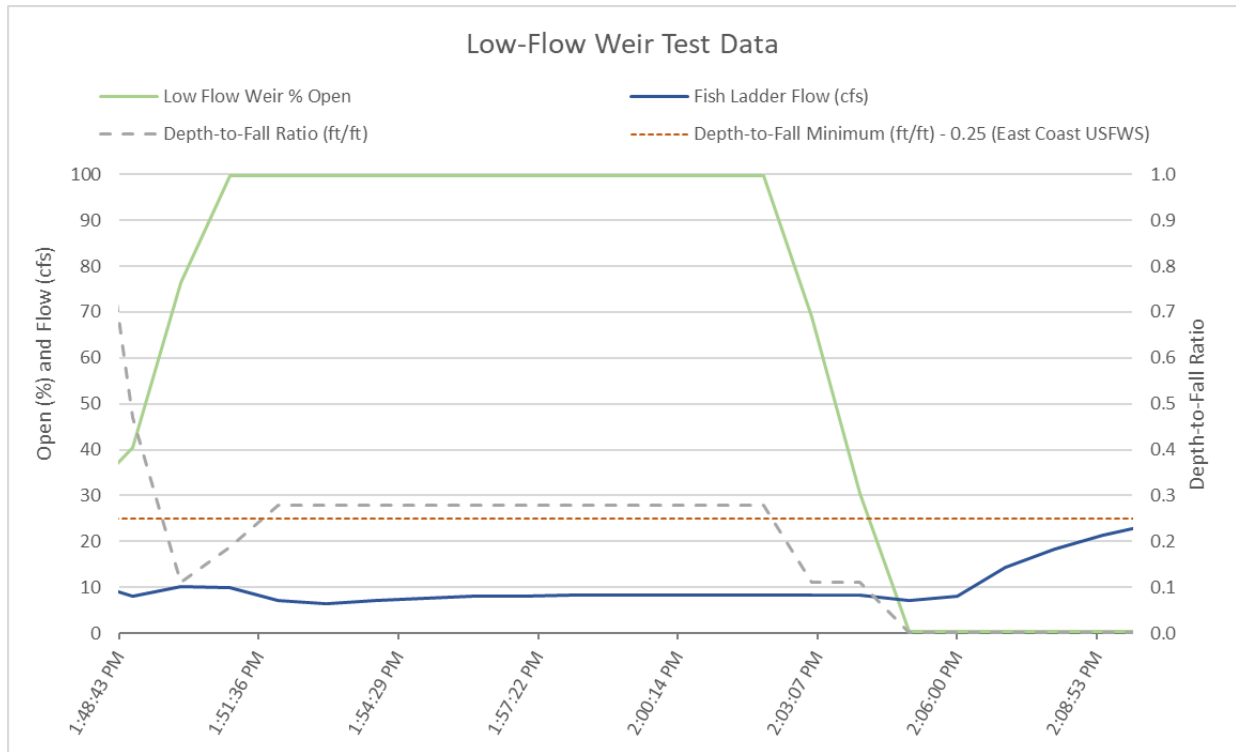
Depth-to-fall ratios calculated during low-flow gate testing met the BODR minimum threshold of 0.25 ft/ft at flowrates greater than approximately 8 cfs. At flowrates lower than about 8 cfs it is expected that baffles could be installed in the vertical slots between Pools 20, 19, and 18, to increase the water depth in pool 20, and maintain the 1-foot head drop criteria between pools downstream of Pool 20. During out-migration season, the low flow gate is not expected to be used at flow rates below 8 cfs unless additional exit gates, mainly exit gate 5, provide flow and additional water depth in Pool 20 below the low flow gate. Figure 4-10 below shows the low flow gate testing data collected on 12 December 2022.

Figure 4-10: Low flow gate test data to evaluate depth-to-fall criteria. Minimum recommended depth-to-fall ratio is met when flow through the low flow gate is a minimum of approximately 8 cfs.

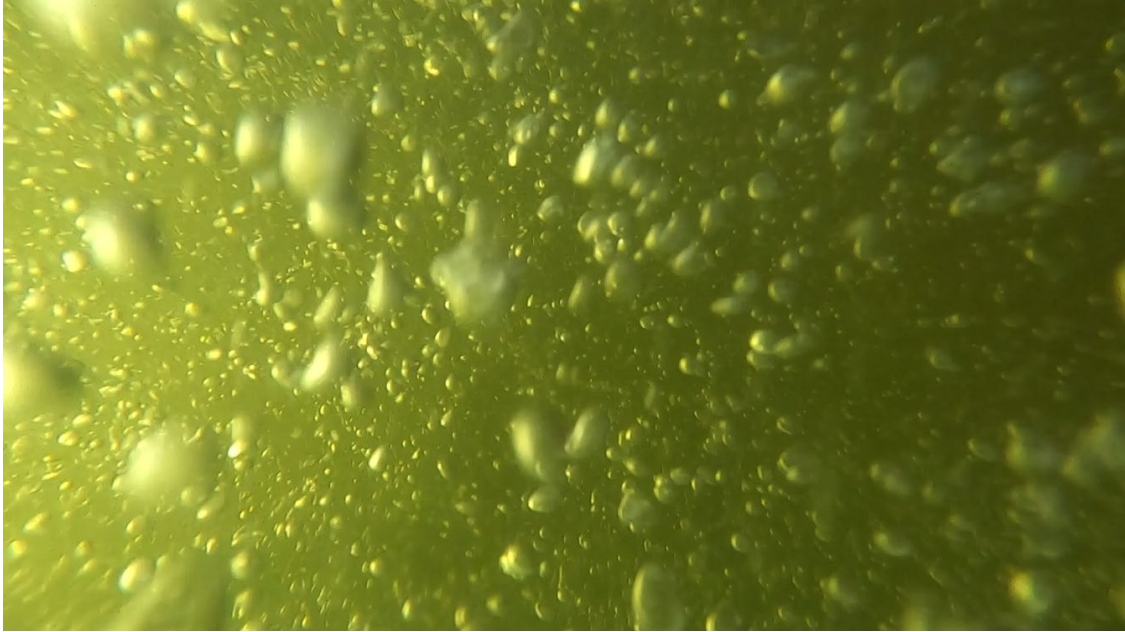
*Figure 5-6. Video 2; High Turbulence/ Bubbles; Ladder Pool 1. 25 April 2023.*

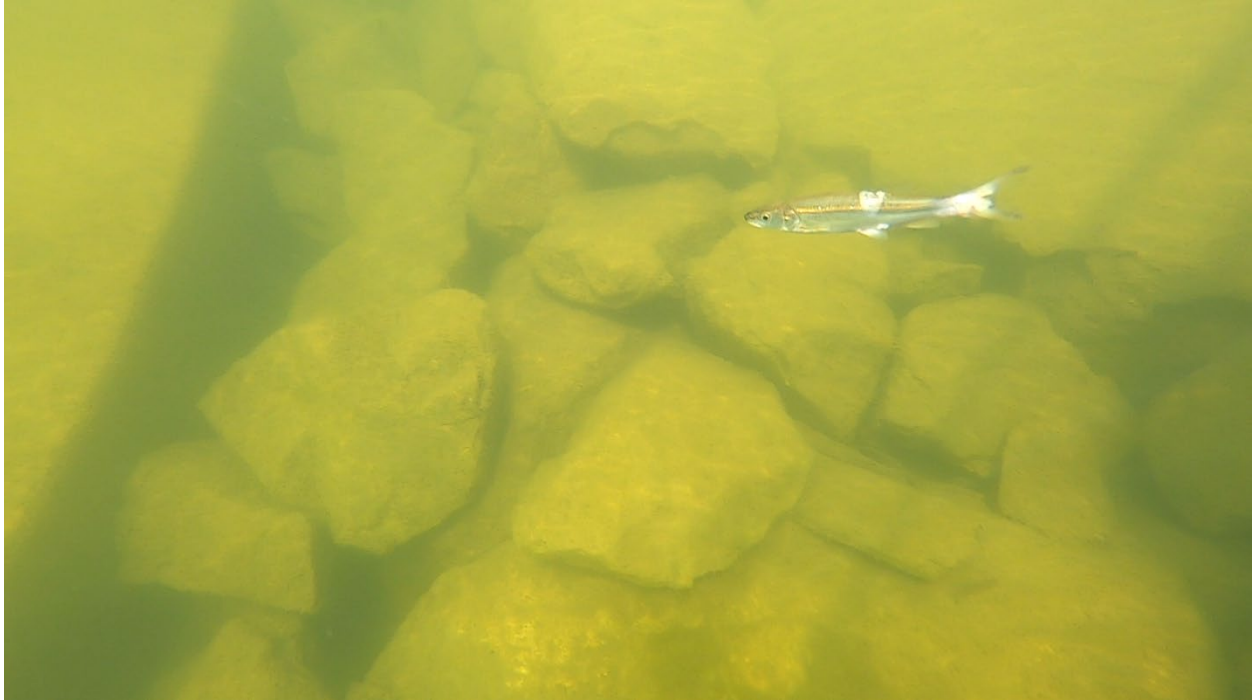
Figure 5-12. Juvenile Sacramento Pikeminnow from Video 1. Note possible bird scars and infection.

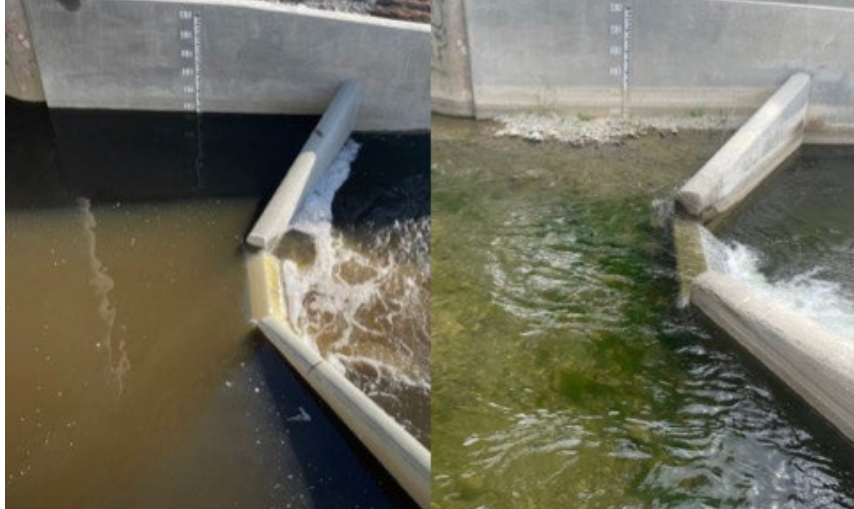
During system surveys in the early summer of 2023, it was determined that the above normal runoff in Alameda Creek deposited a relatively high volume of sediment (e.g., gravel, sand, silt) within the lower ladder of RD1 (see Figure 5-13). Unlike the upper portion of the RD1 fish ladder, which utilizes a vertical slot design, the lower ladder at RD1 uses a vortex pool and chute design. ACWD therefore set up a field survey of depths and velocities within the lower ladder to determine to what extent passage criteria were impacted by the sediment.

Figure 5-13. Demonstration of sediment deposited at the upstream extent of the RD1 lower ladder. Photo on the left was taken on 15 December 2022 and photo right was taken on 21 August 2023.

Jump heights and pool depths met adult passage requirements (Table 5-2). During the survey of submerged orifice sedimentation, only 1 orifice in the 5 total bays we had access to (10 total holes), was open (Figure 5-13 and Figure 5-14). The other 9 holes were under at least 1 ft of sediment.

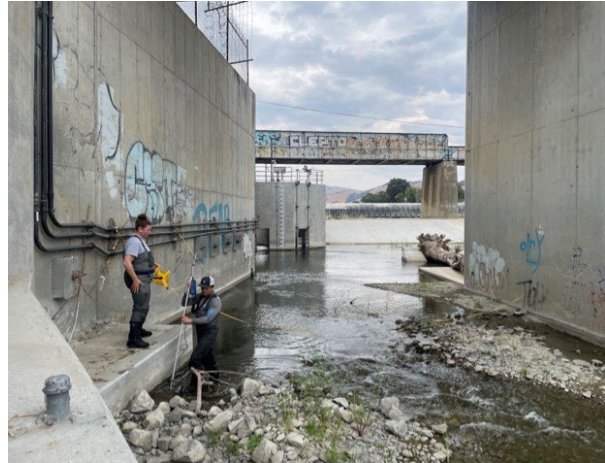
Figure 5-15: Site 5 Transect above lower fish ladder entrance.

Results from this survey suggest some impediment for adult and juvenile salmonid passage at the lower RD1 fish ladder (Figure 5-15). In general, water depths at critical riffles identified at the entrance and exit of the lower ladder would expose backs, eyes and portions of gills of larger adult salmon for short distances. This may in turn, expose them to greater chances of predation and/or stress although these shallow riffles (~<15 ft) could be negotiated. Jump heights and pool depths within the sediment-filled ladder were well within adult salmon capabilities. However, when passing this style of ladder, fish have the choice of leaping or swimming over the weir or swimming through the orifice, and it is NMFS' experience that most salmonids prefer to swim through the orifice (NMFS 2022). Because the submerged orifices are generally full of sediment, juvenile and adult salmonids might be confused during low flows or be exposed to predation, especially by birds if they were forced to swim near the surface to negotiate the weirs.
