The California Department of Transportation (Caltrans) approved the <u>Niles Canyon Safety</u> <u>Improvements Project</u> to improve safety along State Route (SR) 84 within the Niles Canyon corridor in Alameda County. Improvements will include replacement of the reinforced box culvert at Stonybrook Creek with a single-span bridge and associated creek channel improvements.

Niles Canyon Safety Improvement Project Alameda County, California Proj ID 0414000039 EA 04-2A3321

Stonybrook Creek Geomorphic Assessment

Stonybrook Creek Culvert Replacement Bridge Design Report Niles Canyon Safety Improvements Project (04-2A332)

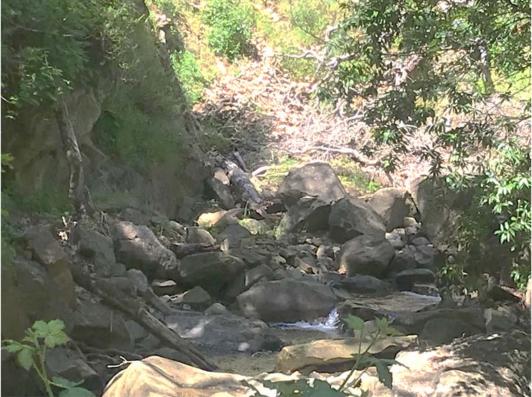
Photo 1. Stonybrook Creek Approximately 1 Mile Upstream of SR 84, Facing Upstream (April 2019)

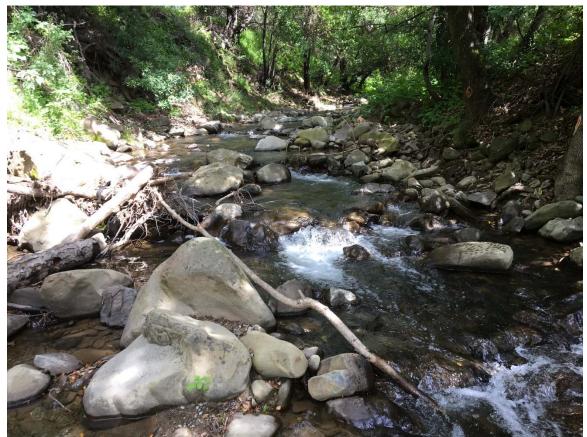
Photo 3. Boulder Step Pools Upstream of the Existing Culvert, Facing Upstream, (April 2019)

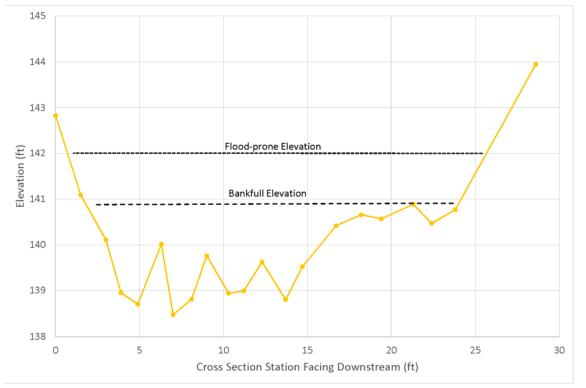
Figure 6. Cross Section of Stonybrook Approximately 50 feet Upstream of the Existing Culvert, Geomorphic Survey, April 2019

The bankfull width is approximately 21 feet, and depth is approximately 1.2 feet, which calculates out to a bankfull area of 25.2 square feet and a width to depth ratio of 17.4. The flood-prone width is estimated to be 28.6 feet, giving the channel an entrenchment ratio of 1.3, which is considered entrenched.

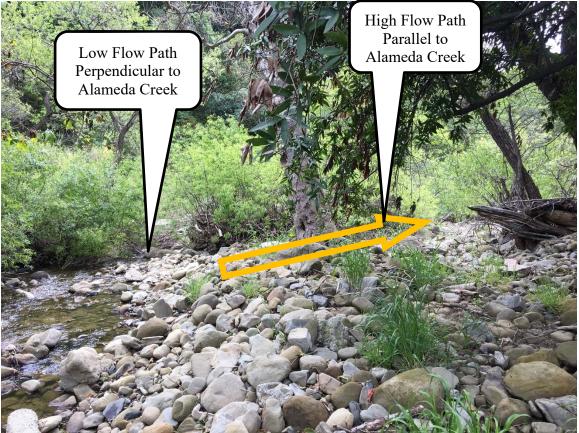
There is no exact boundary between Stonybrook Creek and Alameda Creek. Observations made in April 2019 indicated that at low flows, Stonybrook Creek has a direct flow path and enters Alameda Creek perpendicularly (see Photo 4). This flow path includes a step pool complex that appears to be at the bankfull elevation of Alameda Creek (see Figure 7). Located at the step pools and running perpendicular to Stonybrook Creek but parallel to Alameda Creek, there are well-established willows running at least 50 feet along the length of Alameda Creek upstream and downstream of Stonybrook Creek. From the perspective of Alameda Creek, these willows are part of the riparian habitat near the bankfull level of Alameda Creek. It is believed that during high flows, when Alameda Creek flows are elevated, Stonybrook Creek flows are prevented from discharging to Alameda Creek along the low flow channel. It is believed that high flows from Stonybrook Creek flow parallel to Alameda Creek in the downstream direction for at least 50 feet. This theory is supported by observations of a cobble-lined channel located above the well-established willows of Alameda Creek that appears to be the flow path of Stonybrook Creek when Alameda Creek has high flows.

Photo 4. Facing Downstream of the Existing Culvert, Stonybrook Creek (April 2019)

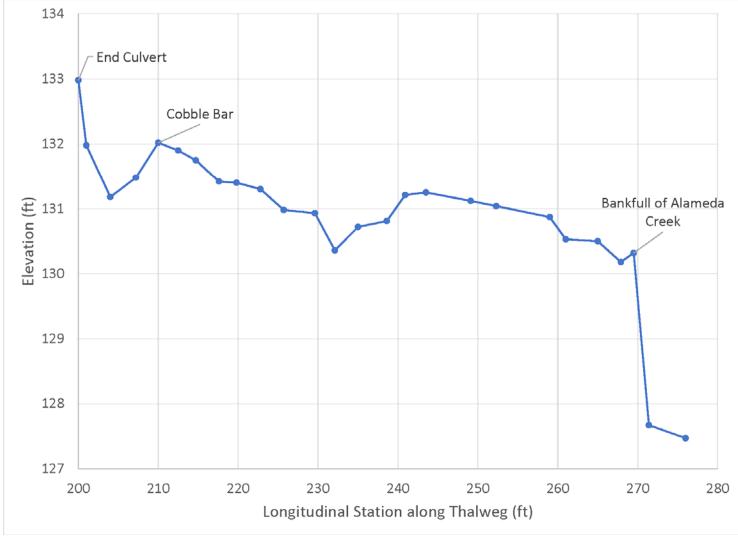
Figure 7. Longitudinal Profile of Stonybrook Creek Downstream of the Existing Culvert, Geomorphic Survey, April 2019

Flow discharging from the existing culvert has formed a scour pool which was about 2 feet deeper than the culvert outfall (see Figure 7). This pool is lined with cobbles (see Photo 5), and a cobble bar has formed a short distance (about 10 feet to the crest of the bar) downstream of the culvert outfall. The cobble bar extends across the channel and in the downstream direction. The right bank is composed of cobbles as well, and the channel Stonybrook Creek follows when Alameda Creek flows are high is composed of well-sorted cobbles and is clear of vegetation.

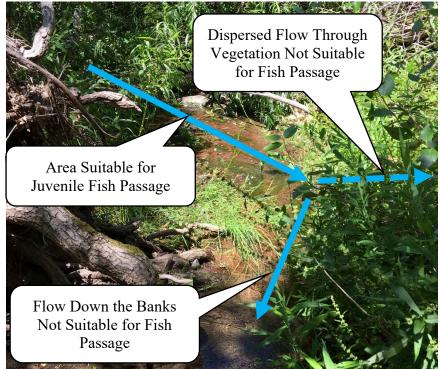
Photo 5. Low Slope Flow Path (June 2019)

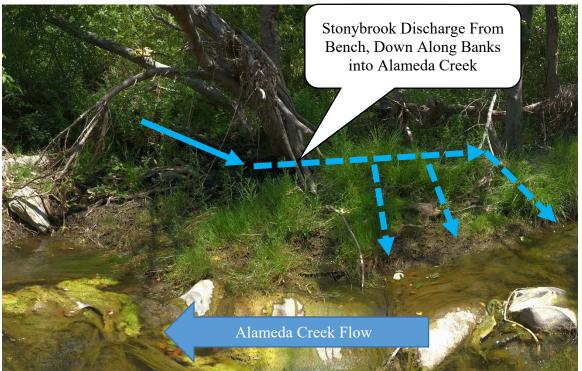
Downstream of the willow and debris, the channel flowed along a bench of Alameda Creek parallel and opposite to the flow of Alameda Creek. The bench is approximately at the elevation of bankfull flows in Alameda Creek. The flow from Stonybrook Creek along the bench was about 2 feet wide, flat, with a bed composed of fine sediments, fine roots, and few large cobbles (see Photo 5). About 15 feet downstream of the willow and debris, the flow split again with about half flowing off the bench and down the bank directly into Alameda Creek and half continuing along the bench further before dispersing through vegetation along the bench before flowing into Alameda Creek (see Photo 6). Flow along the bench appeared suitable for juvenile fish passage, but where the flow went down the banks of Alameda Creek, it appeared to be too shallow and steep to allow upstream migration of juvenile fish.

Photo 6. Right Bank of Alameda Creek Showing Stonybrook Creek Discharge (June 2019)

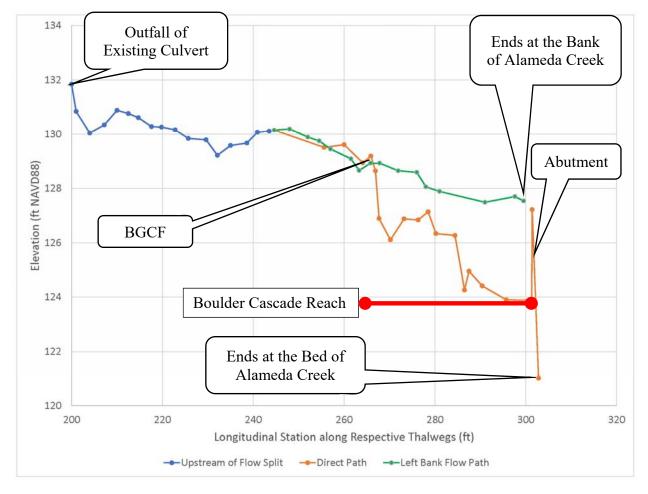
A geomorphic survey was taken of the two flow paths to compare the slope of the flow paths (see Figure 3). The geomorphic survey found that the more direct flow path over the BGCF was steeper than the other flow path.

Figure 3. Longitudinal Survey of Stonybrook Creek

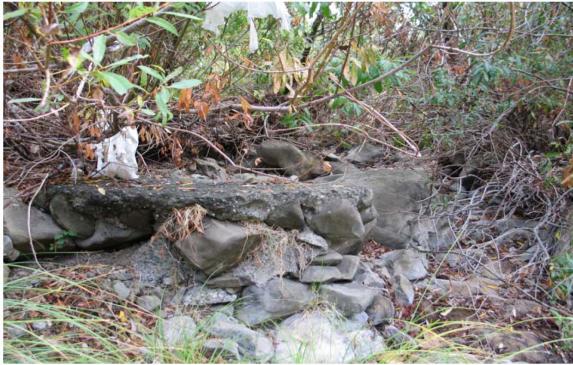
In the 2005 memorandum, CDFW describes the old road remnant as an "impediment to sediment movement" to Stonybrook Creek (see Photo 7). Observations made by WRECO during April 2019 found the old road remnant to be away from the thalweg of Stonybrook Creek (see Photo 8). The old road remnant appears to be at or below the elevation of the bankfull of Alameda Creek and therefore, could impact the sediment transport of Alameda Creek, which in turn could impact the sediment transport of Stonybrook Creek. The extent of the old road remnant is not known.

Photo 7. Photo of the Old Road Remnant from the CDFW Memo (2005)

5. Remove the old road remnant and the bridge abutment at the confluence of the creeks (see Attachment). As noted above, these structures are impeding the movement of sediment from the tributary into Alameda Creek. The removal of these structures will help maintain the form of the low flow channel and fish passage through the project reach. As we discussed in the field, these structures should be broken down with a jackhammer and the concrete and asphalt debris removed from the stream corridor. Rock from the road remnant that is relatively free of asphalt and concrete may be left on site. The old bridge abutment should be broken off at ground level; the footing of the structure should be left in place and not exhumed from the substrate, and any exposed rebar should be cut off or ground down so that it poses no hazard to fish, wildlife, or human beings.
