## Road Safety Assessment (RSA)

SR 84 – Niles Canyon Corridor  
Alameda Co., California  
May 2012

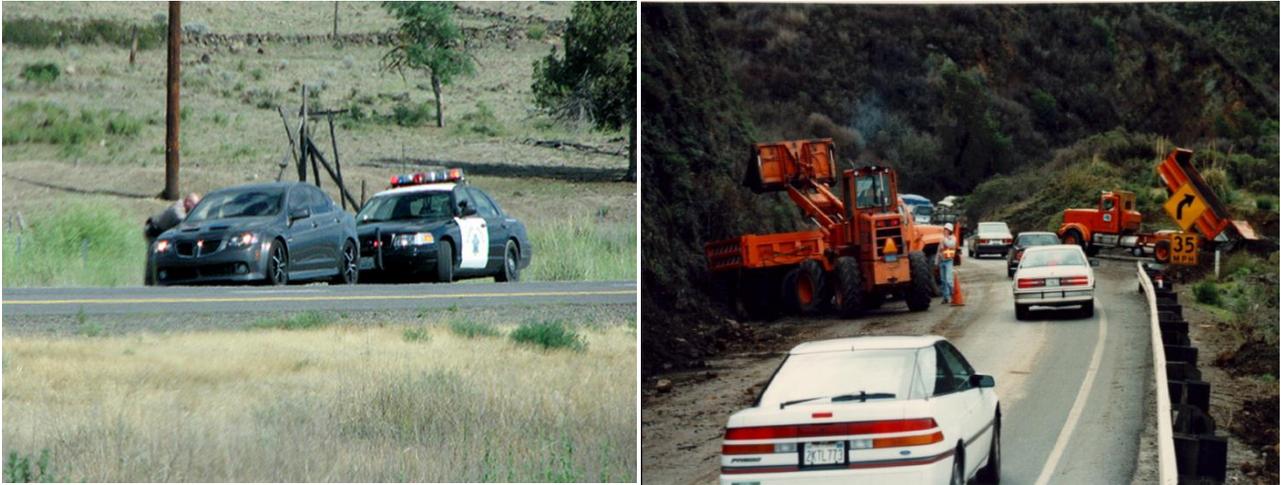
**Figure 9 Shoulders allow for law enforcement and maintenance activities**

The limited width shoulders also limit other important functions of the shoulder, including safe refuge for motorists whose vehicle may break down, a place to walk or bike outside of the travel lane, and work space for road maintenance crews (**Figure 9**).

The relatively few clearly delineated safe stopping locations or pull offs within the corridor leads to reduced traffic violation enforcement and delayed emergency responses. Their scarcity severely limits safe stopping locations for law enforcement stops, as law enforcement officers must wait until the violator reaches areas where the roadway shoulders are improved or visible. Additionally, violators are often unwilling to pull off the roadway when the condition of the shoulder is unknown - risking damage to their vehicle or running off the roadway.

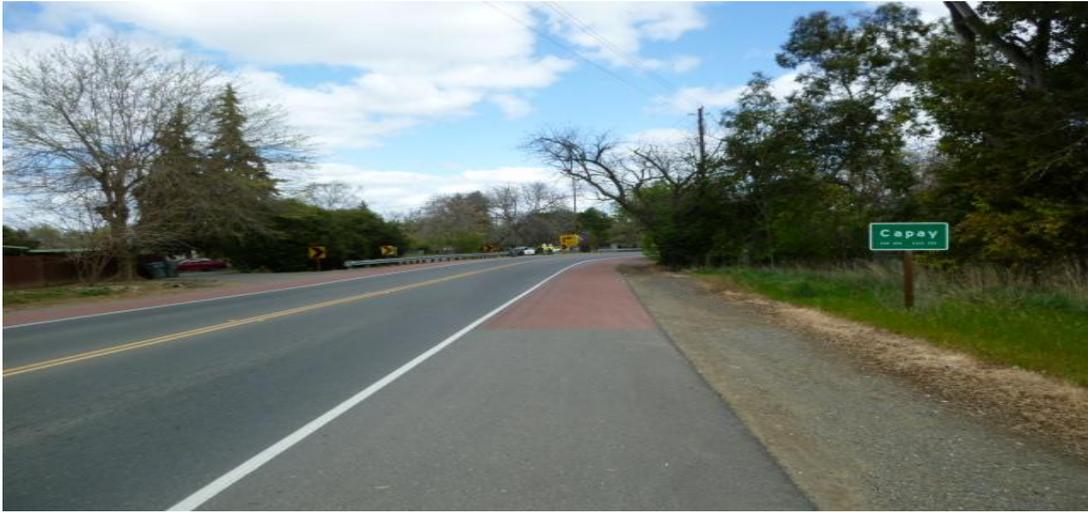
Figure 17: Paved shoulders with contrasting color

In many cases, gravel shoulder “backing” is already sufficiently wide to accommodate additional paved width within the existing roadway “footprint”.

*Providing a contrasting color or texture for the paved shoulder may help calm traffic (control speed) and more clearly delineate road space where drivers should expect bicyclists and pedestrians.*
