#### STONYBROOK CREEK SALMONID MIGRATION BARRIER REMOVAL PROJECT

December 2005

American Rivers and California State Coastal Conservancy

# **CONCEPTUAL DESIGNS FOR TWO** STONYBROOK CREEK SALMONID MIGRATION **BARRIER REMOVAL PROJECTS**

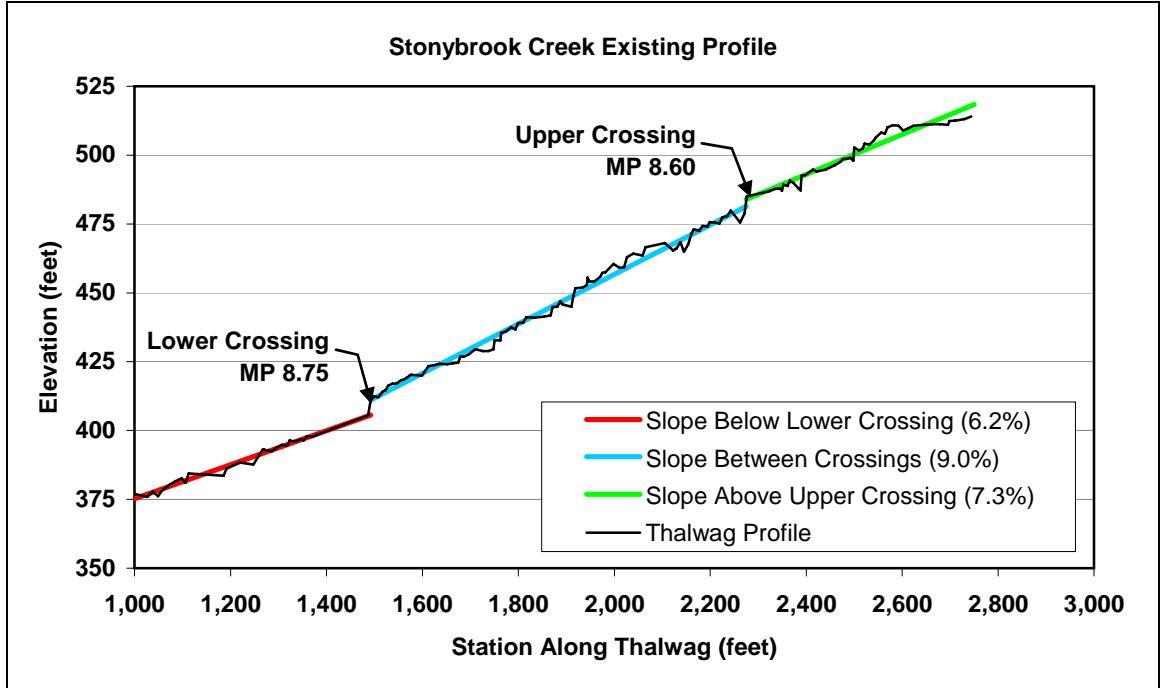
Figure 2.1 - Figure 1 – Longitudinal profile of Stonybrook Creek through the project area. Slopes were estimated using linear regression of surveyed thalweg points, excluding the culverts.

Surveying a longitudinal profile through the project site is essential for developing successful channel designs. Since the two crossings are less than 800 feet apart, we chose to survey one long continuous profile. It extended over 1,700 feet, beginning 455 feet below the downstream crossing to 400 feet above the upstream crossing. The average slope of the surveyed channel was 8.7 percent. However, the slope varied substantially above and below each of the crossings, ranging between 6.2 percent below the downstream crossing to 9.0 percent between the two crossings (Figure 1).

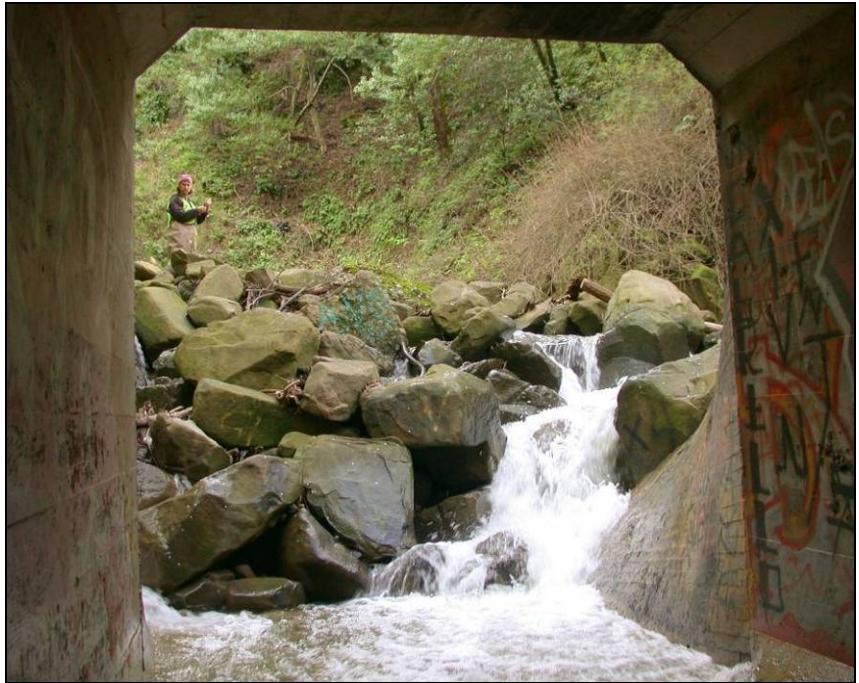
Figure 2.2 - Inlet of the downstream crossing (MP 8.75), as flow cascades down a 5.5 foot drop over boulders deposited due to the channel constriction caused by the culvert.

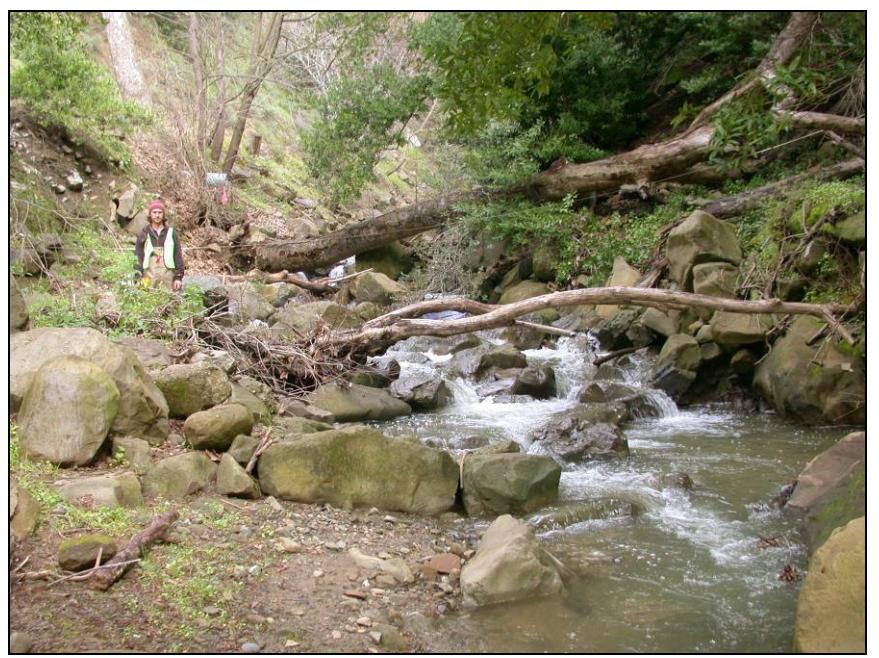
Figure 2.3 - Location of the reference reach, 200 feet upstream of the downstream crossing (MP 8.75)

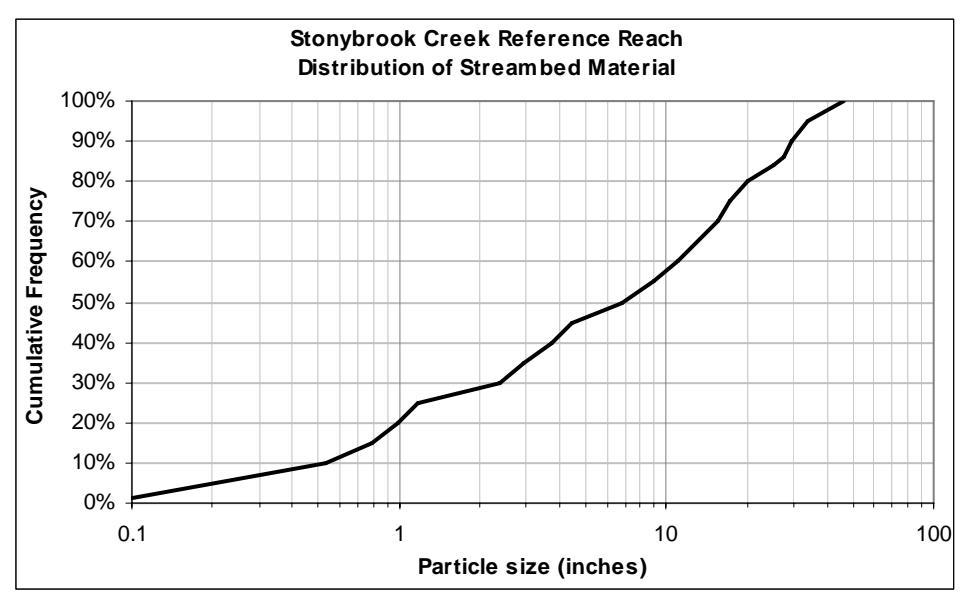
Figure 2.4 - Particle size distribution of streambed material located within the reference reach approximately 200 feet upstream of the downstream crossing.

To characterize the streambed material and aid in estimating appropriate hydraulic roughness, a particle size distribution was created from the pebble count. It found the d84 (84 percent of particles less than the d84) to be approximately 2 feet and the d50 to be nearly 7 inches (Figure 4). These values correspond with large bedload characteristic of a steep stream such as Stonybrook Creek. The material size and distribution is considered suitable for reconstructing step-pools into the regraded channel without needing to import large rock.

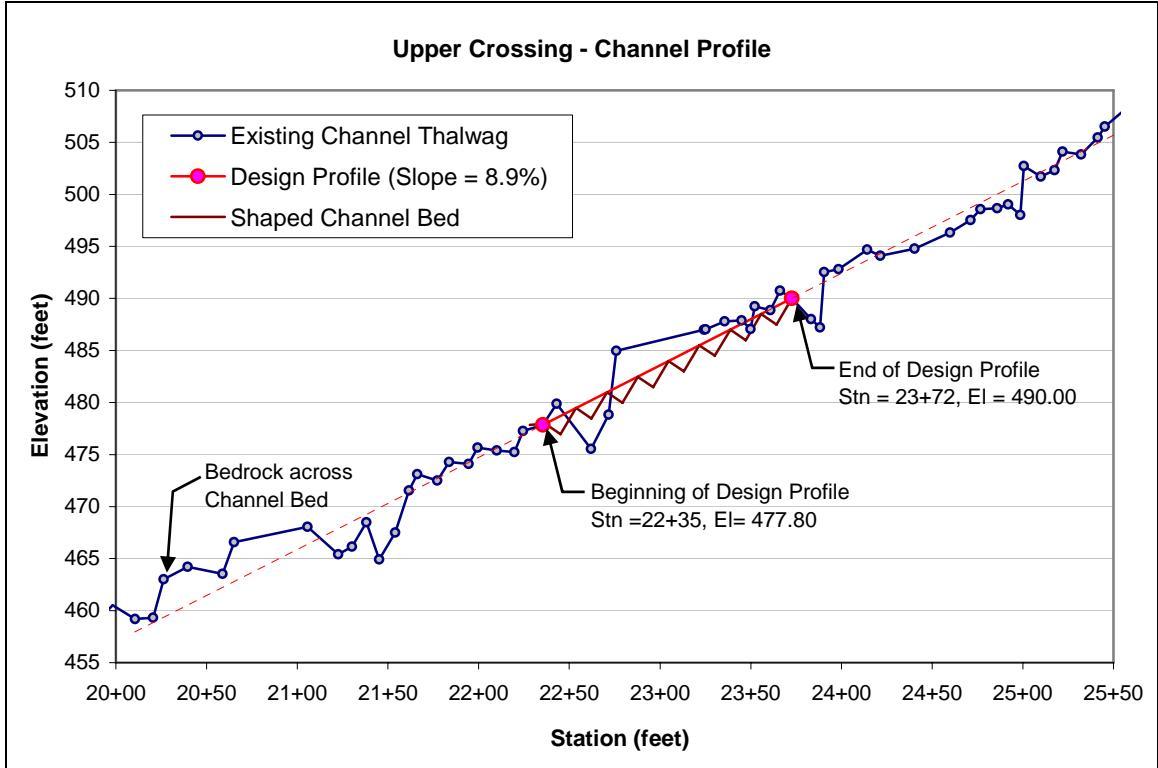
Figure 2.5 - Design channel profile for the upstream crossing at Mile Post 8.60.

Determining stable design slopes at the two crossings required examining the channel grade upstream and downstream, and identifying hard features in the channel that control the stream's grade. For the upstream crossing the stable channel slope is estimated to be 8.9 percent. The channel will be regraded from Station 22+35 to Station 23+72, a total of 137 feet to match the existing adjacent stream grades approximately 100 feet downstream and 200 feet upstream of the crossing (Figure 5). The survey also noted bedrock spanning the channel bottom at a location about two hundred feet downstream of the upstream crossing. Bedrock typically functions as a hard point in the channel, and is expected to prevent the streambed from incising below the upstream crossing following the replacement of the downstream crossing.

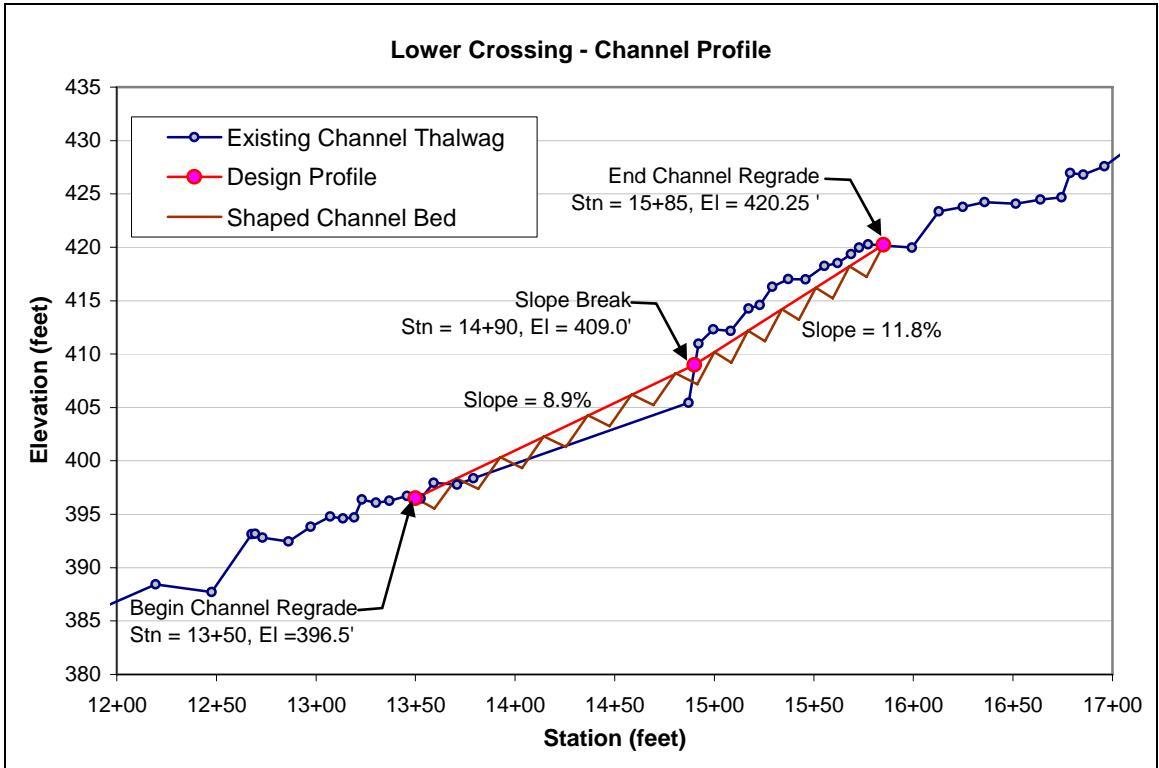
Figure 2.6 - Design channel profile for the downstream crossing at Mile Post 8.75.

at an average slope of 8.9 percent. At Station 14+90 there is a slope break and the design channel grade steepens to 11.8 percent. The regraded channel ends at Station 15+85, approximately 15 feet below a 4 foot high falls over an extremely large stable boulder that spans the channel. A slope break was needed to balance the amount of native streambed material available for grading.

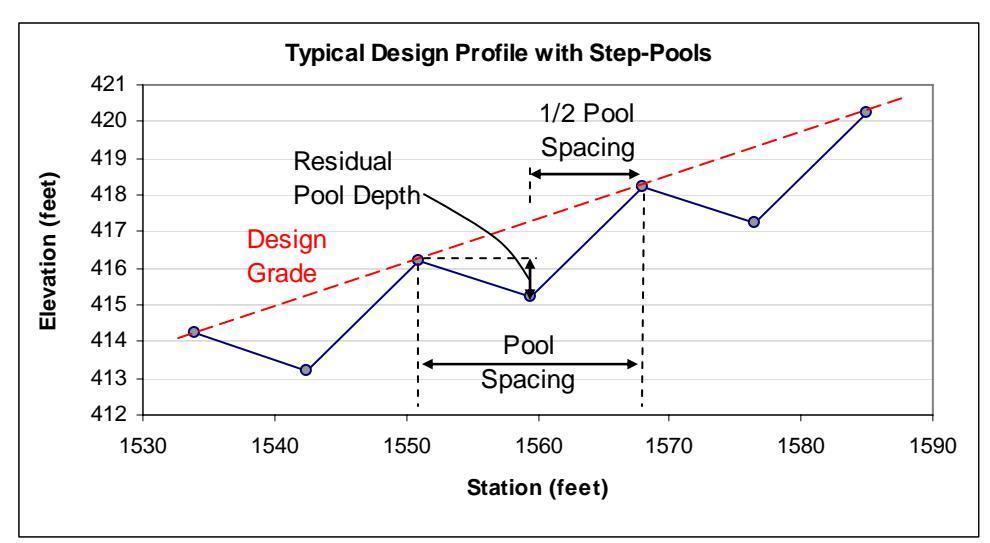
Figure 2.7 - Typical of step-pool configuration for regraded channel sections.

The step-pool design is intended to be relatively easy to construct, provide suitable resting areas for fish, and be shaped in roughly the same configuration that is found in steeply sloping natural streams (i.e., 9 to 12 percent). Specified pool spacing for this project was determined through field observations of the adjacent channel and use of pool spacing relationships developed for other steep streams (Chin, 1999; Zimmermann and Church, 2001) (Figure 7 and Table 3). Additionally, each step pool must have a residual pool depth of one foot to provide adequate

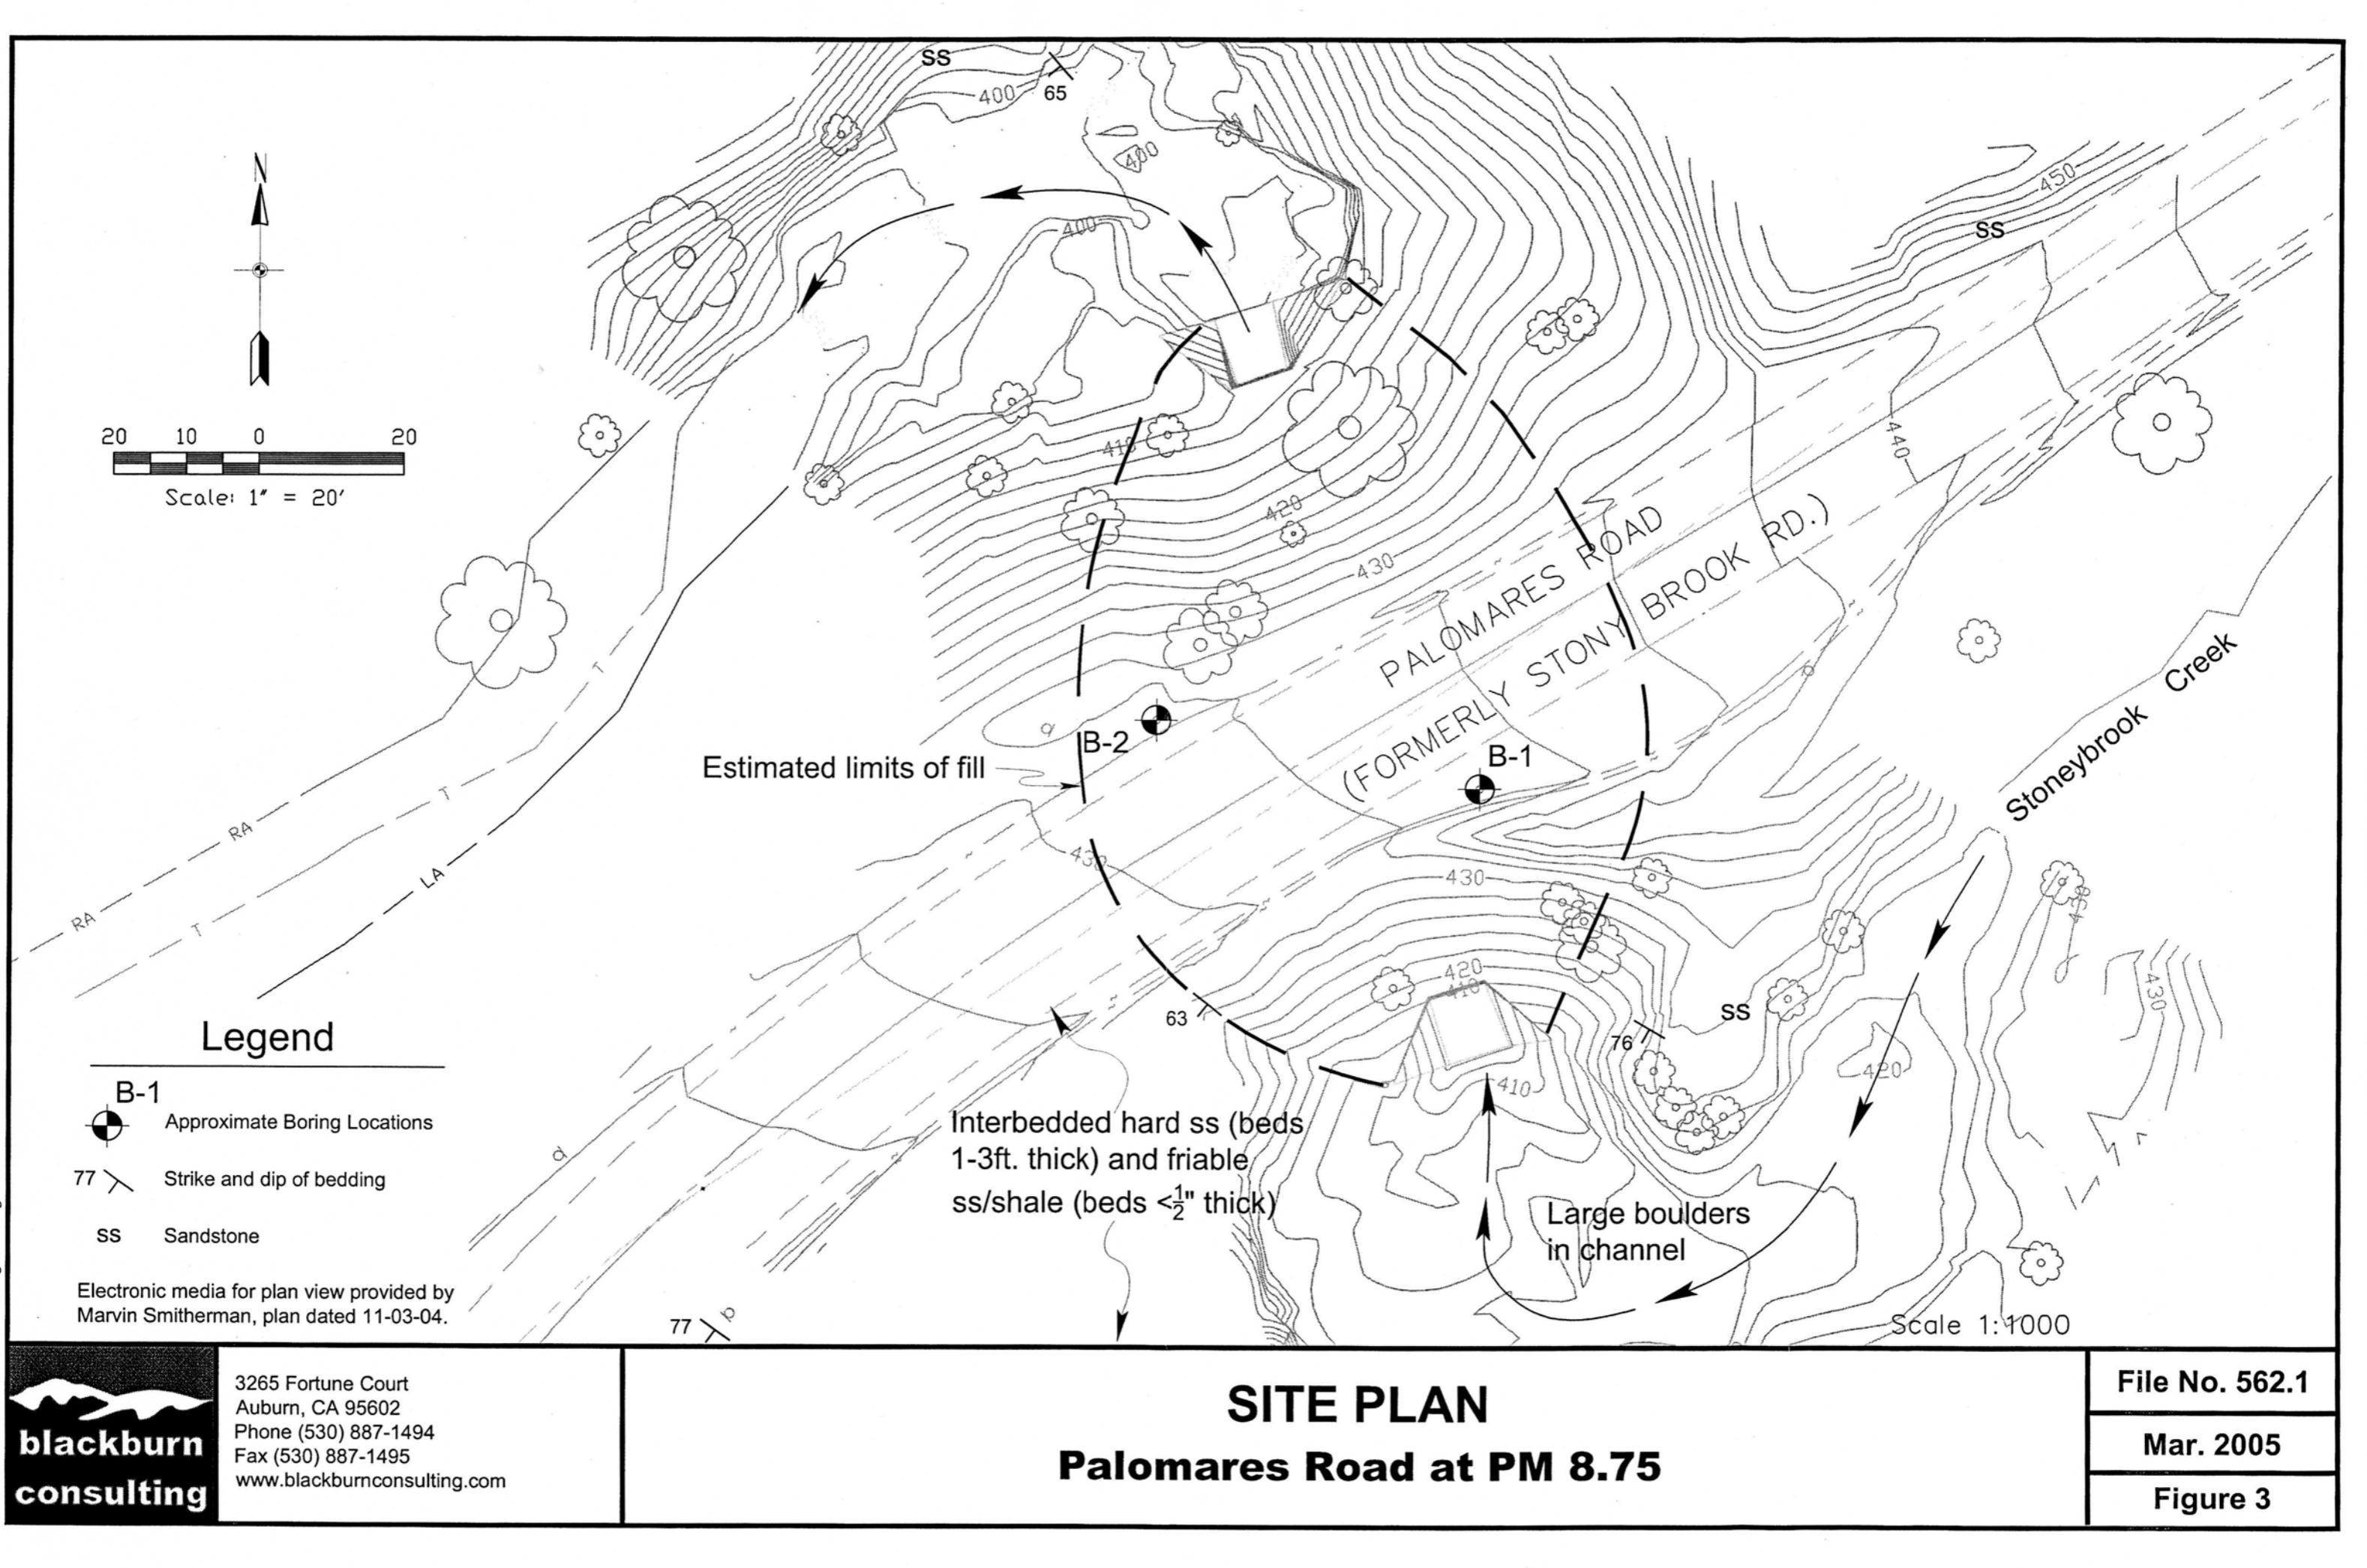
The boring locations are shown on Figures 3 and 4. Detailed logs are included in the Appendix. The degree of weathering and hardness noted on the logs are keyed to the descriptors included in the Appendix.
