Alameda Creek Aquatic Resource Monitoring Report 2007

San Francisco Public Utilities Commission
Water Enterprise
Natural Resources and Lands Management Division
Fisheries and Wildlife Section
Sunol, CA

December 2009

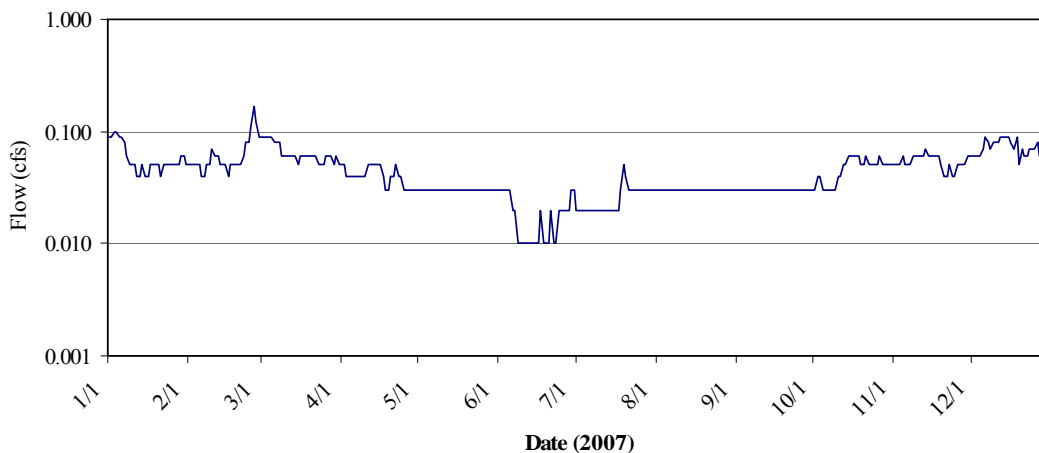
Located in Calaveras Creek at the second weir downstream of Calaveras Dam, this streamflow gauge collected data throughout the year. No water was released from Calaveras Dam during 2007. Flows averaged 0.04 cfs and ranged from 0.01 cfs in June, 2007 to 0.17 cfs on February 26, 2007 (Figure 3-7).

Figure 3-7. Daily mean streamflows recorded at USGS station 11173500, located in Calaveras Creek below Calaveras Dam, for 2007.

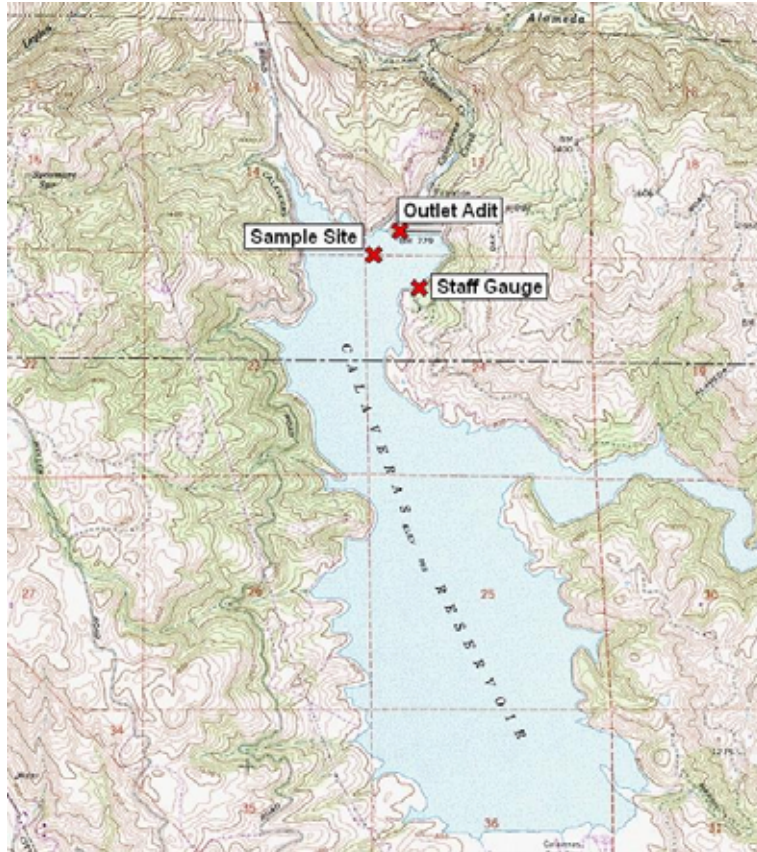
Figure 4-1. Map of Calaveras Reservoir.

Watershed keepers from the SFPUC take Calaveras Reservoir elevation readings daily at about 8:00 a.m., from a staff gauge just south of the dam (Figure 4-1). Readings are maintained by reservoir managers and reported to state resource agencies. Data are presented in acre-feet in this report. Natural Resources and Lands Management Division biologists monitor Calaveras Reservoir water quality conditions approximately twice monthly (Appendix B). Sampling includes measurements taken at ten-foot intervals using a Hydrolab® multi-parameter probe that records *in-situ* water quality conditions including temperature, conductivity, pH, dissolved

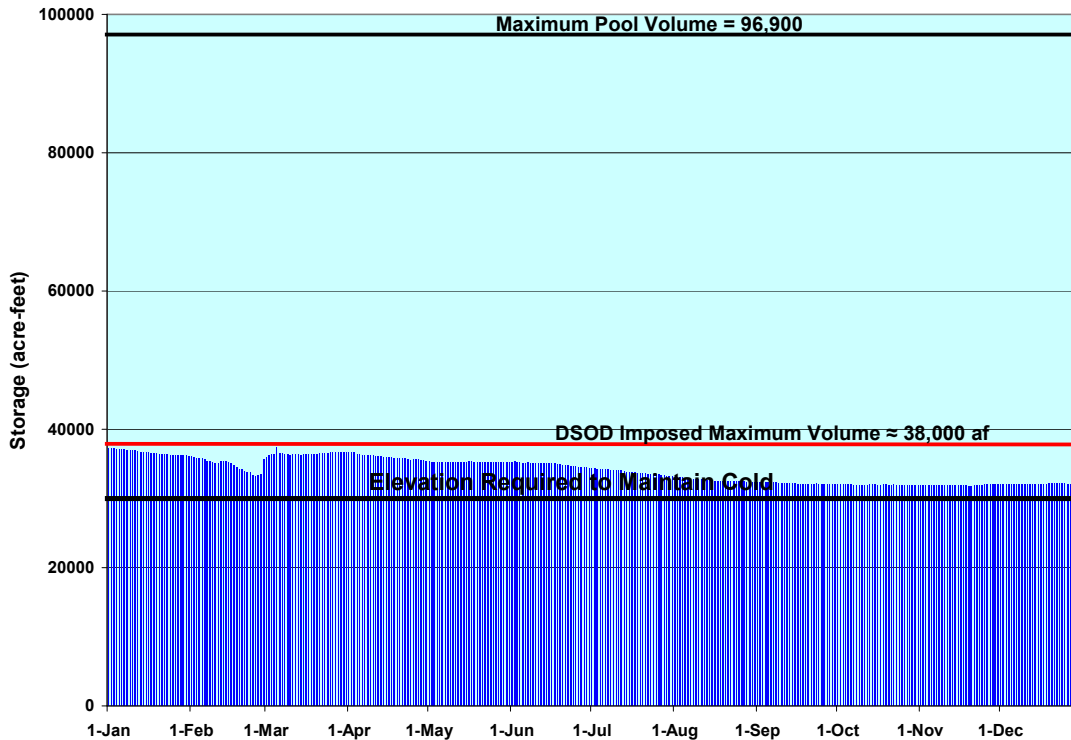
Calaveras Reservoir was operated to comply with both the DSOD restriction and the requirement to maintain the recommended 30,000 acre-feet of storage throughout 2007 (Figure 4-2). Due to the lack of major storm events, and the SFPUC’s need to provide additional drinking water during a scheduled Hetch Hetchy supply shutdown, that objectives were met for the entire year.

Reservoir storage started to decrease in February due to increased demands at the Sunol Valley Water Treatment Plant. In late February, however, several storms produced enough rainfall to result in a peak annual inflow from Arroyo Hondo of 1,680 cfs. The flow in Arroyo Hondo had dropped to below 20 cfs by April, and continued decreasing until seasonal rains returned in October. Reservoir storage also declined slowly during this six month period, but stayed within the range required to maintain the cold water pool below the thermocline.

Figure 4-2. Calaveras Reservoir daily storage 2007

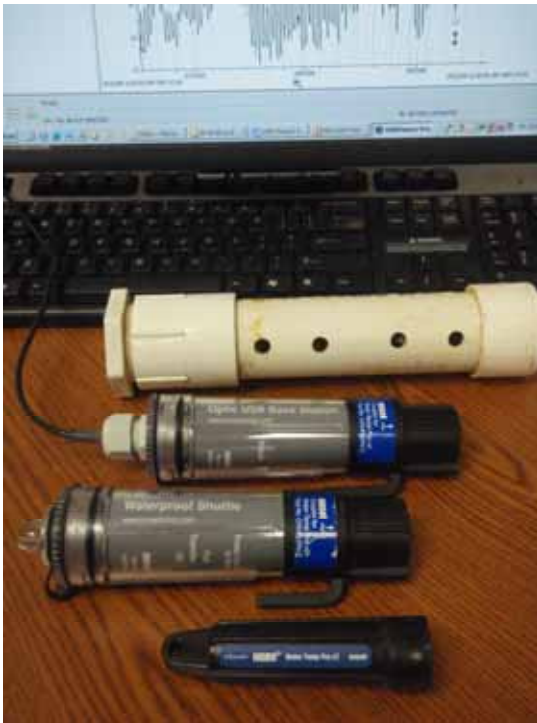
Figure 5-1. *Upgraded temperature recording equipment deployed in 2007.*

Water temperature loggers (Onset, Optic StowAway®, Hobo® H8 and Hobo® Pro V2 temperature recorders; Figure 5-1) were deployed in a variety of protective cases, including PVC and steel pipes, pipe insulation as padding, and proprietary protective sensor sleeves, attached by means of swaged stainless steel cabling to a variety of rebar, stakes, and existing structures as anchors. A typical deployment is pictured in Figure 5-2. Sensor locations are concealed on public lands to prevent tampering or vandalism.

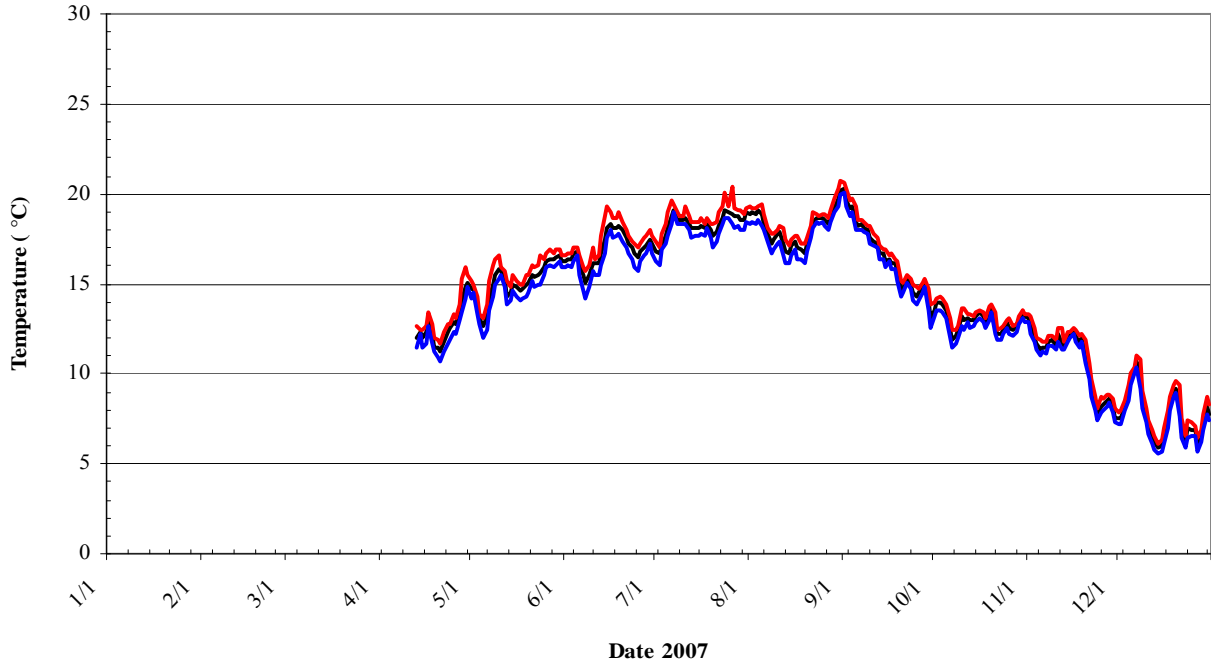
Figure 5-11. Daily mean (black), maximum (red) and minimum (blue) water temperatures at Station T-10 in Calaveras Creek.

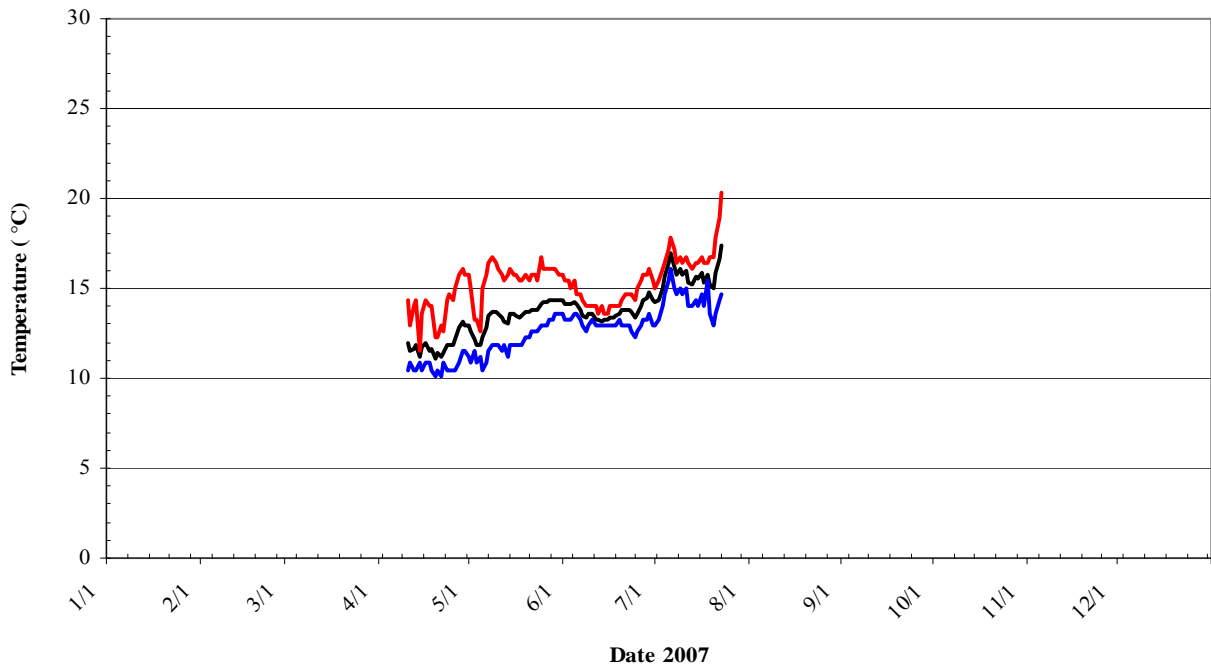
Figure 5-12. Daily mean (black), maximum (red) and minimum (blue) water temperatures at Station T-12 in Alameda Creek.

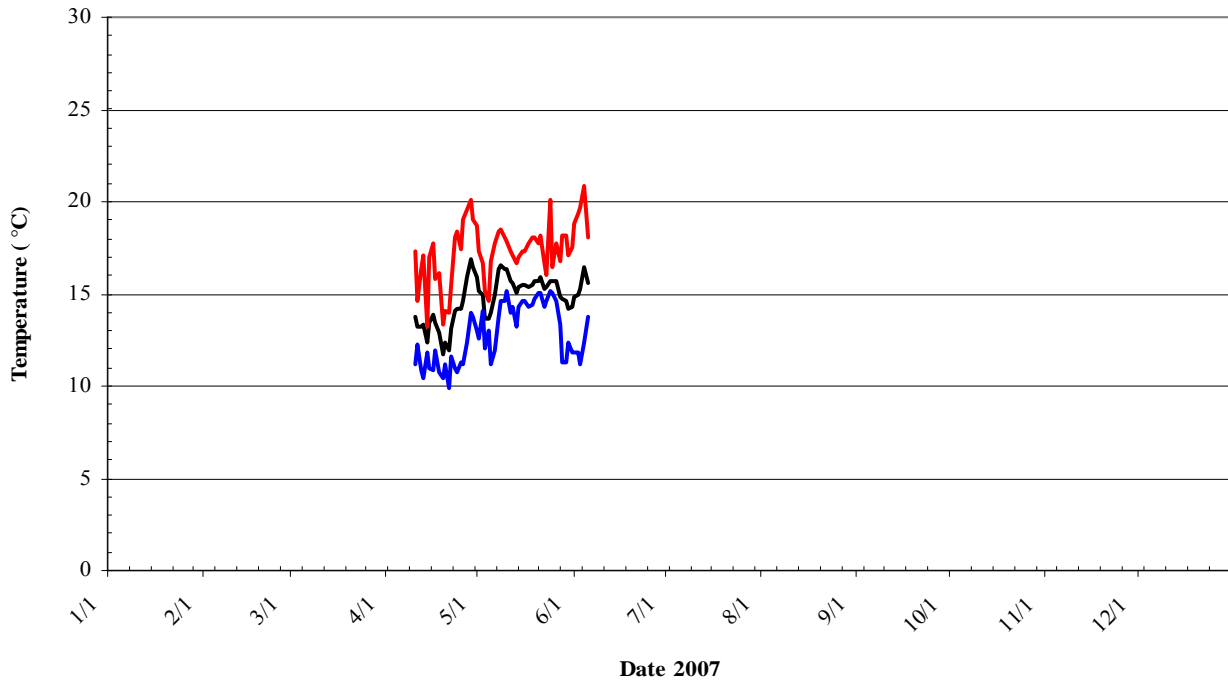
Figure 5-15. Daily mean (black), maximum (red) and minimum (blue) water temperatures at Station T-15 in Alameda Creek.

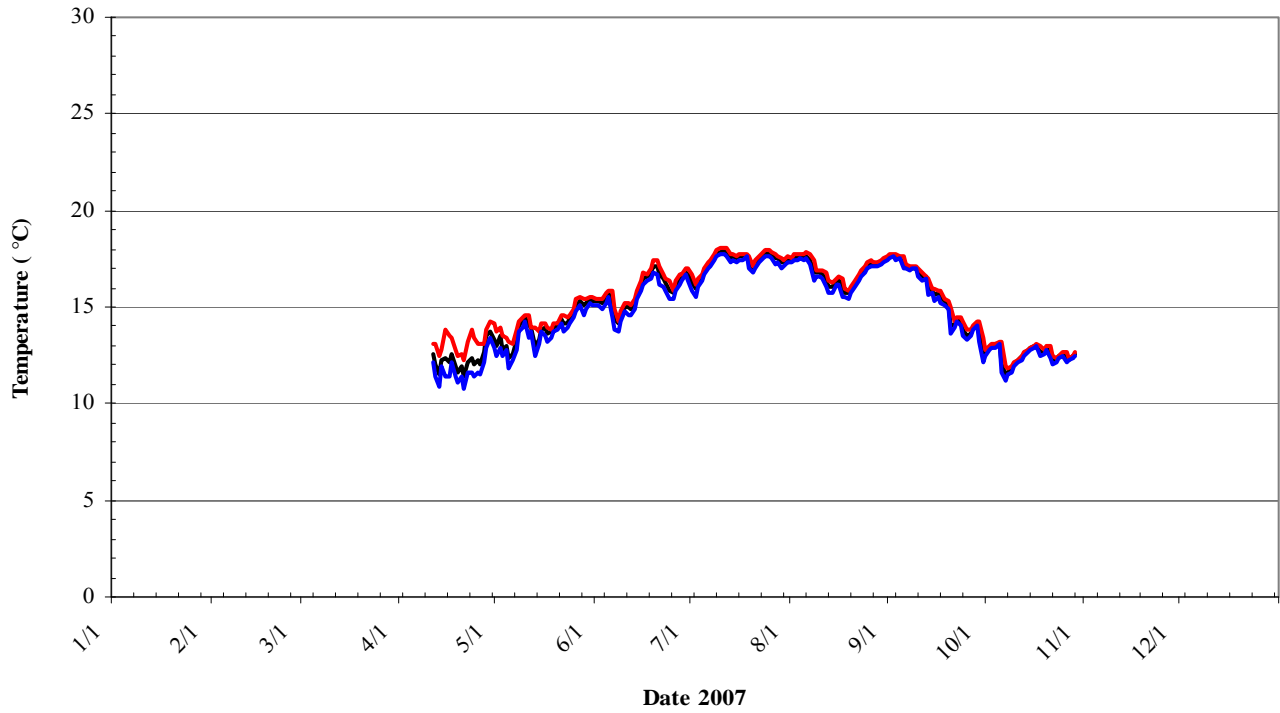
Figure 5-21. Daily mean (black), maximum (red) and minimum (blue) water temperatures at Station T-22B in Arroyo Hondo.

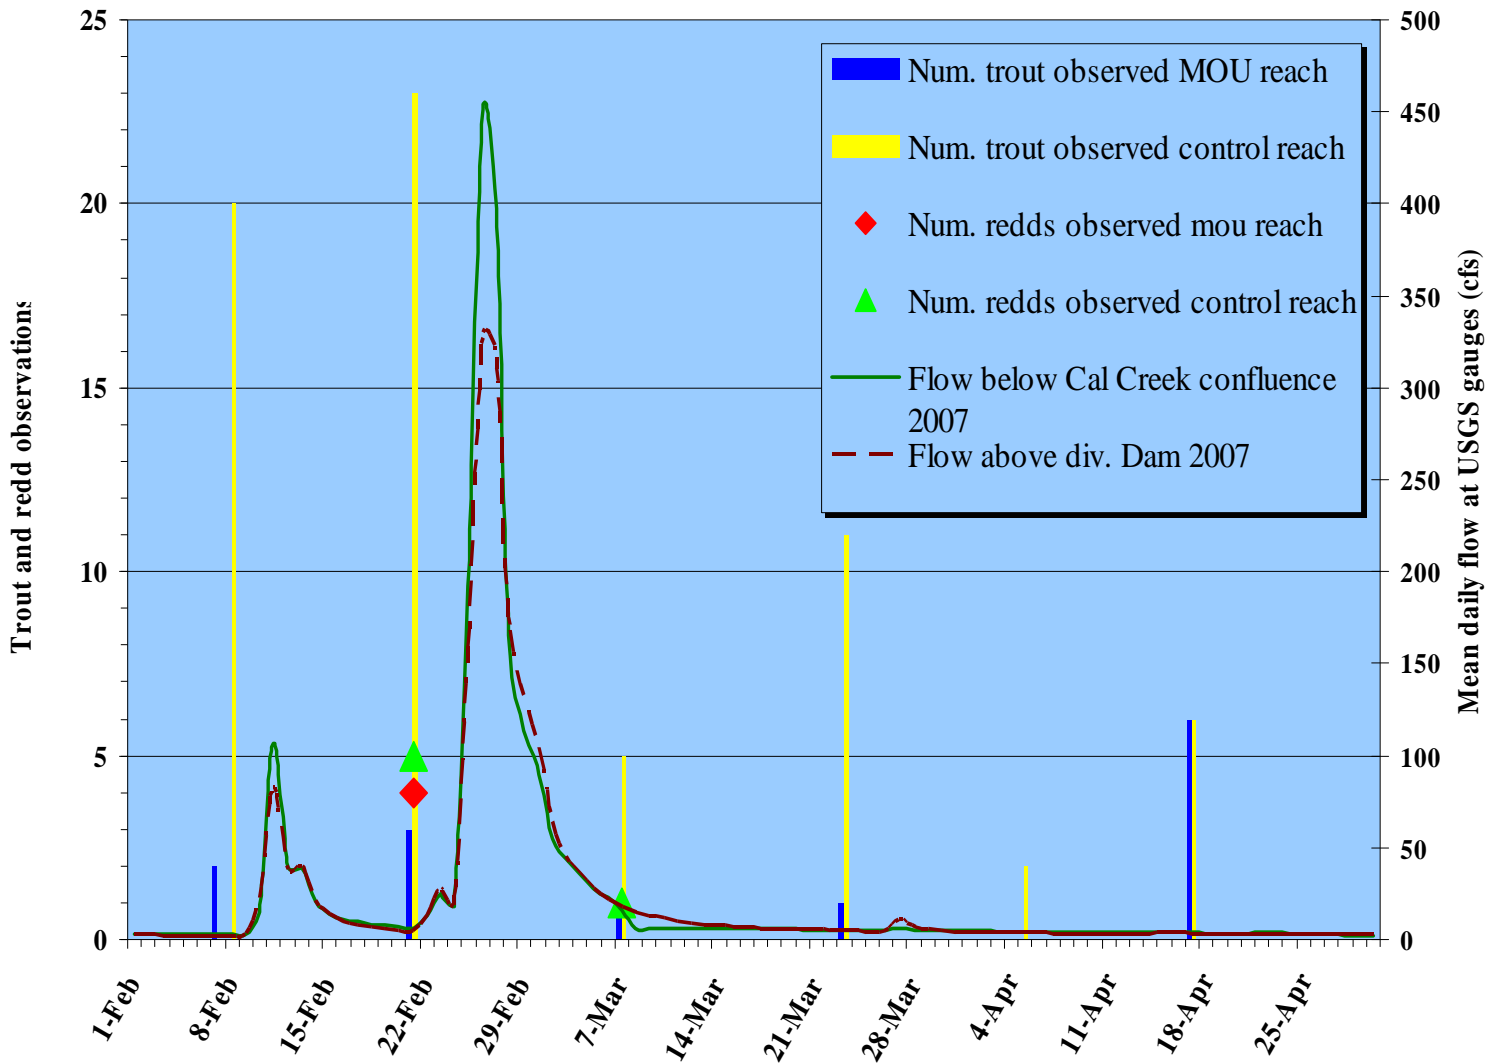
Figure 6-3. Rainbow trout and redd observations, and Alameda Creek flows, for the 2007 spawning season.

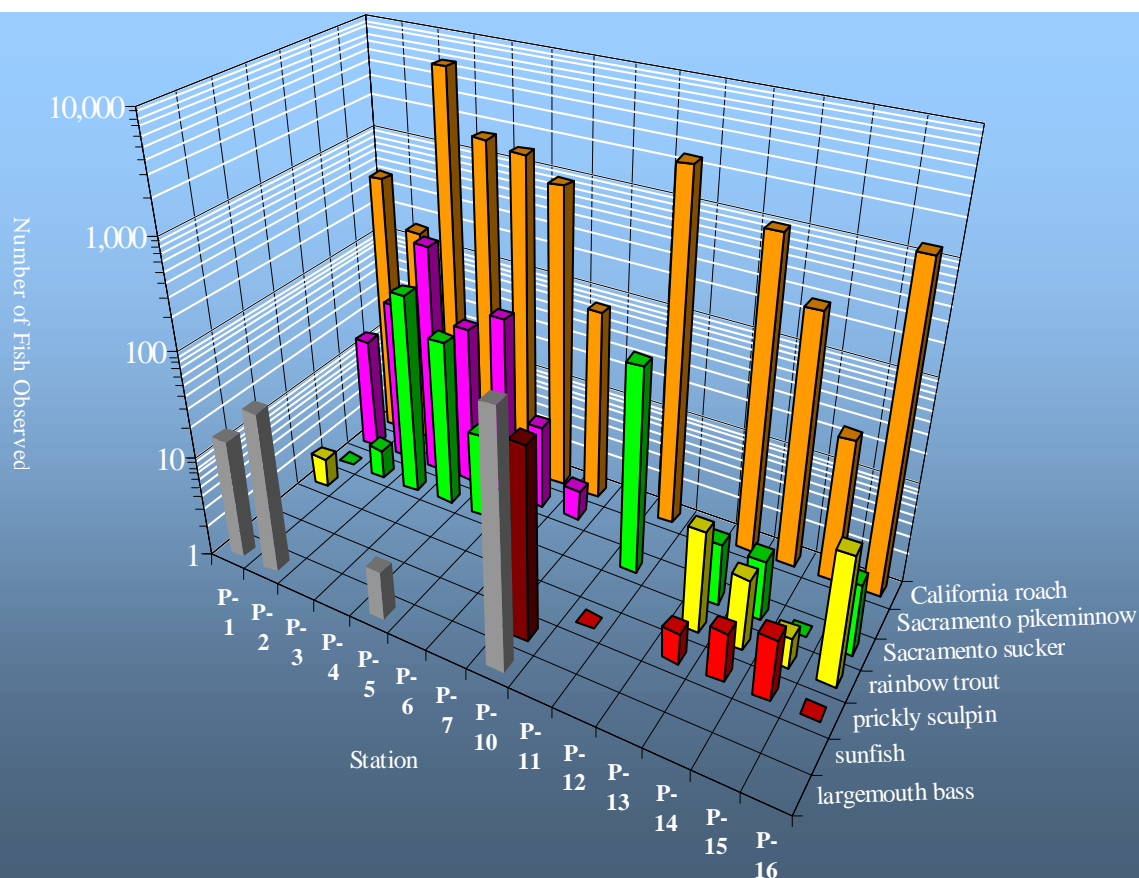
Figure 7-4. Number of fishes observed by pool during snorkel surveys for 2007.

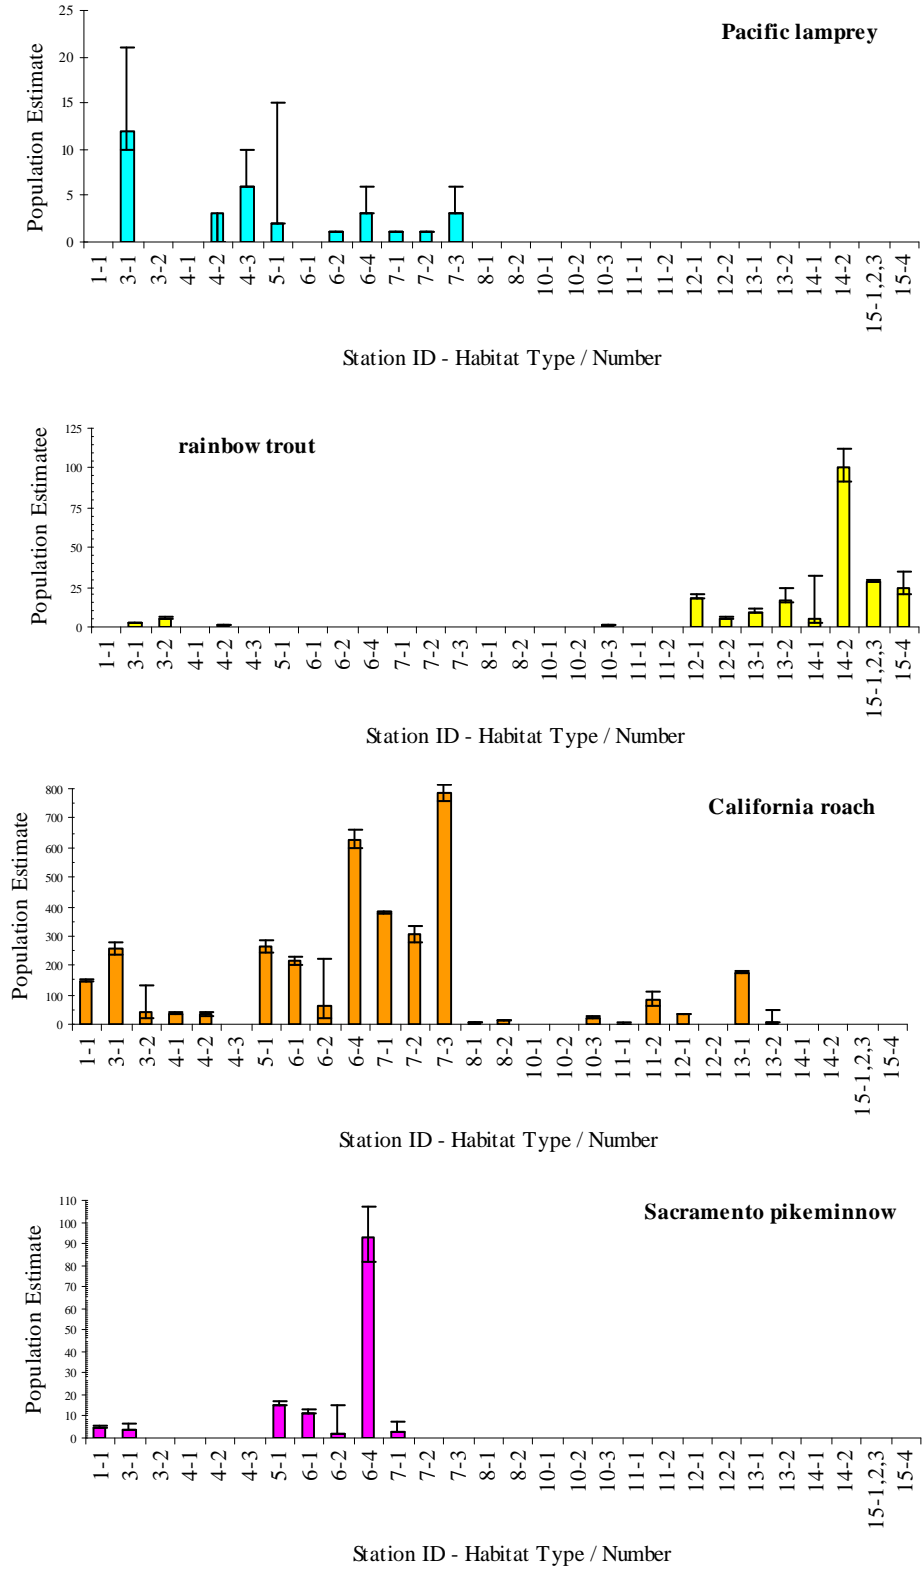
Figure 8-5. Population estimates and 95 percent confidence intervals for each species by station and habitat type for the autumn 2007 electrofishing surveys.
